CASTELL PEN-YR-ALLT, LLANTOOD, PEMBROKESHIRE: GEOPHYSICAL, TOPOGRAPHICAL AND PHOTGRAPHIC SURVEY

Prepared by Dyfed Archaeological Trust
for Cadw

RHIF YR ADRODDIAD / REPORT NO. 2017/11
RHIF Y DIGWYLLIAD / EVENT RECORD NO. 110327
CADW PROJECT NO. DAT A112

Mawrth 2017
March 2017

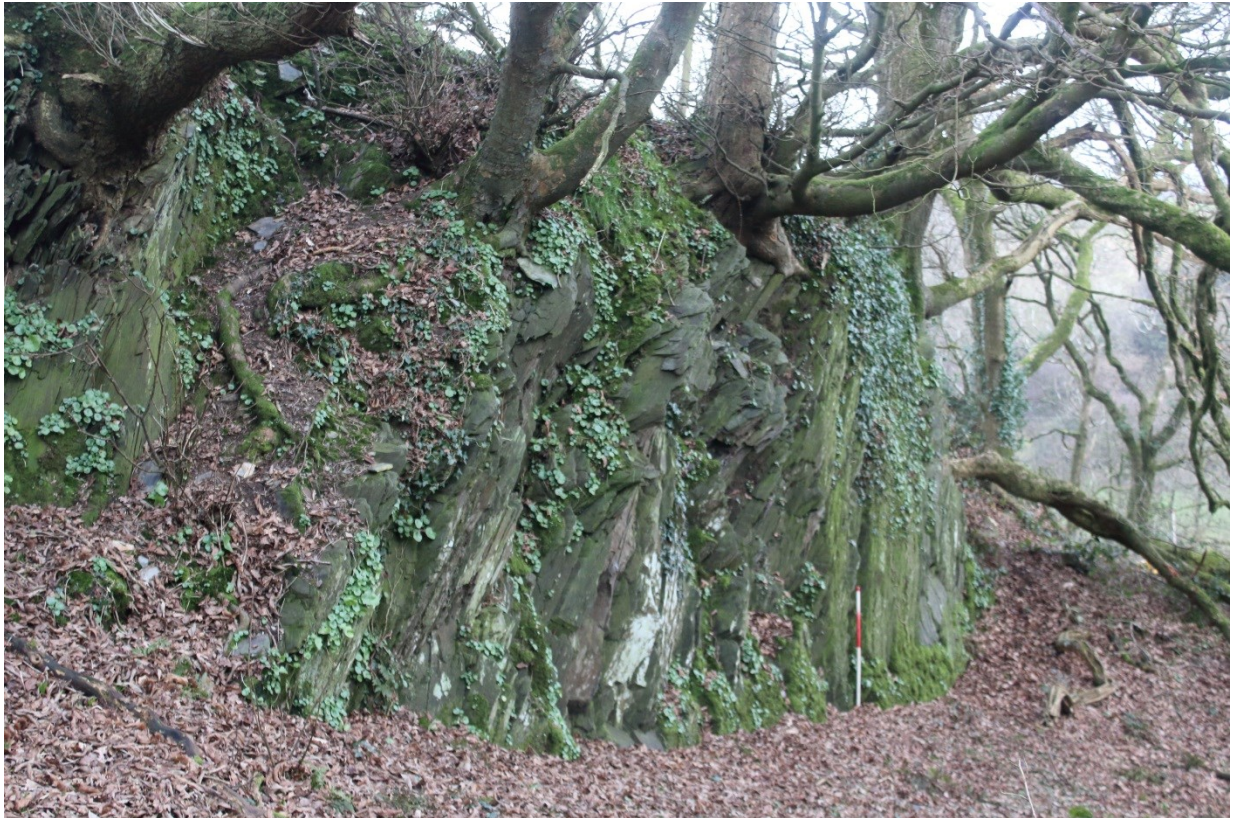
Photo 23: Facing southeast. Sheer rock-cut side of the rampart on the west side of Castell Pen-yr-Allt, with a 1m scale.

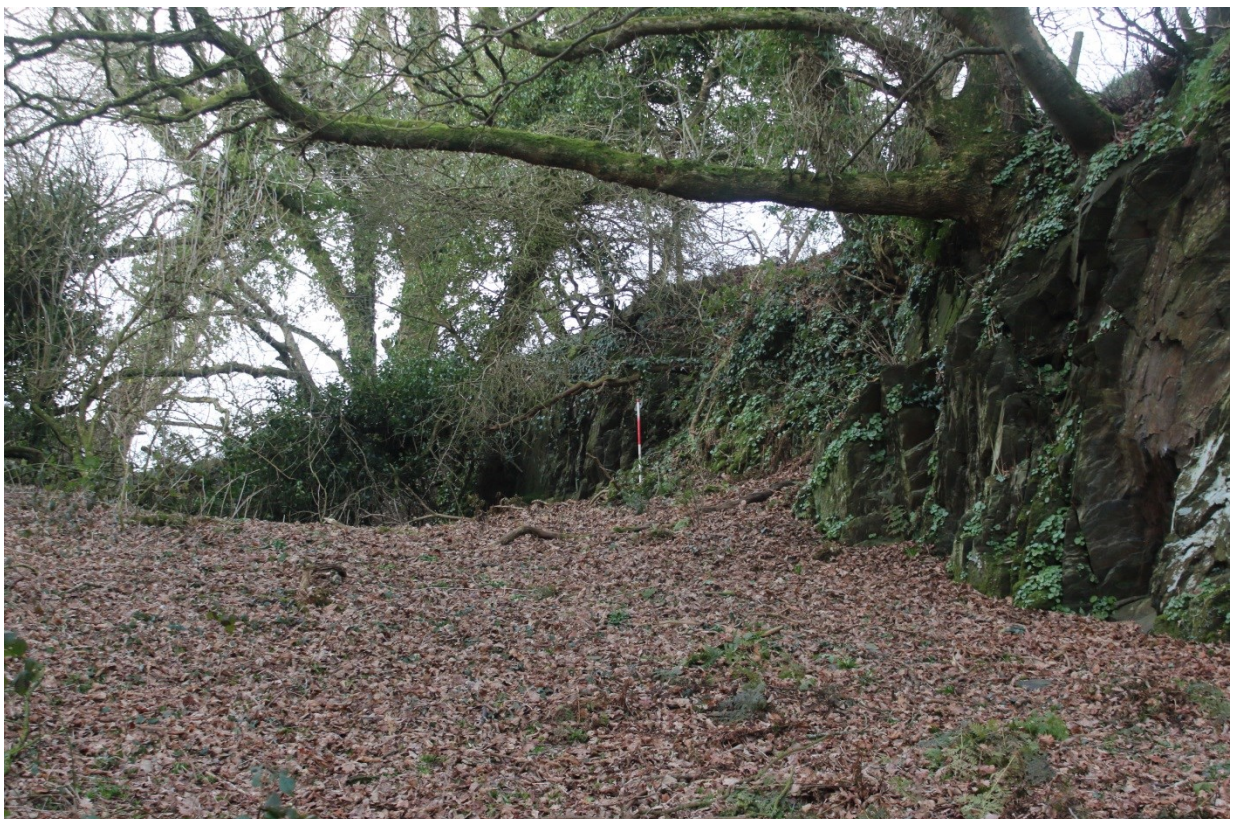
Photo 24: Facing north. Sheer rock-cut side of rampart and remains of ditch on west side of Castell Pen-yr-Allt, with a 1m scale.

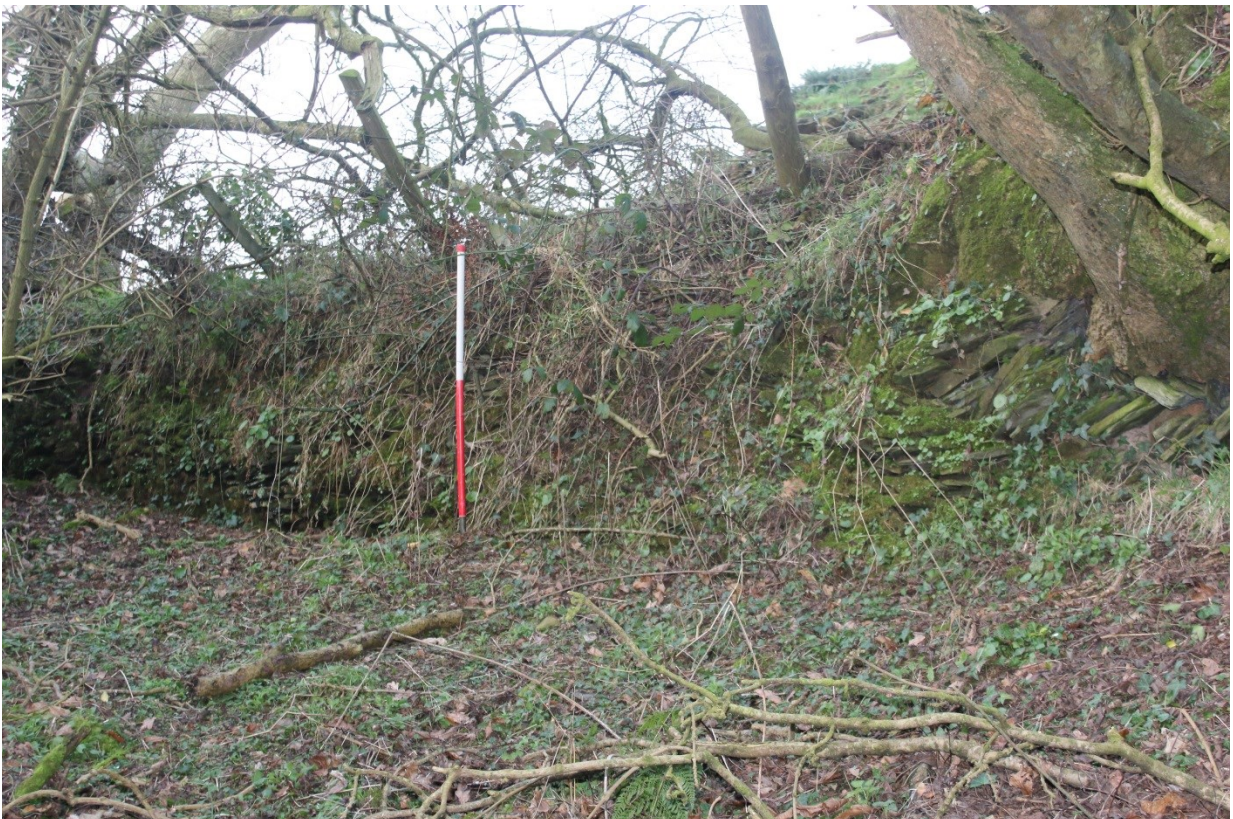
Photo 26: Facing northwest. Wall retaining the outside of the bank on the west side of Castell Pen-yr-Allt, with a 1m scale.
