**MAES YR HENDRE, MAENAN
BUILDINGS ASSESSMENT
for
Ieuan Hughes**

Govannon Report GC384

MAES YR HENDRE, MAENAN – BUILDINGS ASSESSMENT

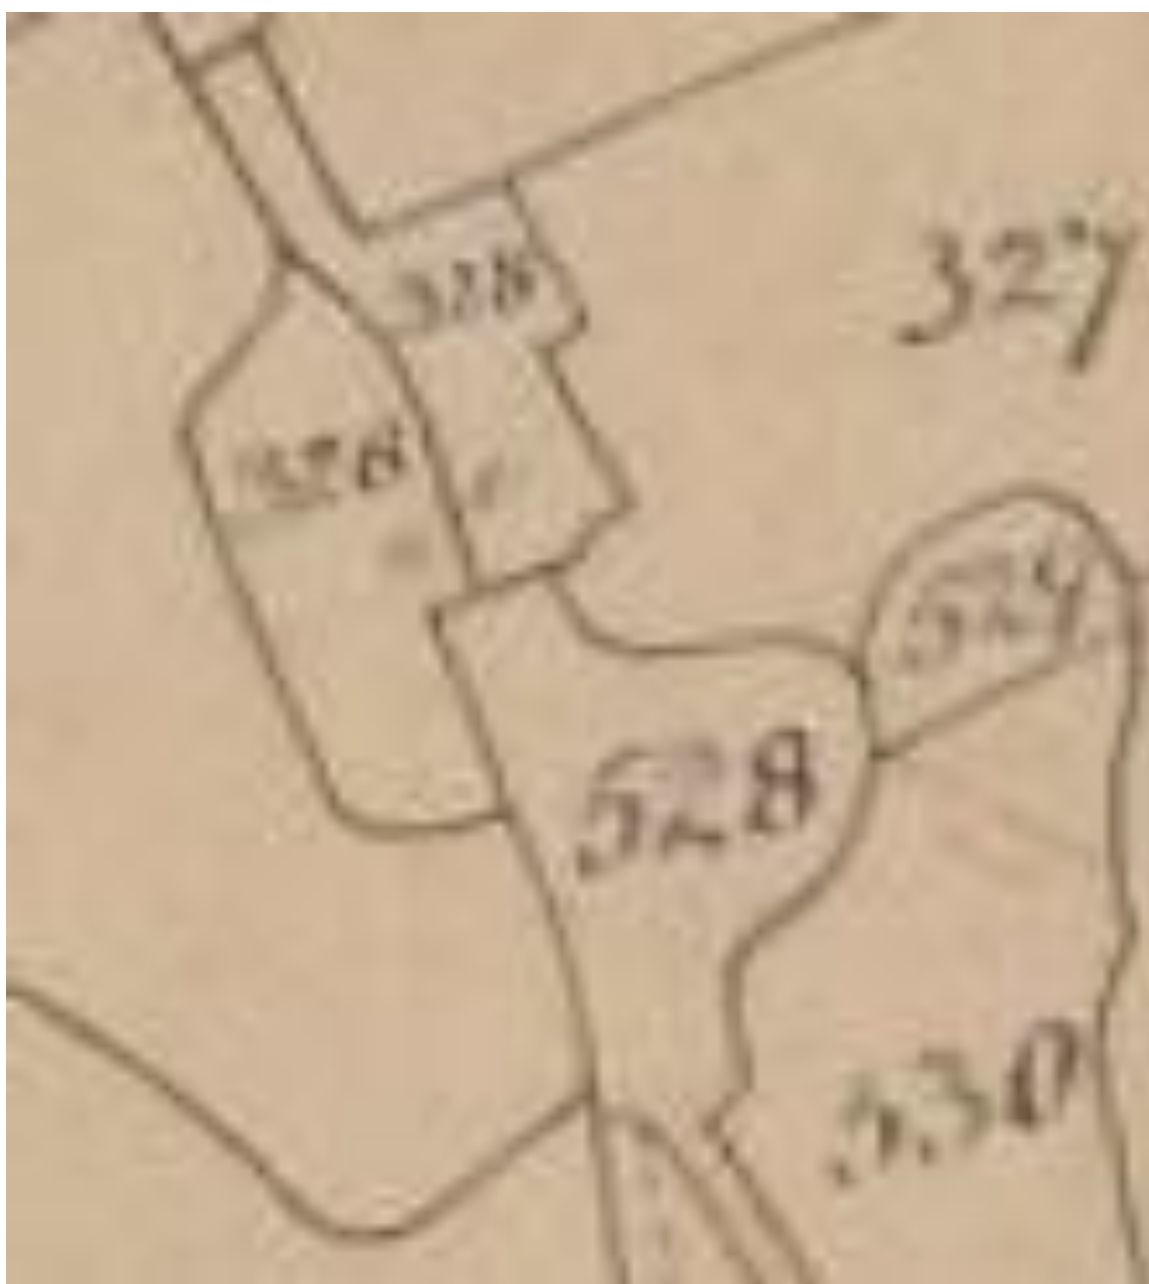
Map 3a: detail of 1847 tithe map

At the time of the tithe map (**Map 3**) apportionment of 1847 the following are indicated:

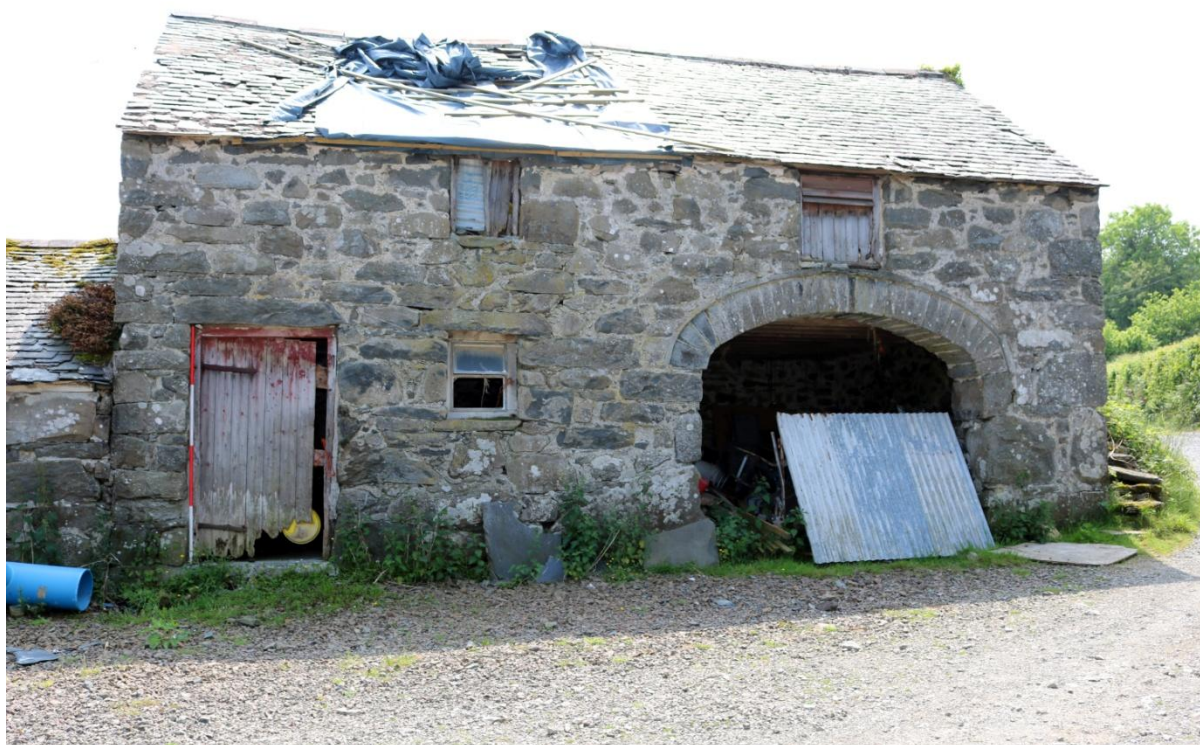
Cart shed (building A) SH 7921 6744

A single-bay cart shed located on the south-eastern perimeter of the yard, orientated south-west to north-east. It may be of early 19th century construction with an adjoining, later 19th century structure (see below). It is of rubble construction with a slate roof. It is a rectangular storeyed block with a wide, a depressed-arched cart opening at R; the voussoirs are slate ashlar below a narrow arch ring. To the left of this is a small window with modern glazing and beyond, a plain entrance with boarded door. There are two further, plain windows to the upper floor, under the eaves. External slab-stepped access to upper boarded entrance at rear and in the south-west facing gable; this first floor area is likely to have been a granary. A cart-shed (*hofel* or *hofel droliau*) is a common feature on farms in north-east Wales, though the splendid voussoirs at Maes yr Hendre are very unusual. They reflect the growing adoption of wheeled farm vehicles in the area in the late 18th century, and the use of carts for transporting hay and peat. The earliest dated cart-shed in North-east Wales was built in 1816 (Wiliam 1982, 236).

Cart-sheds are introduced on farm in north-east Wales from the first quarter of the 19th century onwards (Wiliam 1982, 228-239). Mr Hughes suggests that the finely wrought voussoir arch in the cart shed range might have come from an earlier building in the locality; the Maes yr Hendre example is unusual in this respect.

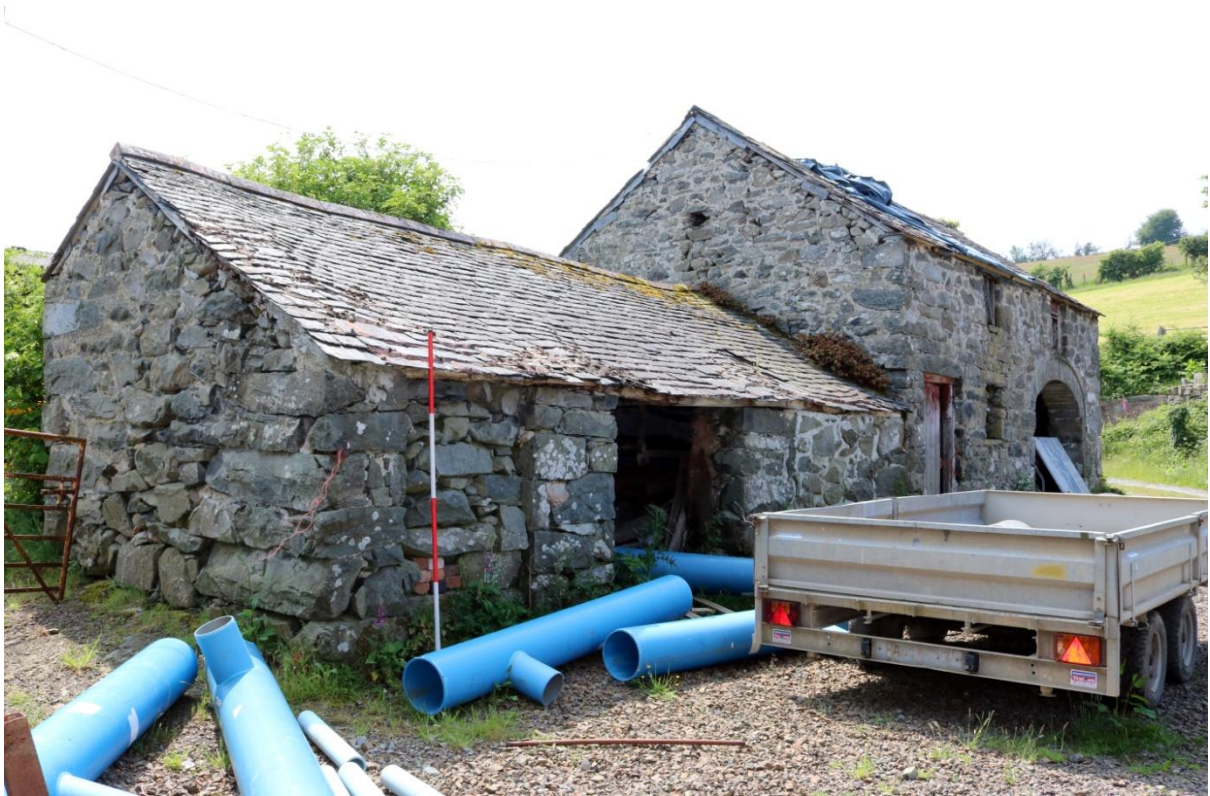
Cart shed, possible hayloft (building A) SH 7922 6745

This building is located on the south-eastern perimeter of the yard and is orientated south-west to north-east. It adjoins the cart shed and is stepped down from it. It is a single-storey building of rubble construction with a roof of thick torched slates. Facing the yard is a plain central cart entrance which originally had a further entrance to the right and a wider opening to the left; these are now blocked. It is suggested that this building may have functioned as hayloft at one stage.

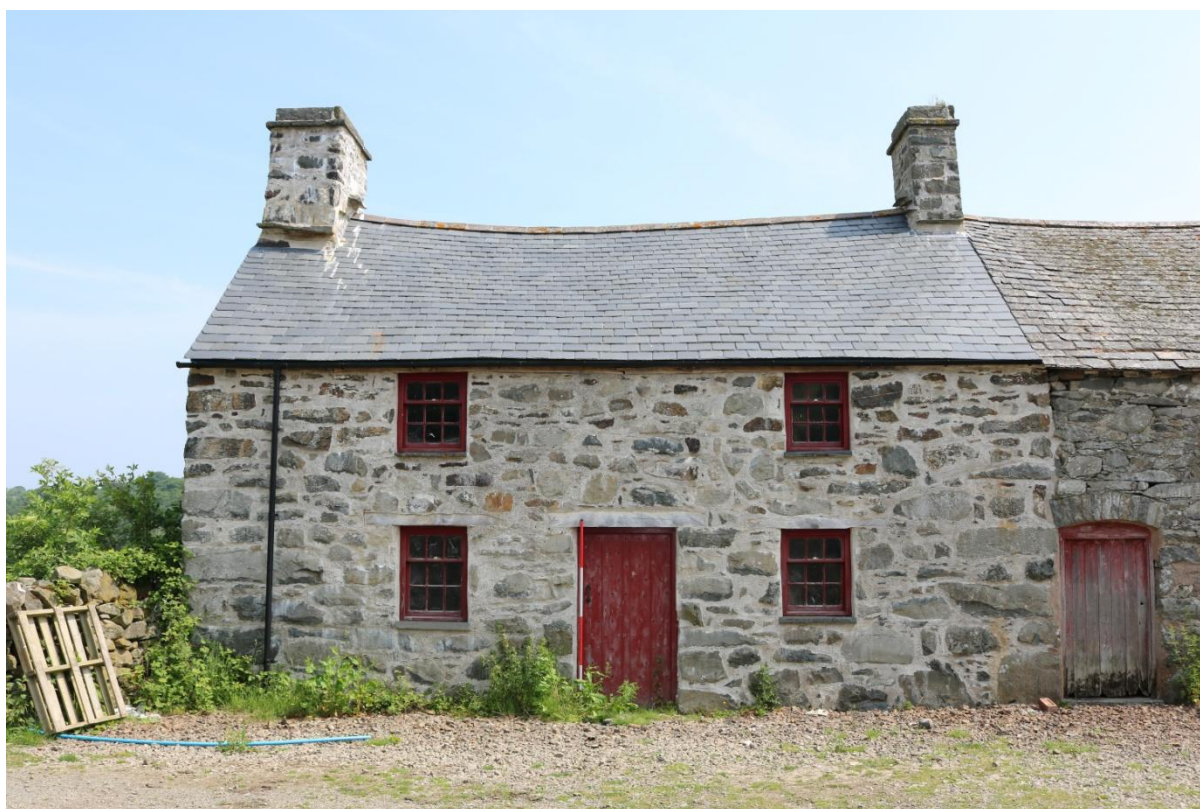
Maes yr Hendre cottage (building B) SH 7922 6747

Maes yr Hendre cottage (so called) is located on the eastern perimeter of the yard and is orientated north-west to south-east. It is a two-window two-storey end-chimney farmhouse, probably of early 18th construction, restored externally under a grant scheme in 2012, built of rubble with a recent replacement slate roof; weather-coursing and simple corncicing to chimneys, that to the right formerly projecting.

The front doorway is a near-central entrance, with a slab lintel. The door is boarded and studded door (the bottom section replaced) and pegged wooden frame. The window frames are modern replacements that replicate the pattern of earlier windows. Small 9-pane slightly-recessed sash windows to left and right of entrance and on upper floor, under the eaves; windows with modern frames of historical pattern to rear, and single-storey 19th century rubble lean-to with (restored) slate mono-pitch roof.

The interior has not been restored. The principal features are the hearth with timber lintel in the centre of the north-west gable and an adjacent oven of stone and brick construction. The ceiling joists are rotten. The roof is supported on possibly original rafters secured by collars. Internal divisions are timber. The ground floor room to the right of the main door retains an ornamented Victorian fireplace.

The cottage is of earlier construction than the 19th century farmhouse on the same site (see below) and the contrast between the vernacular character of the one and the estate-sponsored character of the other is instructive in showing the more 'hands-on' approach to the estate's provision of accommodation for tenants.

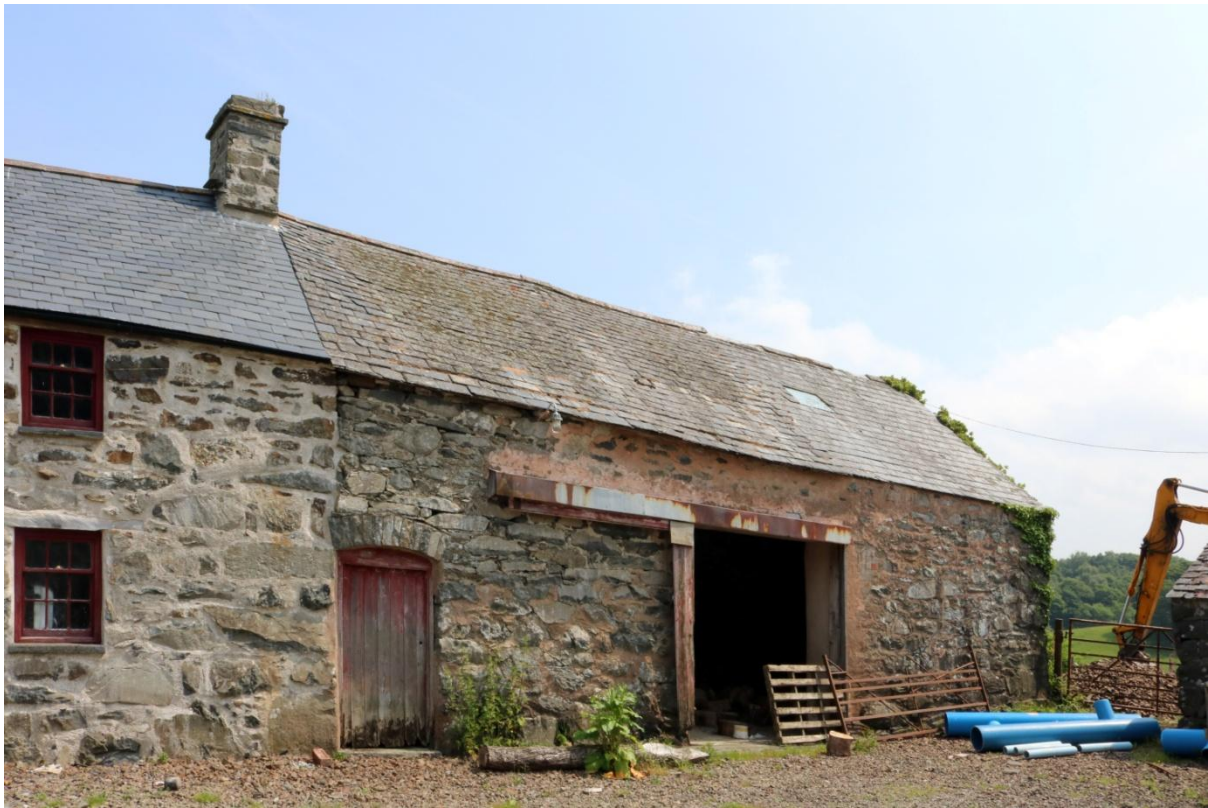
Barn (building B) SH 7923 6746

The barn is located on the eastern perimeter of the yard and is orientated north-west to south-east. It adjoins flush to the cottage but is of later construction, perhaps dating from the early to mid 19th century. It is rubble-built, with some brick-work in the south-east facing gable; continuous roof of Ordovician slate, with a sky-light, supported by V-strut trusses. There is a segmental-arched entrance with boarded door and pegged frame to the left, large modern sliding barn door to right. A 20th century corrugated iron extension adjoins to the rear.

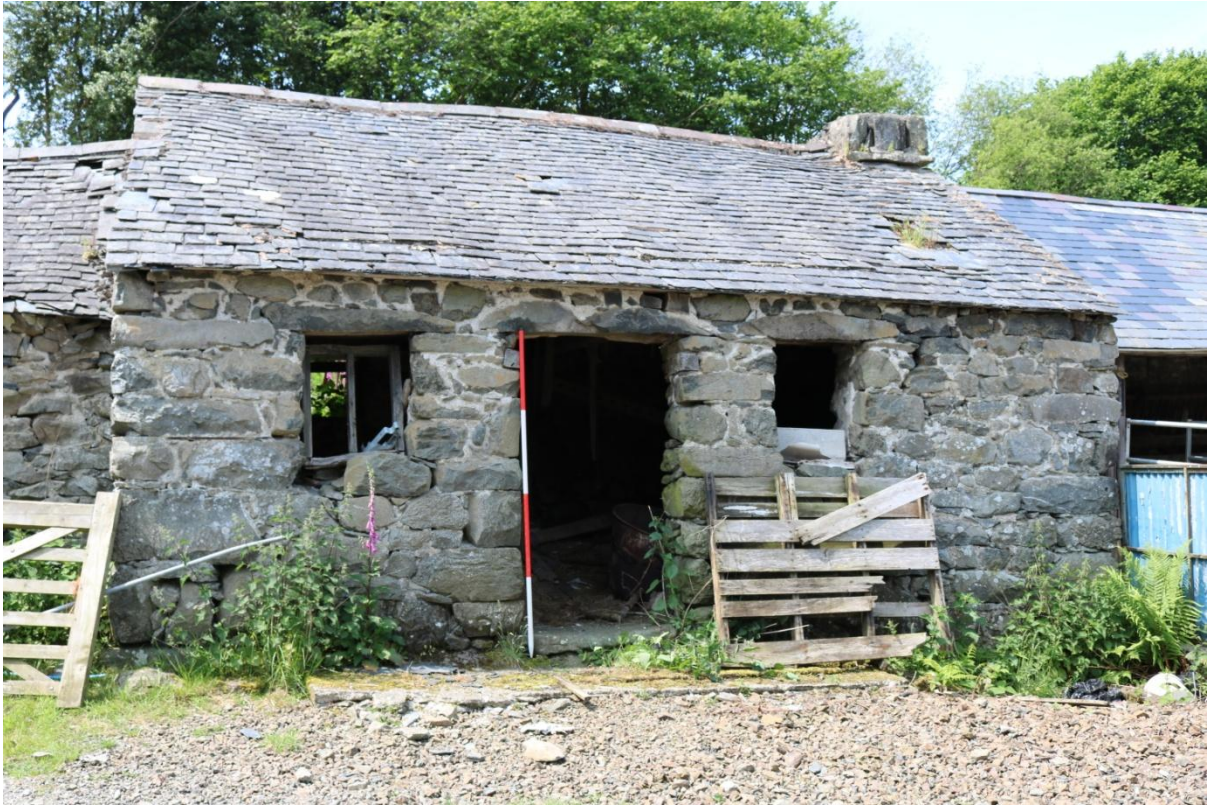
Brew-house (building C) SH 7920 6745

Orientated north to south on the west side of the yard; a vernacular single-storey structure, possibly adapted from an earlier dwelling, with a two-bay interior with pegged oak queen strut and tie-beam truss. Wide fireplace to right, with bread oven inserted to left.

Though it has been suggested (listed building description) that this is of 18th century construction and was possibly originally domestic, it does not seem to be shown on the map of 1843. It is of rubble construction with slate roof and tiled ridge; reduced chimney in the northern gable. Off-centre entrance (L); the pegged oak framed and original boarded door, fragmentary at the time of the listing description, has now gone (June 2016). Flanking the entrance are small 2-light wooden windows from which the wooden boarded shutters referred to in the listing description have now been removed.

A *briws* (brew-house) was not a common feature on farms in the region, and few seem ever to have been of the scale of this example, with its double-fronted facade.

The brew-house is commonly found on farms in Dyffryn Conwy. It was not only where beer might be made but was where clothes might be boiled, potatoes and other foodstuffs prepared for the pigs, and bread baked (Wiliam 1982, 247-249).

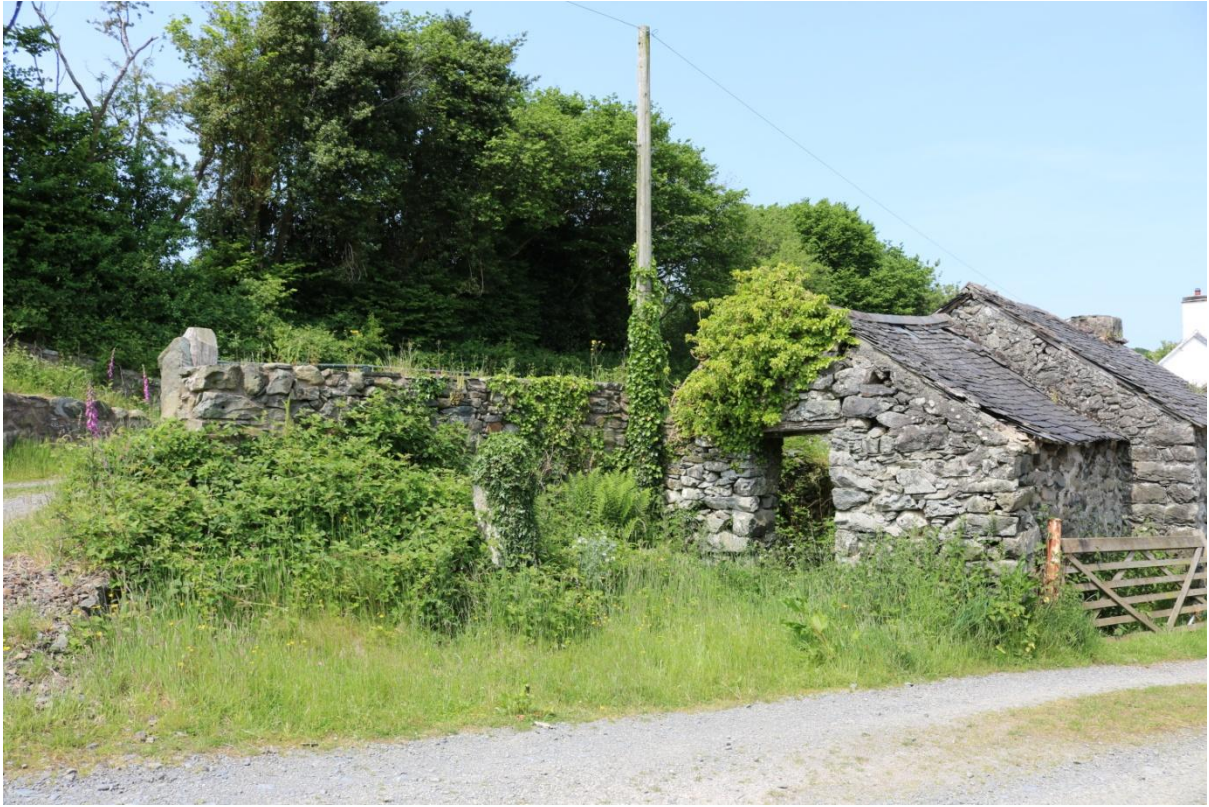
Byre block (building C) SH 7920 6744

Orientated north to south on the west side of the yard; stepped-down and adjoining the brew-house to its north, a small 19th century adjoining building of rubble construction with a part-surviving slate roof; now (June 2016) ruinous. Described as a byre block (listed building description), but it is not clear what its function was.

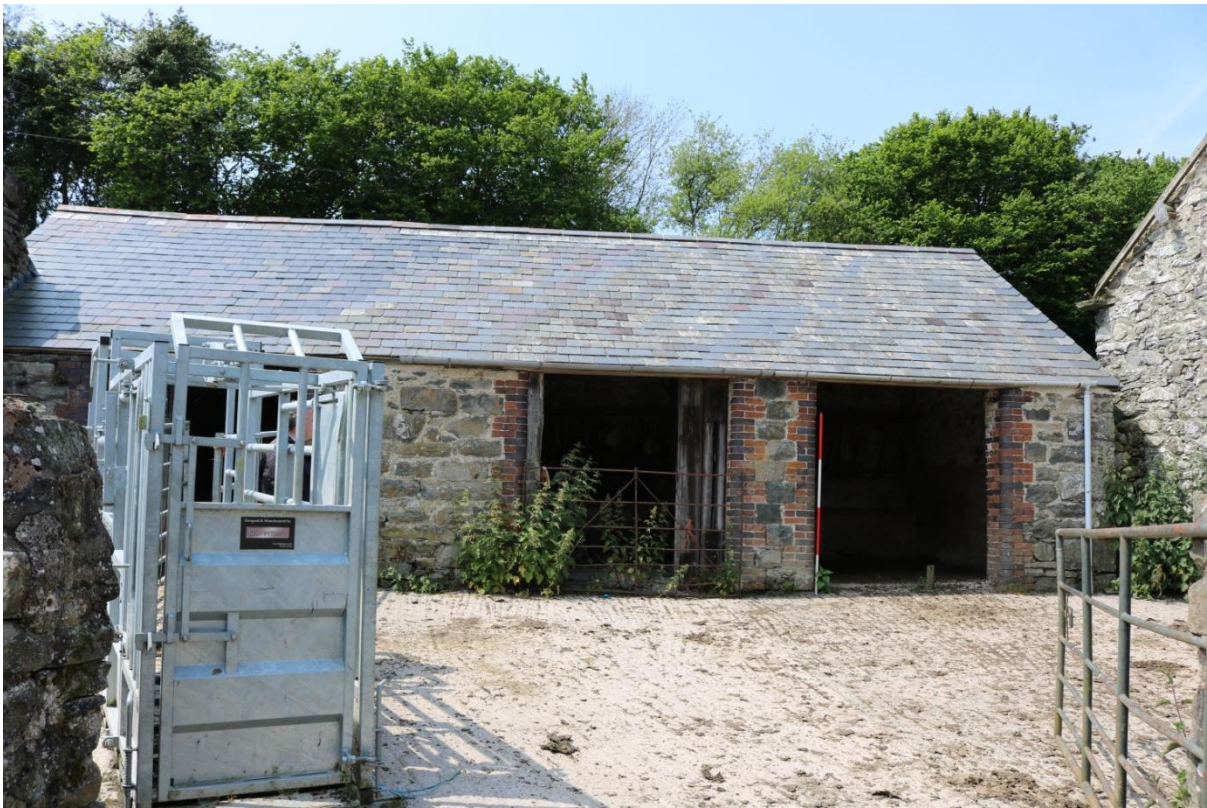
Shippon (building C) SH 7919 6746

Orientated north to south on the west side of the yard; a late-19th century three-door *côr* (shippon, cow-house), apparently not marked on the 1843 plan; stone-built, with some structural brick elements and pine roof timbers; there is evidence of 20th-century reconstruction and rebuilding, including the graffito 'John Hughes 1967' (father of Mr Ieuan Hughes, and the then owner of Maes yr Hendre). Substantially built and in good condition, it indicates the levels of investment in the farm by the Wynnstay estate in the later 19th and 20th centuries.

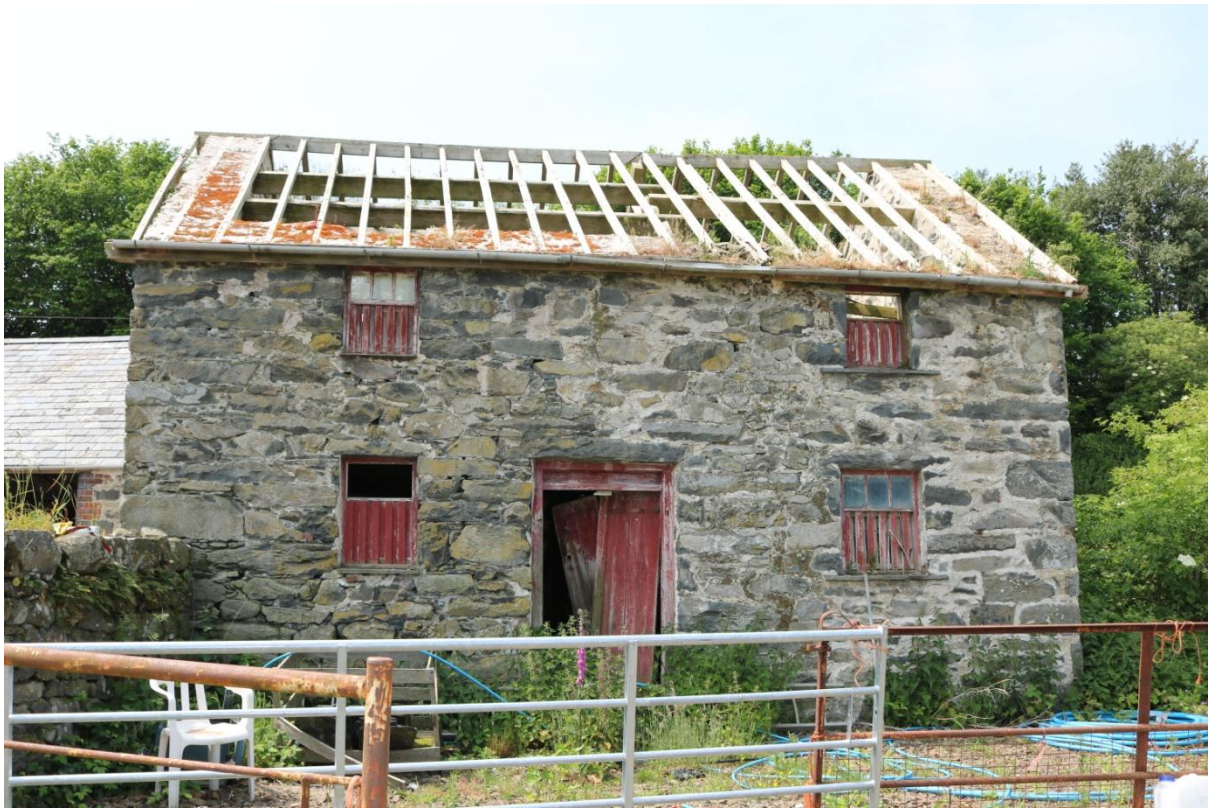
Granary 'granar' (building D) SH 7920 6747

Orientated north-west to south-east on the west side of the yard; a substantial rubble-built double-fronted structure, two storeys high; the slate roof has been removed, revealing the pine rafters. No evidence of chimneys was observed.

The existence of a granary, a storehouse for threshed grain, on such a scale – almost industrial – is an indication of the fertility of the area in which Maes yr Hendre is situated. It appears to have been constructed between 1843 and 1889. It is unusual in regional terms in that it is a dedicated structure, rather than a room above a cart-shed or (less commonly) a stable or a cow-house, and may have been built when the putative granary above building A became too small.

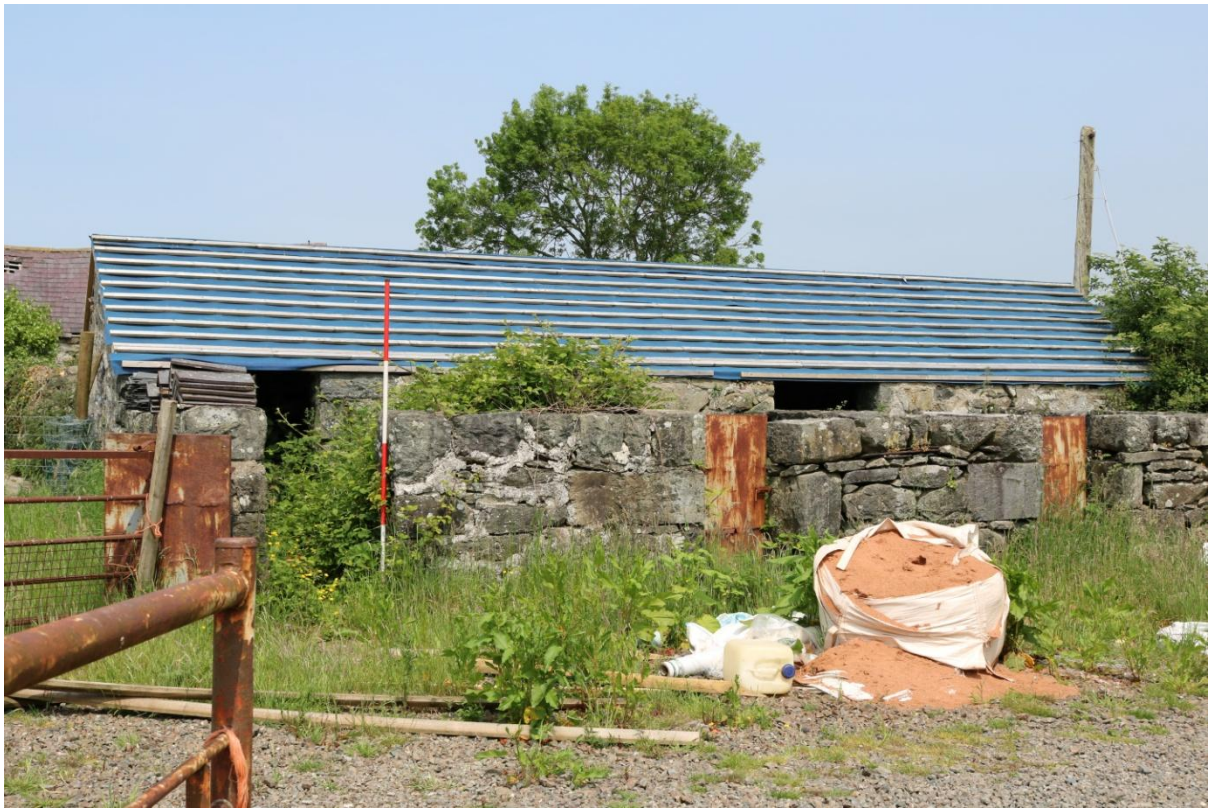
Pigsties (building E) SH 7921 6748

A three-bay set of pigsties, with iron doors on each sty made by the Pont y Gath smithy in Maenan (pers. comm., Ieuan Hughes). The roof slates have been removed.

Pigsties do not appear to have been particularly common features on farms in the region. The examples at Maes yr Hendre are substantial, and unusual in that they have a pitched roof. They are, however, typical as self-contained 'inlet-outlet' types.

The pigsties and the shippon would appear to have been constructed between 1857 and 1889. The pigsties are unlikely to be those recorded as having been built in the 1820s; Mr Hughes suggests that these were at SH 7923 6743, where he recalls being told that the remains of pigsties were cleared to build a modern corrugated iron shed.

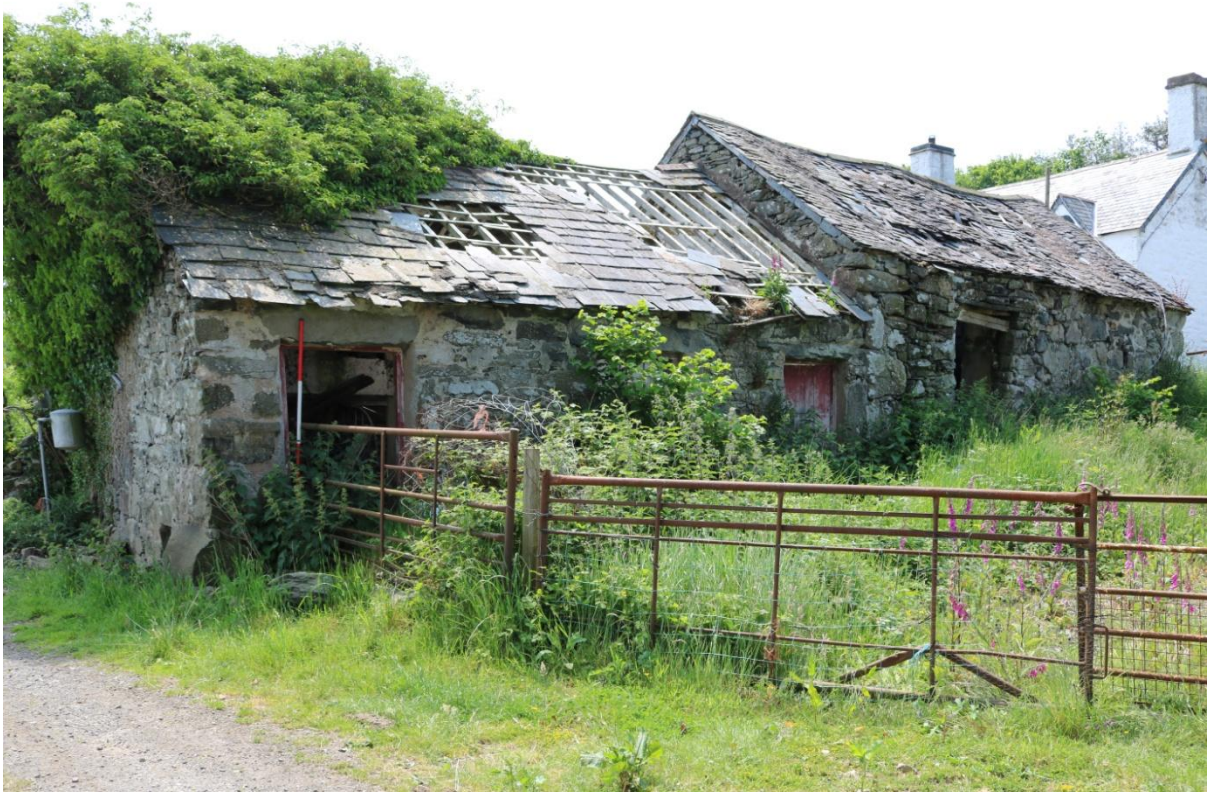
Dairy (building F) SH 7920 6751

A two-unit dairy building, orientated east-west; rubble construction and slate roof, now in poor condition. It was in existence by 1843. Dairies were where the cows were milked and the milk left to cool. They are an unusual feature of farms in the region.

Milking bays survive internally in building F, along with electric light fittings, indicating that lactuals remained an important part of the farm's economy for well over a century.

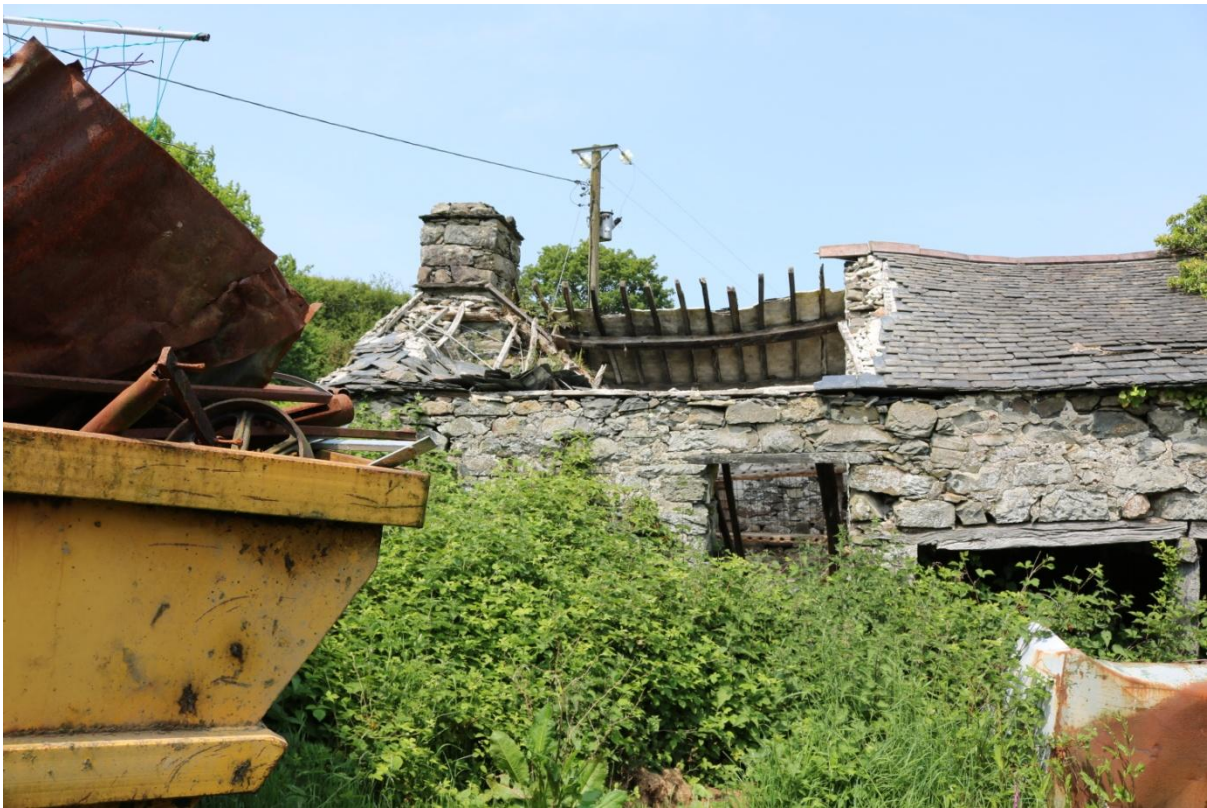
Cottage (building G) SH 7919 6751

A one-unit building, possibly a small cottage, orientated east-west, with a chimney in the west-facing gable. It is rubble-built with a slate roof, which is now collapsing.

In existence by 1843, and possibly accommodation for a *gwas*, a landless labourer working on the farm, indicating both the level of provision for labourers and the fact that they did not reside in the farmhouse itself.

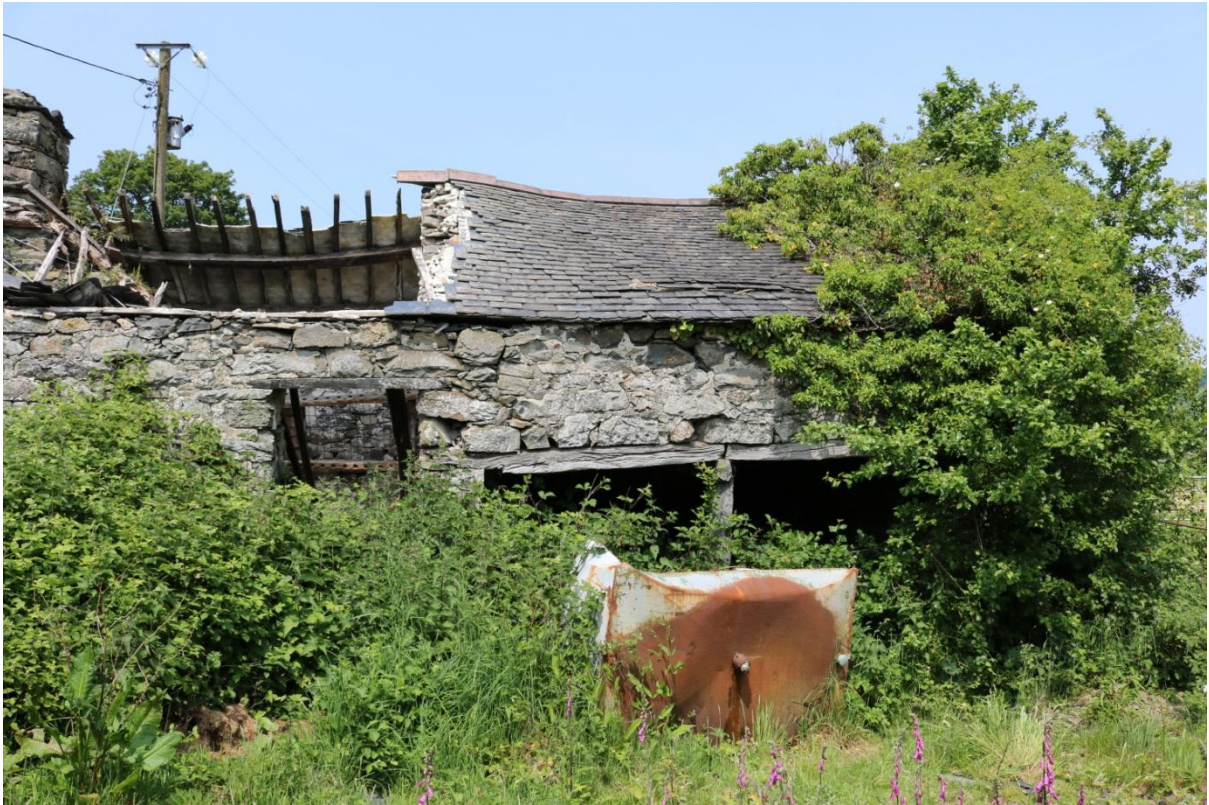
Cart shed (building G)SH 7920 6752

A cart-shed contiguous with the cottage, orientated east-west; the cart opening is supported by a timber lintel on a vertical-positioned slab support. It is now heavily overgrown. It was in existence by 1843; as noted (building A), cart-sheds reflect the growing use of wheeled vehicles from the late 18th century in the area. It is possible that the existence of two cart-sheds reflects the joint tenancy of the farm.

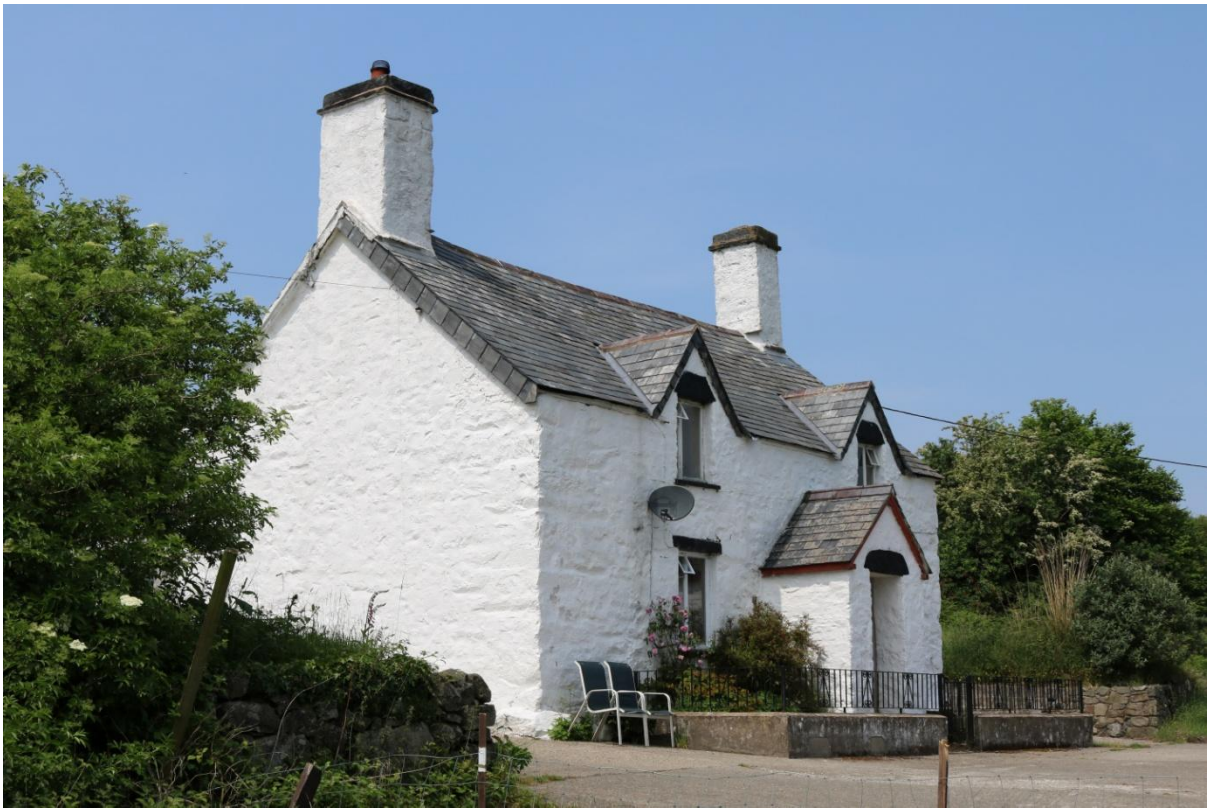
Maes yr Hendre farmhouse is a two-storey double-fronted east-facing structure of probably 19th century date, typical in scale and design of estate-built Conwy valley farmhouses of the period. It is of lime-washed rubble construction with a slate roof, stone end chimney stacks, with modern casement windows and is east-facing. The upper windows rise through the eaves. The gabled porch is a later addition. There is a modern extension to the rear.
