DOLAUGWYN BRYNCRUG

HERITAGE IMPACT ASSESSMENT

GEORGE + TOMOS

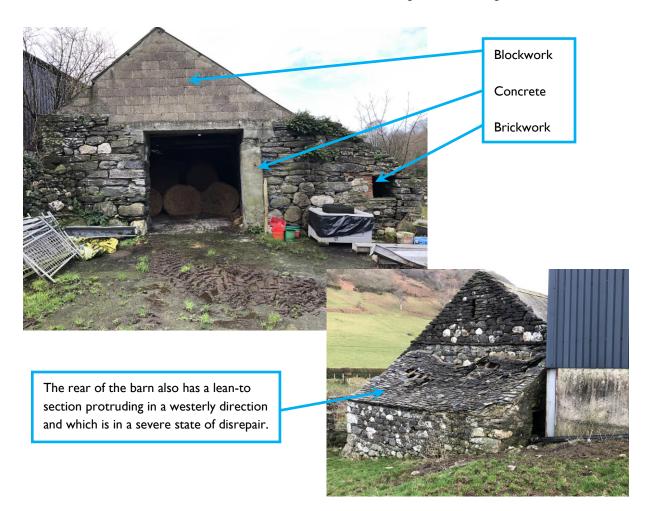
The existing site consists of a stone barn, built of roughly coursed boulders with a corrugate cladding providing a roof covering. References to 'the site' as part of this document refers to the stone barn proposed to be demolished.

A number of obvious renovations can be seen on the property, including brickwork used to form openings, blockwork used to rebuild the Eastern gable and concrete used to patch up historical defects and to stabilise reveals. When these works were carried out is unknown, as is the exact age of the building.

There is little of architectural interest to the site itself. A number of obvious renovations can be seen on the property, including brickwork used to form openings, blockwork used to rebuild the Eastern gable and concrete used to patch up historical defects and to stabilise reveals- when these works were carried out is unknown.

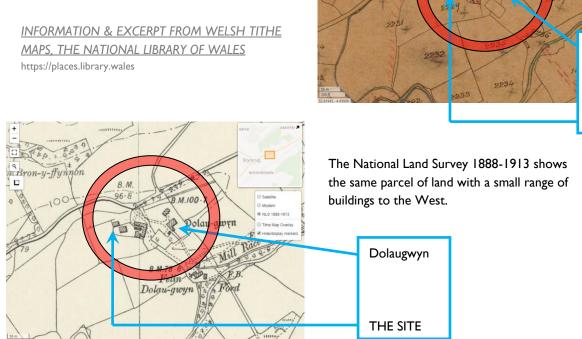
The tithe Map (post 1836) from the National Library of Wales highlights Dolaugwyn as well as a number of barns associated with the farmstead.

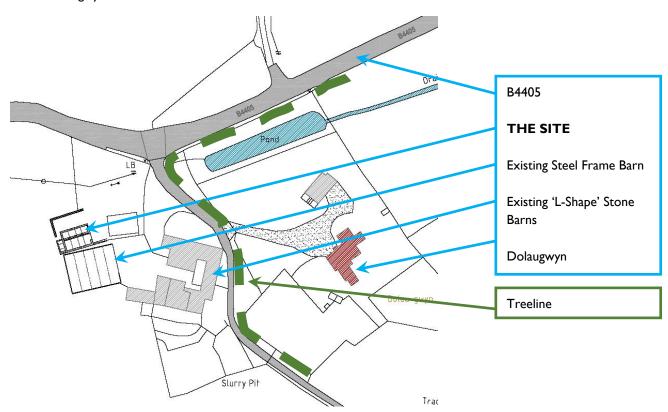
Based on information sourced from Coflein, Dolaugwyn is the primary extent of the historical significance for the whole site. The historic significance of the property must be taken into account as part of any design development for the site as a whole, however there is clear segregation between the farmstead barns and the Dolaugwyn property.

A well-developed treeline and a formal stone boundary wall visually disconnects Dolaugwyn from the various agricultural structures as a whole. There are also a number of other existing stone barns, located centrally on site, provides further visual separation between the proposed site and the historic characteristics of Dolaugwyn itself.
