The Rhiw, Bridgend

Archaeological Photographic Record

Report No: 1391

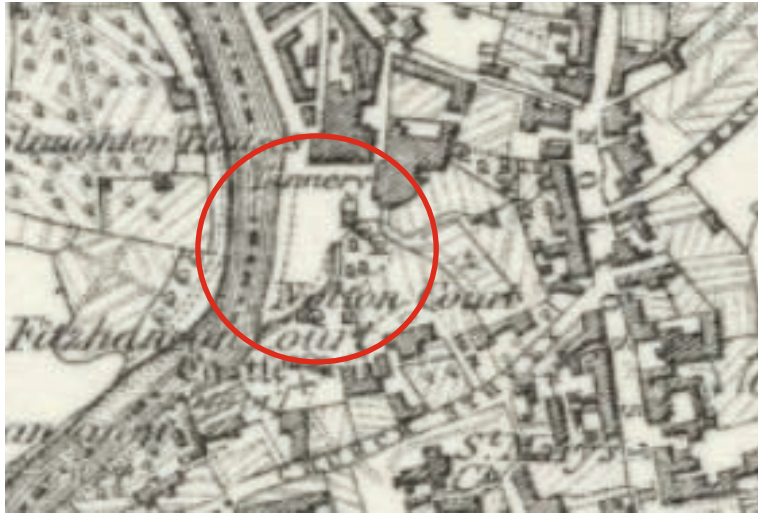
Fig 2: OS 1878 1:2500

The 1878 Edition OS map 1:2500 appears to show only a small section of quarry face toward the southern half of the site, with a small circular wood overlying the site of the arch. A rectangular building which was orientated north-south is also present directly west of the arch and appears to be labelled 'tannery'.

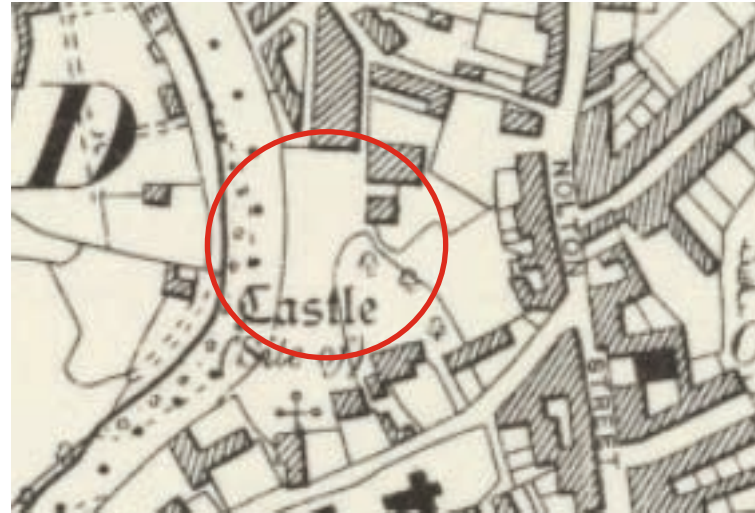
Fig 3: OS 1897 1:2500

The 1897 Edition OS map 1:2500 shows the previous rectangular building has now been removed. The map does not show any quarried sections and the wood which encroaches from the eastern side of site is still present overlying the position of the current arch. There appears to be a small pathway joining the Merthyr Mawr Road to the site of the Rhiw car park.

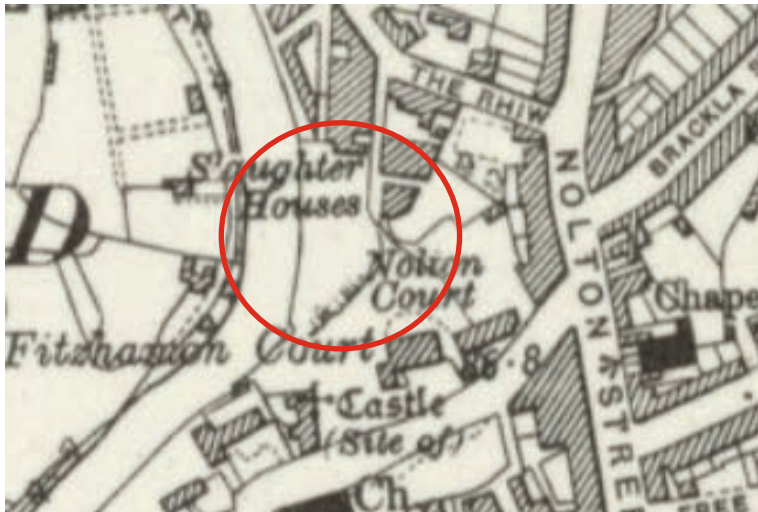
Fig 4: OS 1914 1:2500

The 1914 Edition OS map 1:2500 shows the quarried outcrop as we see it today, with a south west to north east section. The arch marking where the scarp orientates north. The woods along the eastern side of site are no longer present and the path there appears to have its northern edge still marked but now forming a boundary. The boundary along the eastern edge has a small break where it joins the previous path to the north, possibly showing that access is still possible through this point

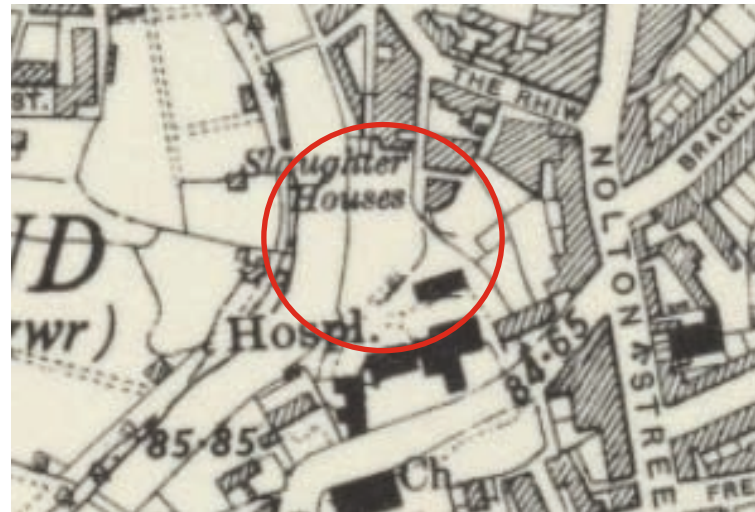
Fig 5: OS 1948 1:2500

The 1948 Edition OS map 1:2500 shows no changes to the previous map, the northern edge of the previous pathway appears to still be marking the boundary with the same small break in the eastern boundary.

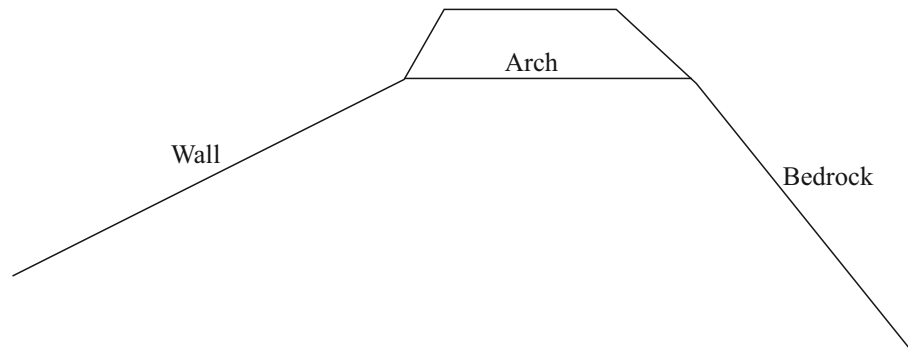
Fig 6: Sketch Plan

Figure 6 shows a measured sketch plan of the existing plan of the arch. Figure 7 shows the existing elevation of the structure and associated wall and bedrock. Figure 8 shows the location and direction from which the photographic plates were taken. The number after each red arrow corresponds to the plate on which the photograph appears. Not all photographs taken on site are presented in this report, however they will be included in the archive.

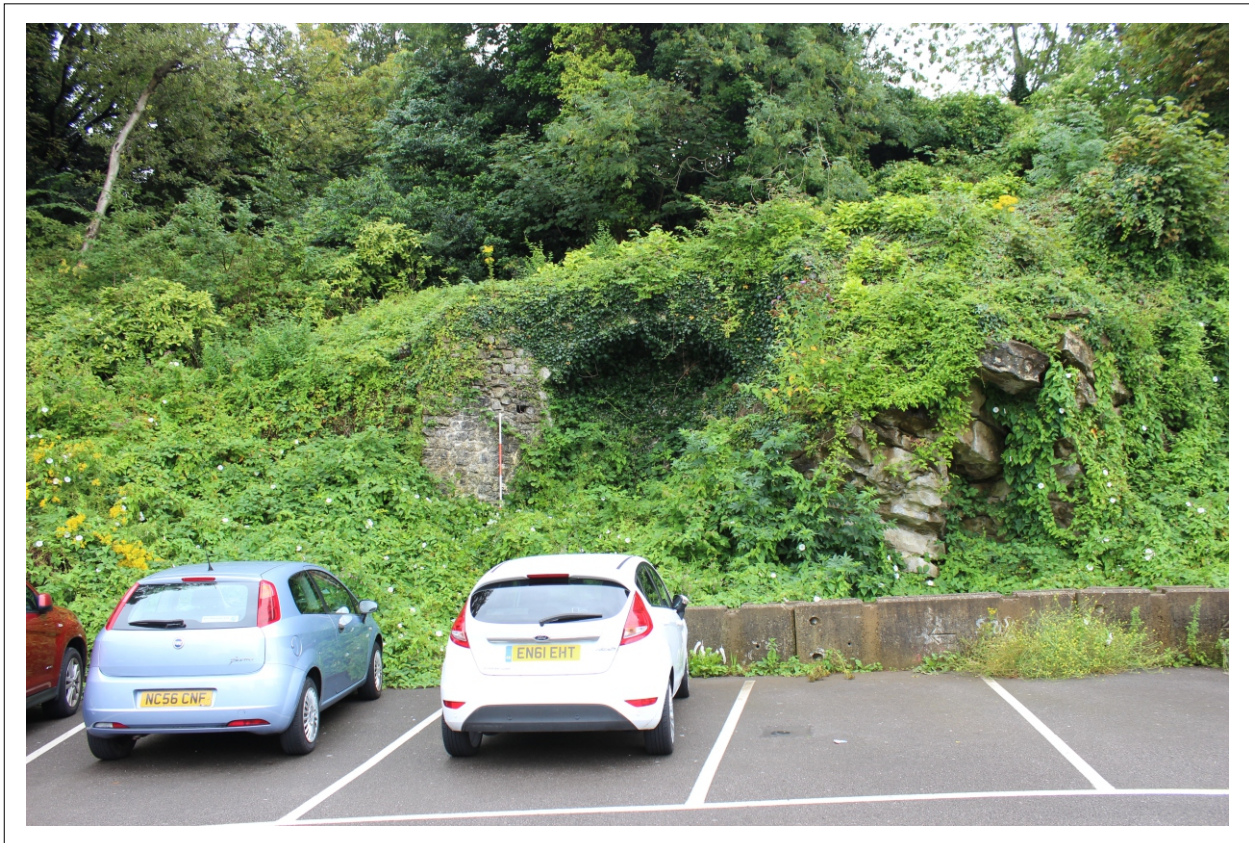
The arch is orientated north to south with a small section of retaining wall attached which changes angle by approximate thirty degrees to the west. The arch is segmented, constructed of flat faced and squared grey limestone blocks with lime bonding mortar. The arch spans a width of approximately 3m at a height of 3.5m above ground level. The wall is of a slightly battered constructed of rough faced random rubble brought to course along a length of approximately 6m.

Plate 1: Western elevation, view from west

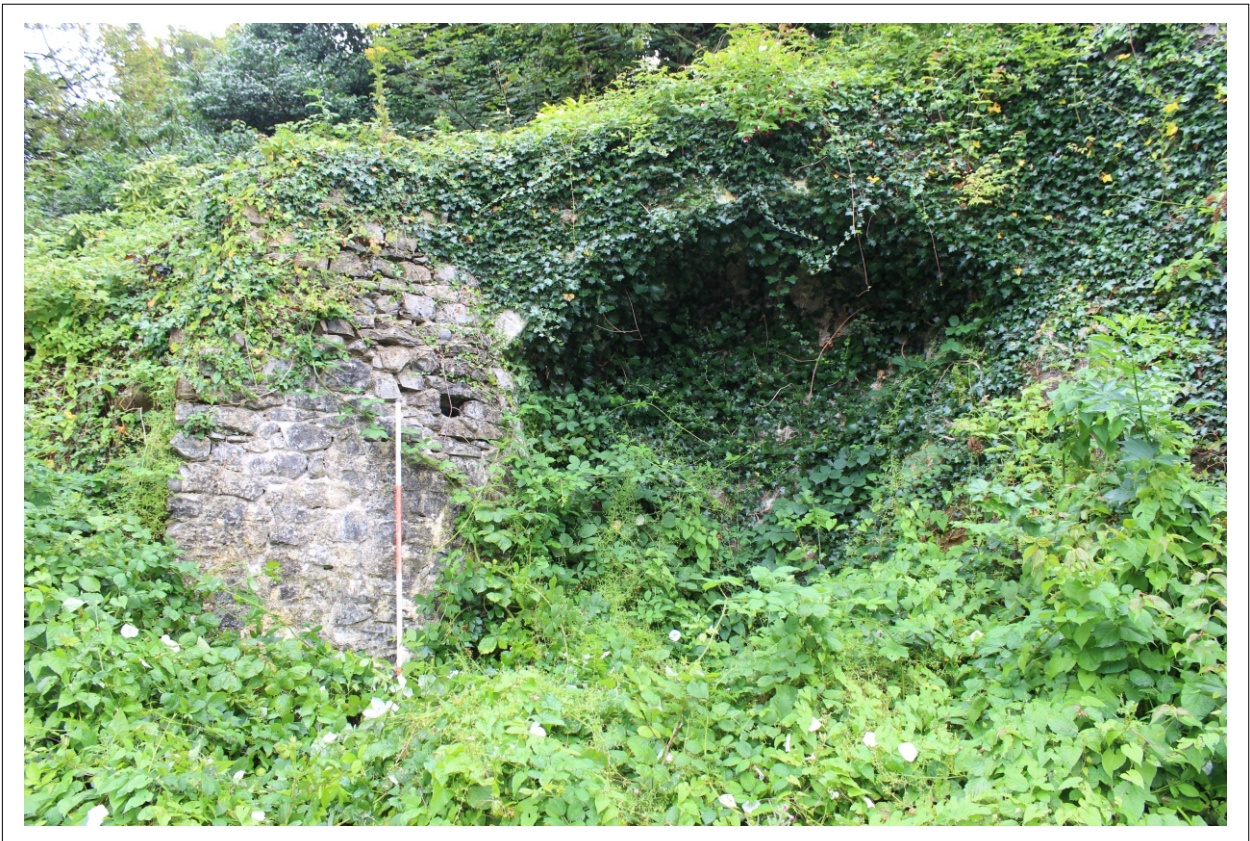
Plate 2: Western elevation, view from west

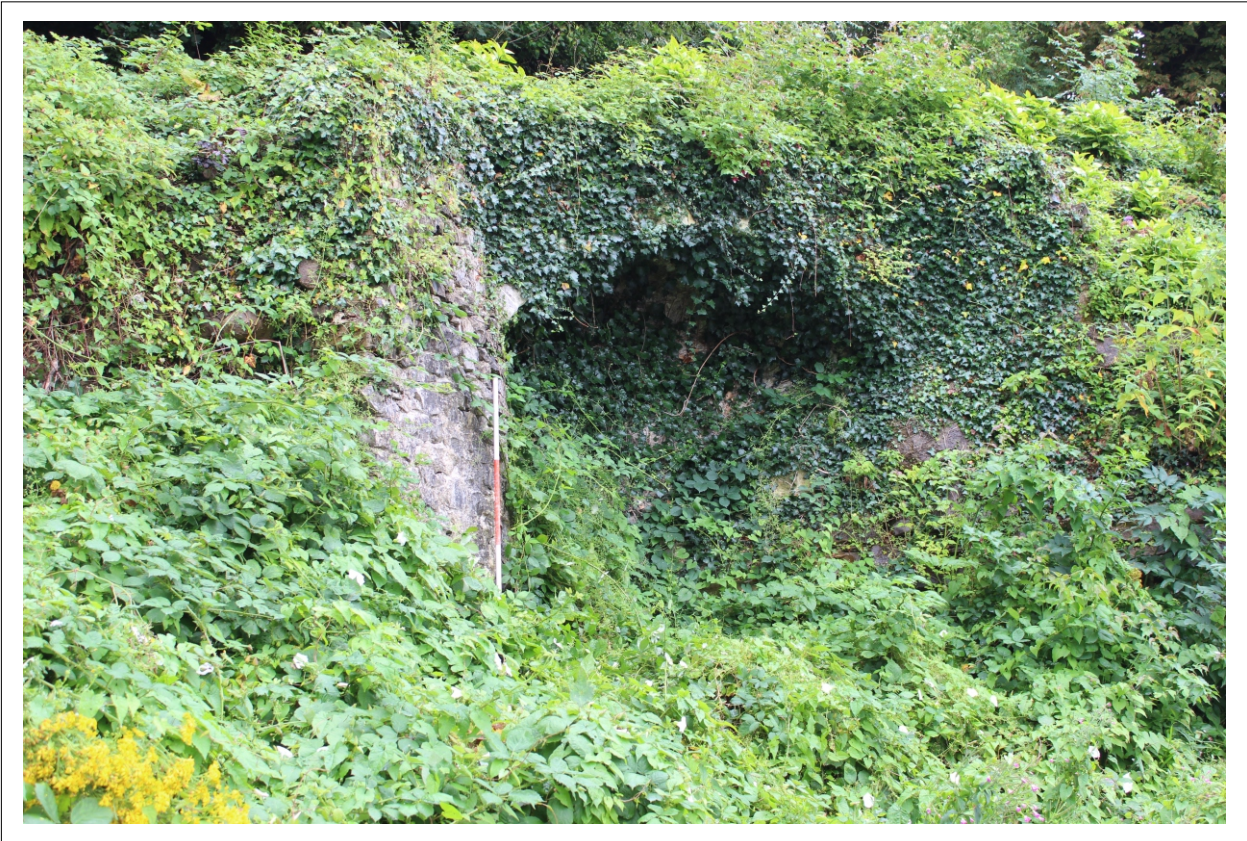
The arch appears to be a double skin of stones with the southern springer of the arch resting directly on the bedrock outcrop. The northern springer of the arch rests on the retaining wall. Lime has leached through on the western elevation and forms a thick lens on the underside of the arch. The arch does not appear to go further east and abuts the bedrock outcrop which forms the east underside of the arch. The northern and southern sides under the arch are battered toward the centre, with the bedrock forming the southern side and the stone wall the northern side.

Plate 3: Close-up of arch, view from west

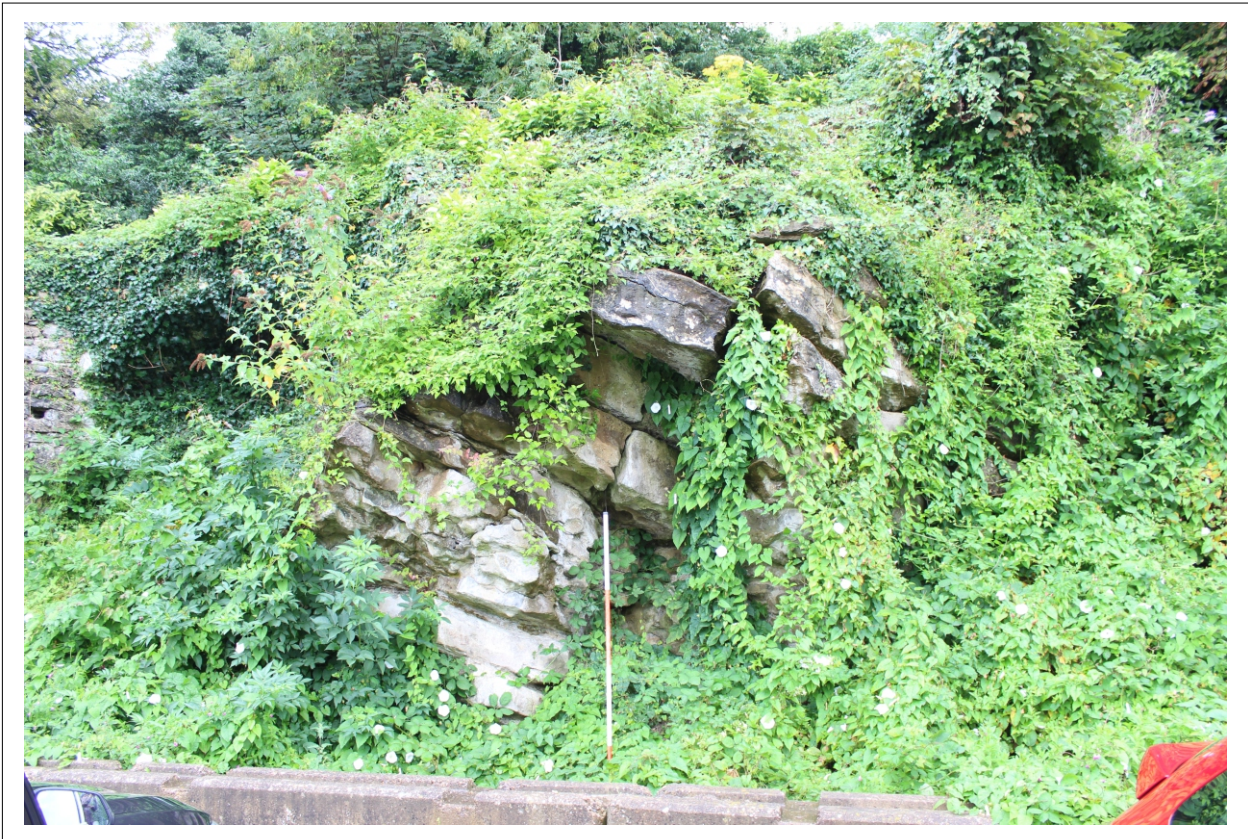
Plate 6: Bedrock outcrop, view from west

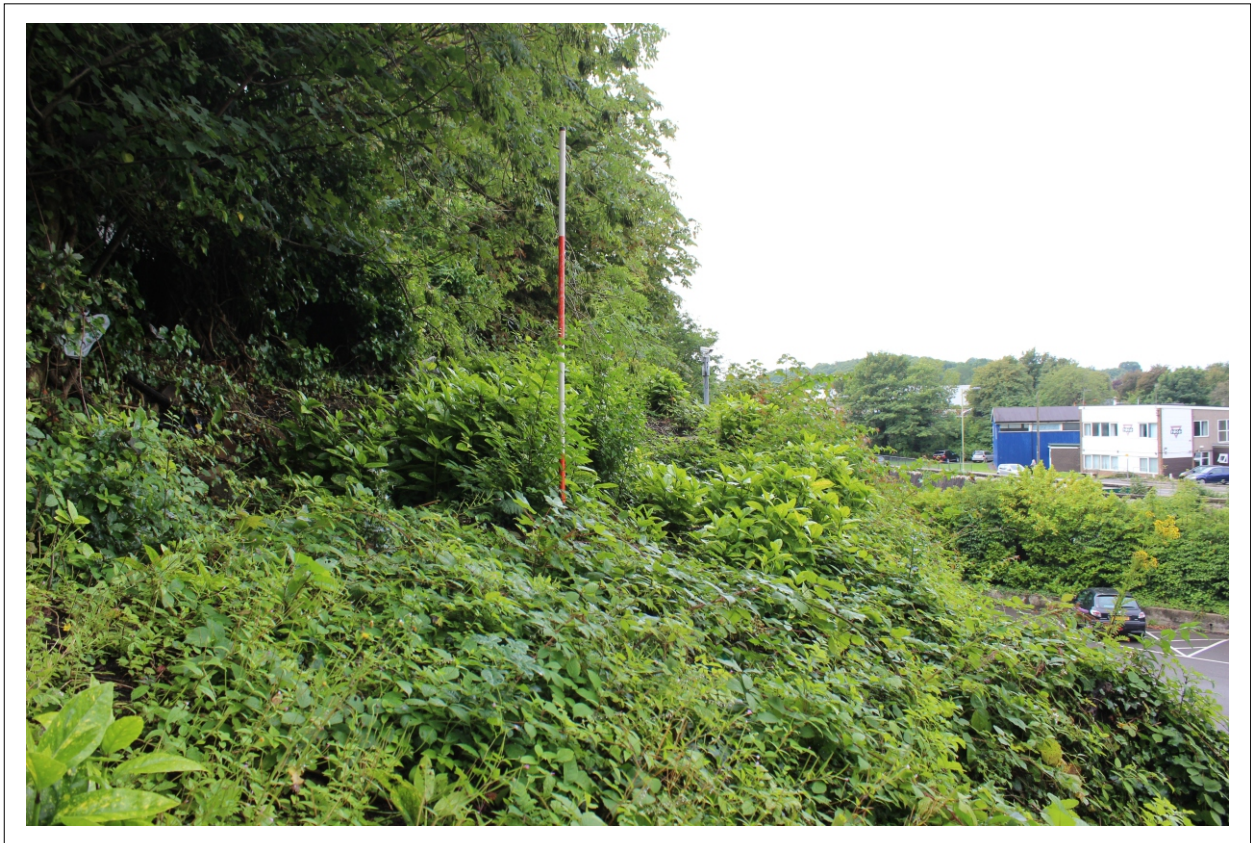
Plate 7: Above arch, view from north

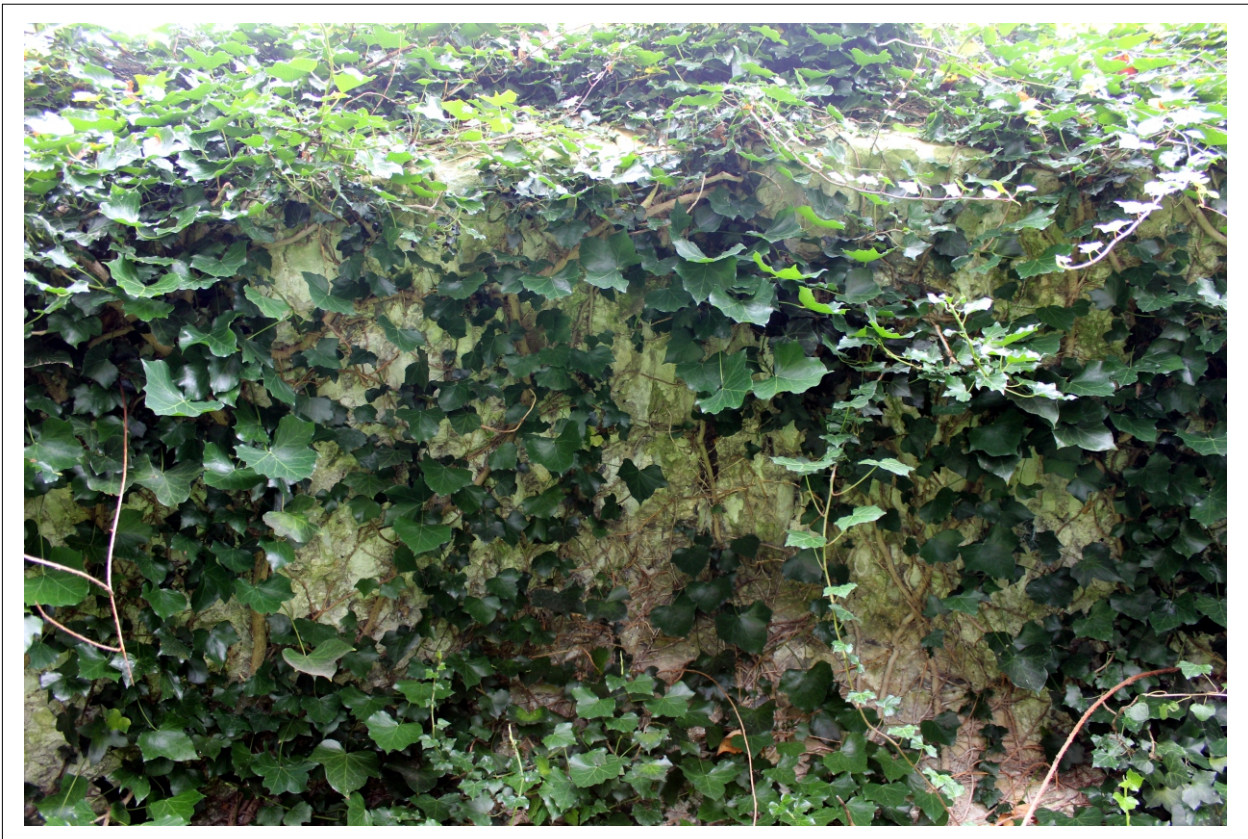
Plate 8: Close-up of underside of arch, view from west

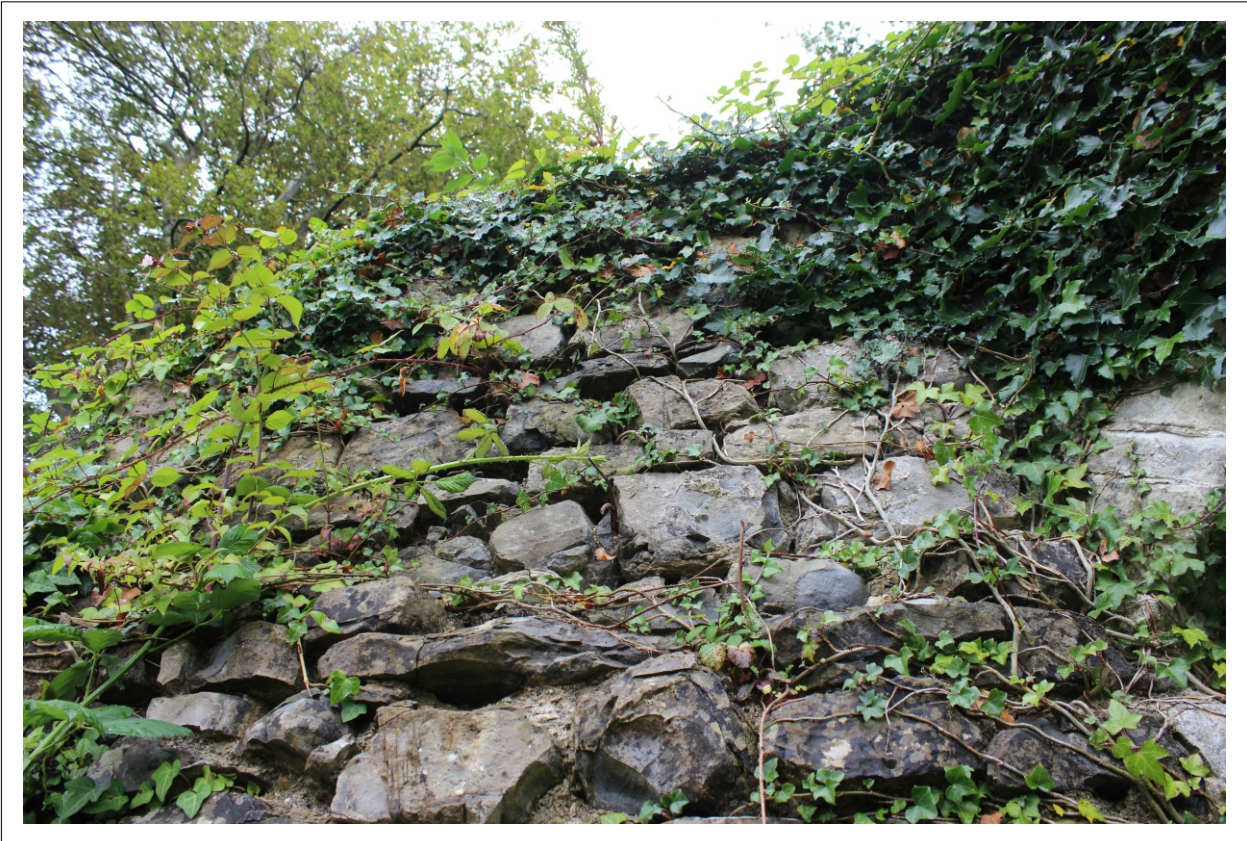
The retaining wall appears to be a single skin of rough faced stone with rubble infill behind. The wall supports the arch on its northern side and continues over the top of the arch before joining the bedrock outcrop to the south. Two putlogs are present in the western end of the wall showing that timber scaffolding was used in the construction. The dense vegetation obscures the majority of the wall but appears to have dislodged the upper courses and removed some of the northern edge of the wall.

Plate 9: Close-up of northern retaining wall, view from west

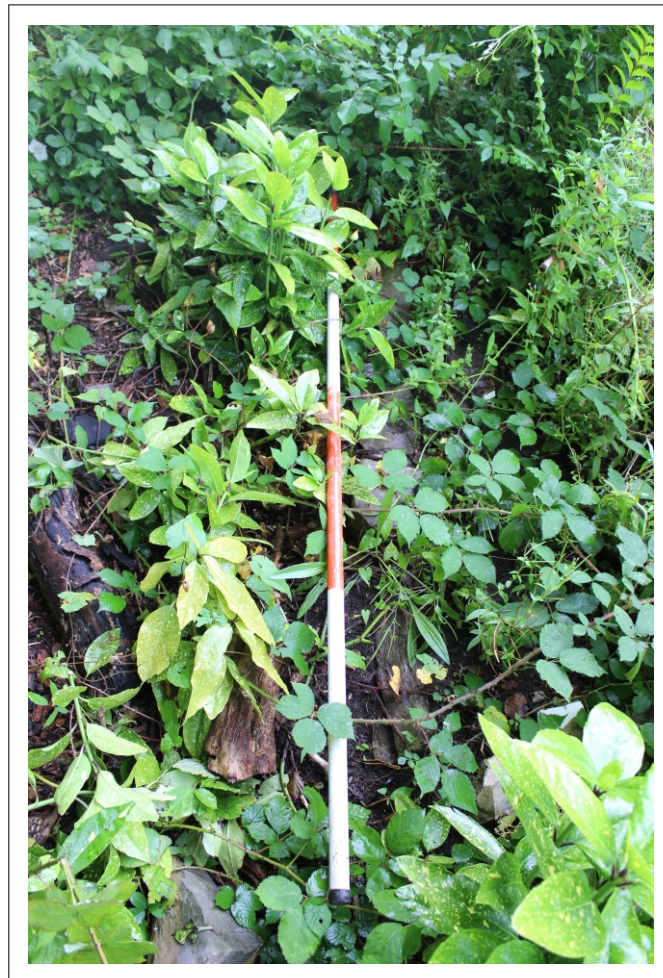
There appears to be little other details of note apart from a probable later insertion of a stone edged path running up the earth bank toward the north of the structure at a higher level, however this was heavily obscured by vegetation.

Plate 10: Detail of stone edged path, view from west

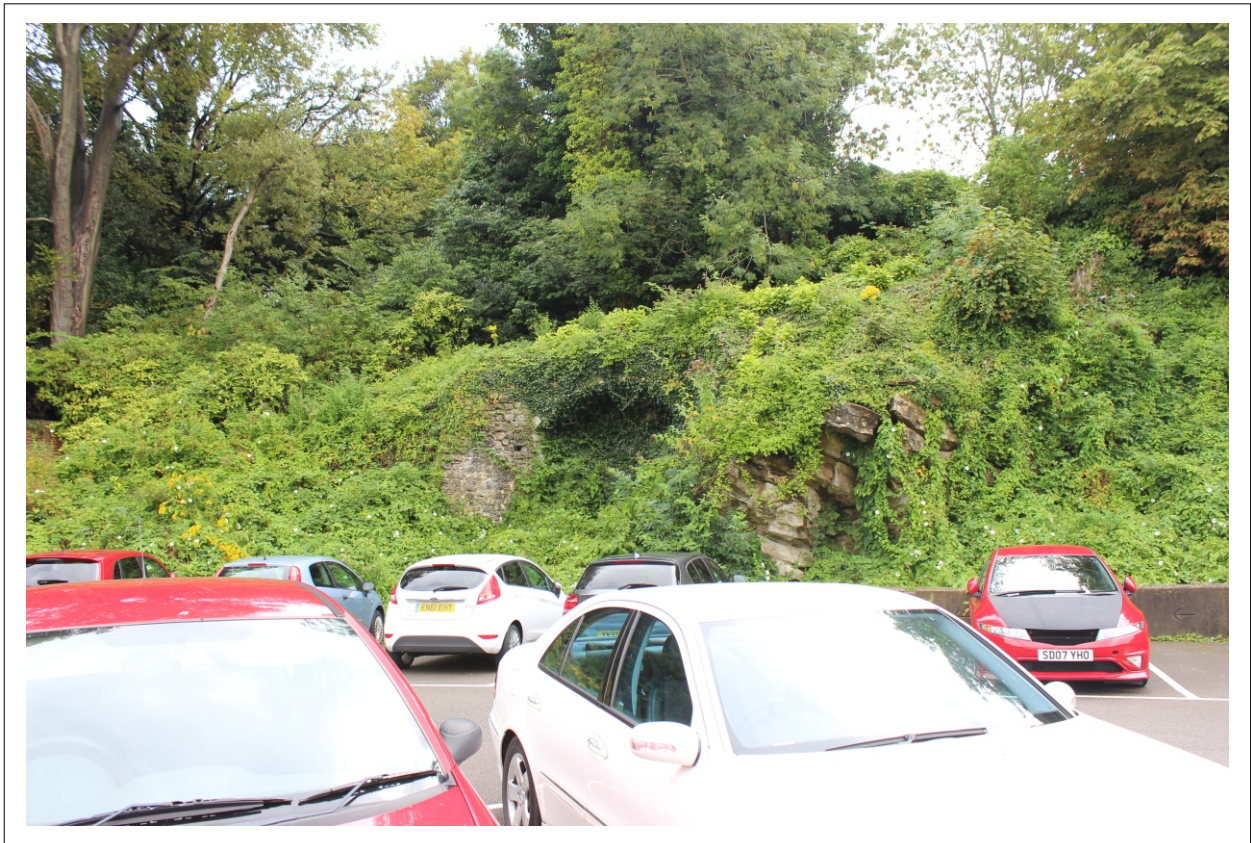
Plate 11: Western elevation, view from west

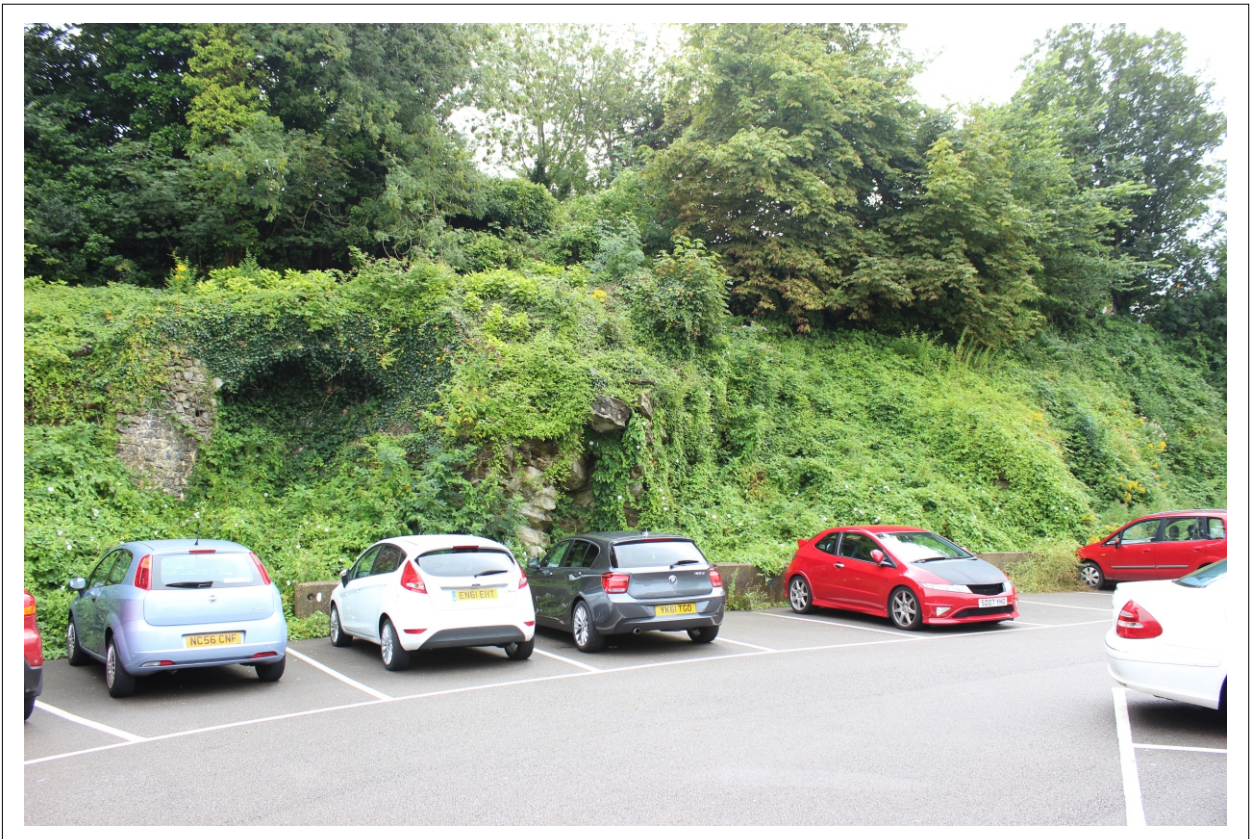
Plate 12: Western elevation view from west
