## **The Rhiw, Bridgend**

Watching Brief Report

Report No. 1466

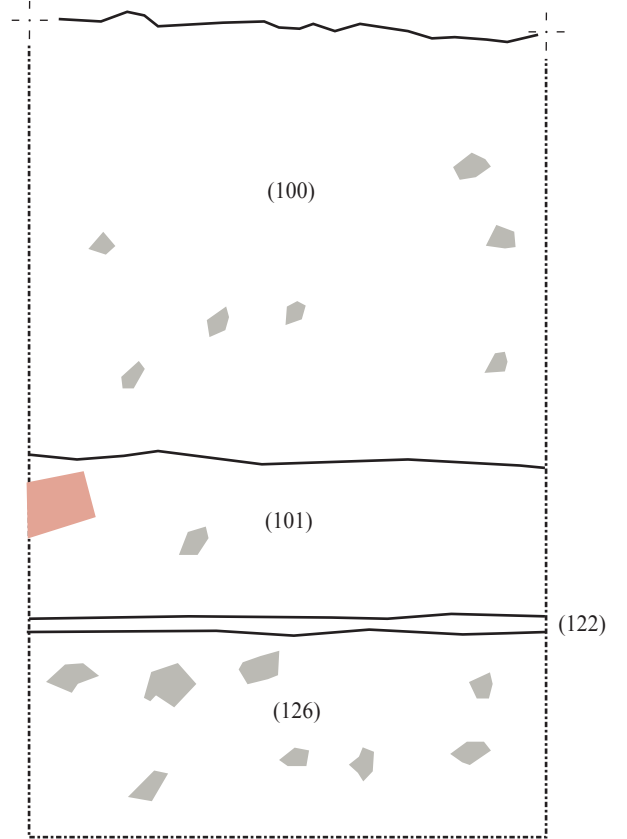
East-Southeast Facing Section of Foundation Trench  
DWG 2 Scale 1:10

Deposit (122) was a 0.14m deep layer of black asphalt located in the north-western area of The Site (Figure 3: Drawing 2). This layer is associated with a previous structure and modern in date. Deposit (122) was situated below (101) and above (123).

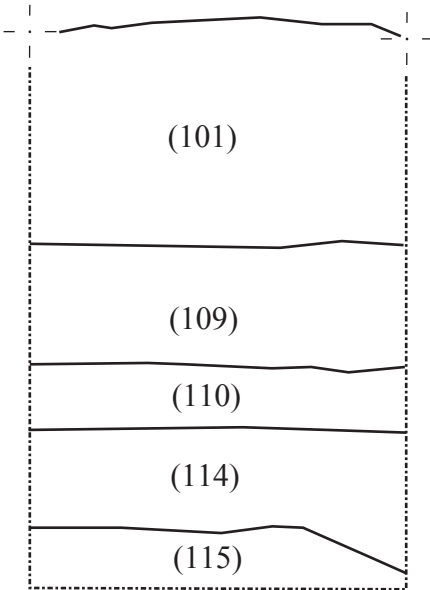
North Facing Section of  
Foundation Trench  
DWG 3 Scale 1:20

Some demolition debris was present within the top of (115), however, this could be residual being pushed down from (114) above (Figure 4: Drawing 3: Plate 6).

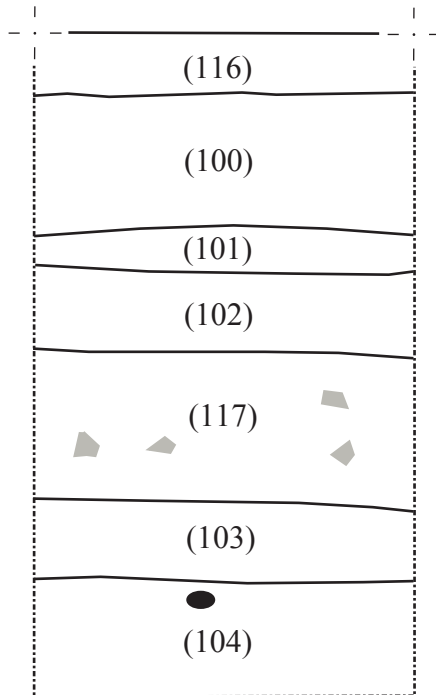
East Facing Section of  
Foundation Trench  
DWG 7 Scale 1:20

Deposit (116) was an asphalt surface created as temporary haul road for access within the western area of The Site and overlaid modern demolition rubble deposit (100) (Figure 4, Drawing 7).

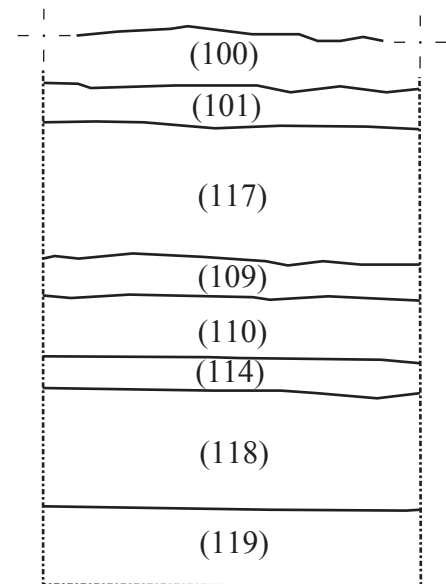
East Facing Section of  
Foundation Trench  
DWG 8 Scale 1:20

Deposit (119) was a light yellowish-white silty sandy layer of crushed/broken mortar that measured 0.2m in depth. Although this layer was not fully exposed during the watching brief, (119) appeared to be the earliest layer of demolition within the site and did not appear to be associated with any structure, however, its presence on site strongly indicates to the demolition of a previous structure within the vicinity (Figure 4: Drawing 8).

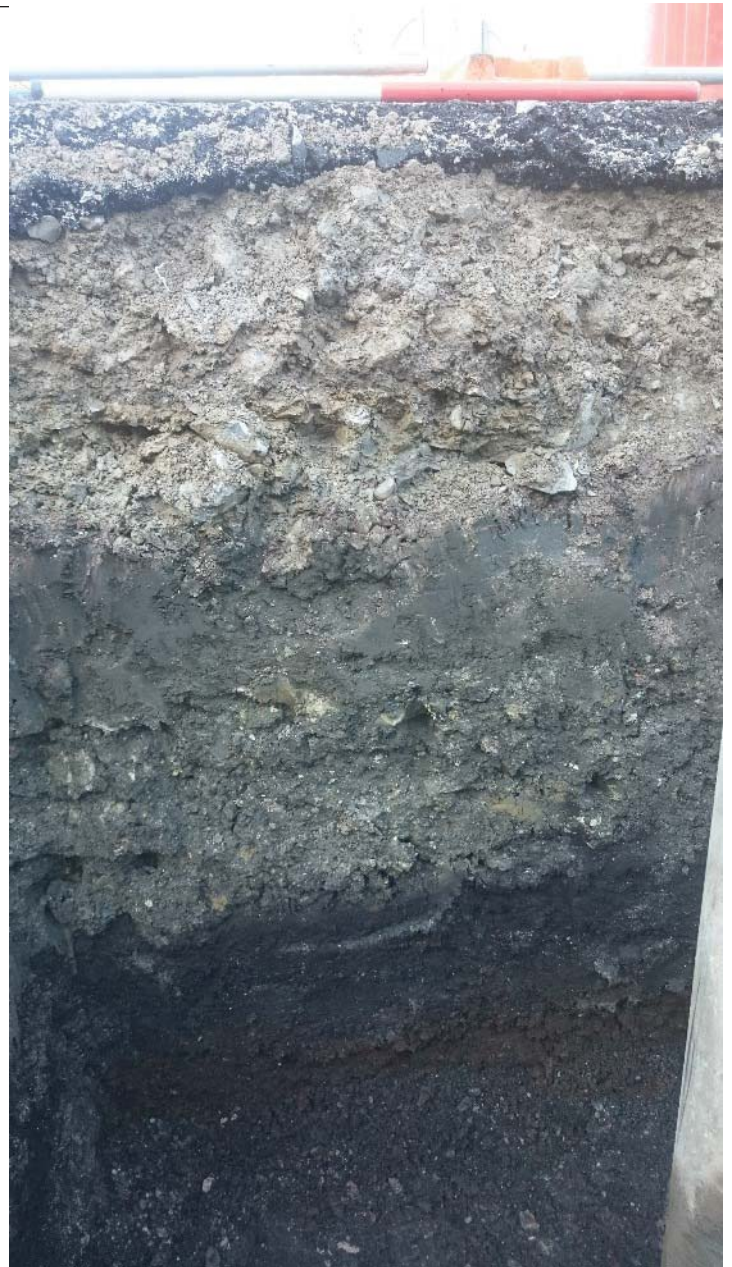
East Facing Section of Foundation Trench  
DWG 6 Scale 1:10

Immediately above (105) was a 0.68m thick deposit (104) of mid-brown sandy silt. This layer was comprised of waterlogged organic material most probably deposited naturally when the Ogmores River extended to this area. Clay pipes, animal bone and remains of a cow skull were recovered from this deposit indicating a post-medieval date. This deposit was also only present in the south-westernmost area of site (Figure 5: Drawing 6: Plate 1).

East Facing Section of Foundation Trench  
Section Drawing and Corresponding Photograph

Plate 1: East Facing Section of Foundation Trench

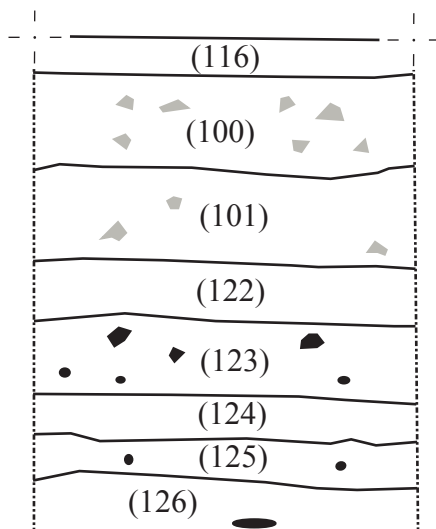
East Facing Section of  
Foundation Trench  
DWG 11 Scale 1:20

Deposit (126) was a 0.16m deep layer of mixed yellowish-brown silty clay brought in to act as a bedding layer or landscaping deposit on The Site (Figure 6: Drawing 11). This deposit was not fully excavated therefore it was unable to determine its place within the stratigraphic matrix. Deposit (126) was overlain by layer (125).

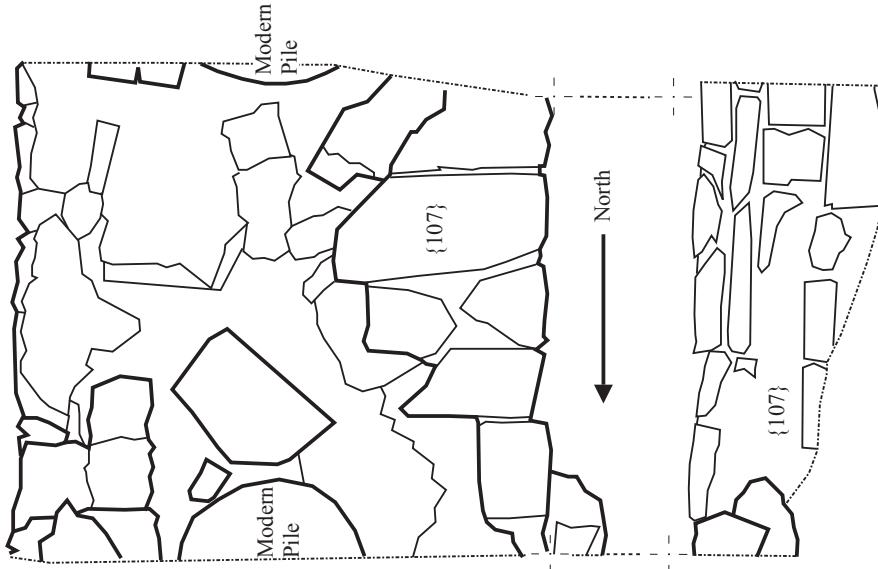
Plan of Culvert Wall {107}  
DWG 15 Scale 1:10

Structure {107} was a stone built culvert contained by cut [106] in the central southern area of the site (Figure 7: Drawings 12-15: Plates 4 and 5). Structure {107} was constructed with dressed stone blocks that measured 0.17m by 0.3m by 0.25m and were bonded with lime mortar. The culvert measured approximately 3m in width (including walls) with an interior space of approximately 1m. The internal height was approximately 1.5m. Culvert {107} ran on an approximately north-south alignment and appeared to follow the route of the adjacent river and was most probably a form of flood prevention. Health and safety concerns resulted in the internal area of the culvert not being recorded. Culvert {107} was followed by deposit (108) and was physically truncated by cut [111].

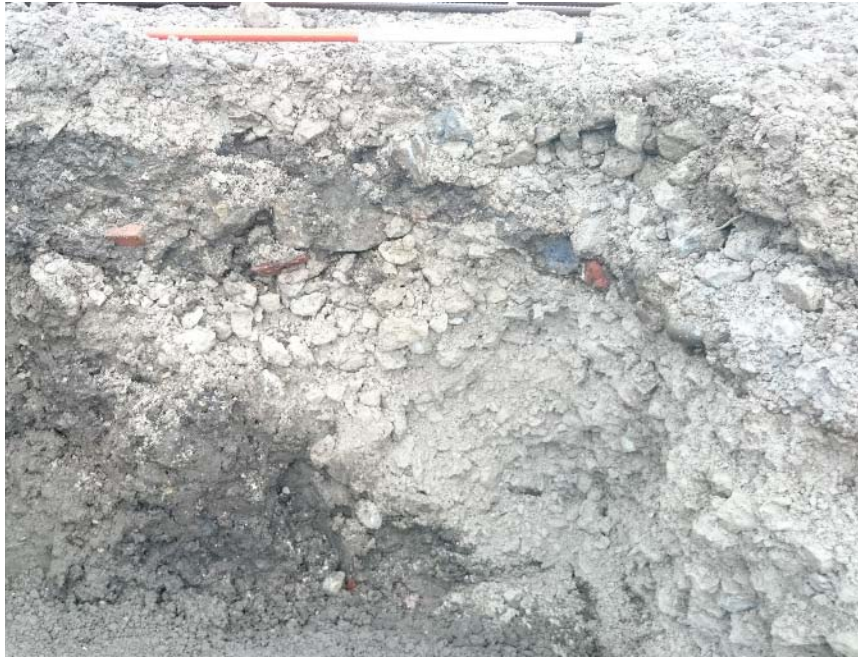
Plate 2: Northeast Facing Section of Cut [120]

Cut [120] was located in the middle of the western end of the site and measured 0.4m deep (not fully excavated) and 2.5m wide (not fully excavated) and contained a single deliberate backfill deposit (121) of crushed concrete and stone very similar to deposit (100). This feature is probably associated with another construction/demolition event with deposit (121) being used to increase the level of the ground surface (Figure 6: Drawing 9 and 10 and Plates 2 and 3). Cut [120] truncated deposit (117) and layer (121) was situated below modern demolition layer (101).

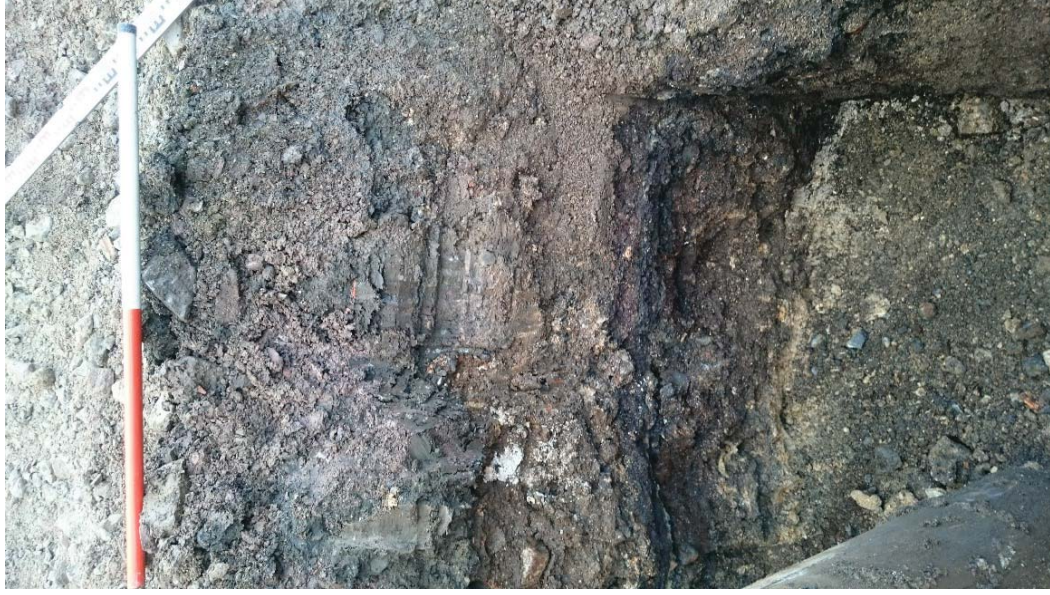
Plate 7: North Facing Section of Foundation Trench Relating to DWG 3

Layer (110) was another layer of deliberate backfill consisting of demolition rubble, natural silts and some slag. (110) was black in colour and measured 0.18m in depth (Plate 7) and was situated stratigraphically above (114) and below (109).
