# EXCAVATION OF A BRONZE AGE ROUND BARROW (PRN 55928) AT PANT Y BUTLER, LLANGOEDMOR, CEREDIGION, 2010

Prepared by Dyfed Archaeological Trust  
For: CADW

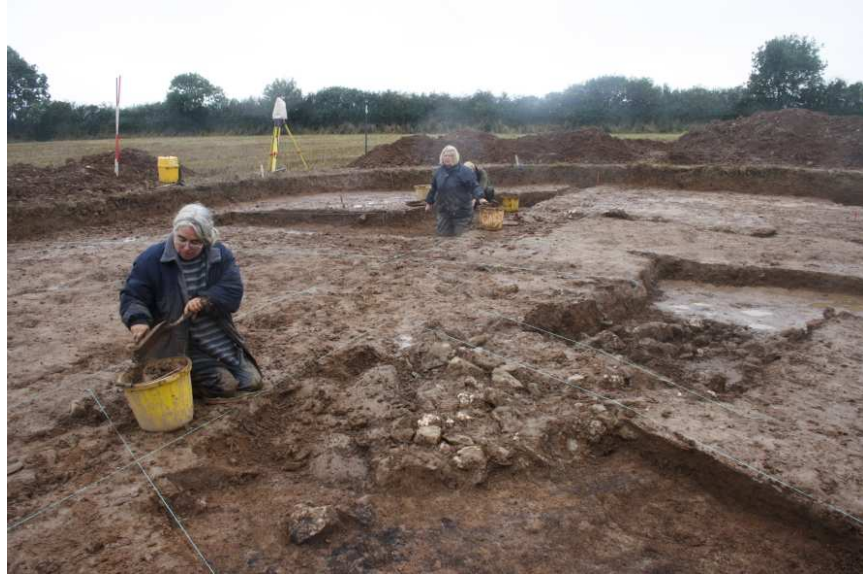
*Photo 5. Removing the last of the mound material (32) exposing the thin layer of burnt material (100) in foreground, turf layer (26) and the large stone monolith (101) at the eastern end of grave cut (43). Photograph taken looking southwest.*

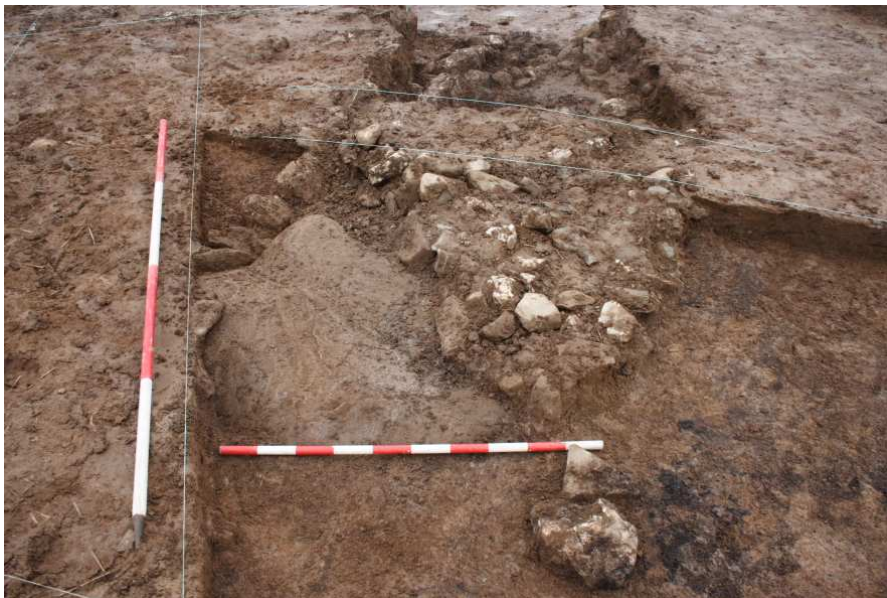
*Photo 6. The stone fill (44) of grave cut (43) butting up against and slightly overlapping the stone monolith (101). Photograph taken looking west.*

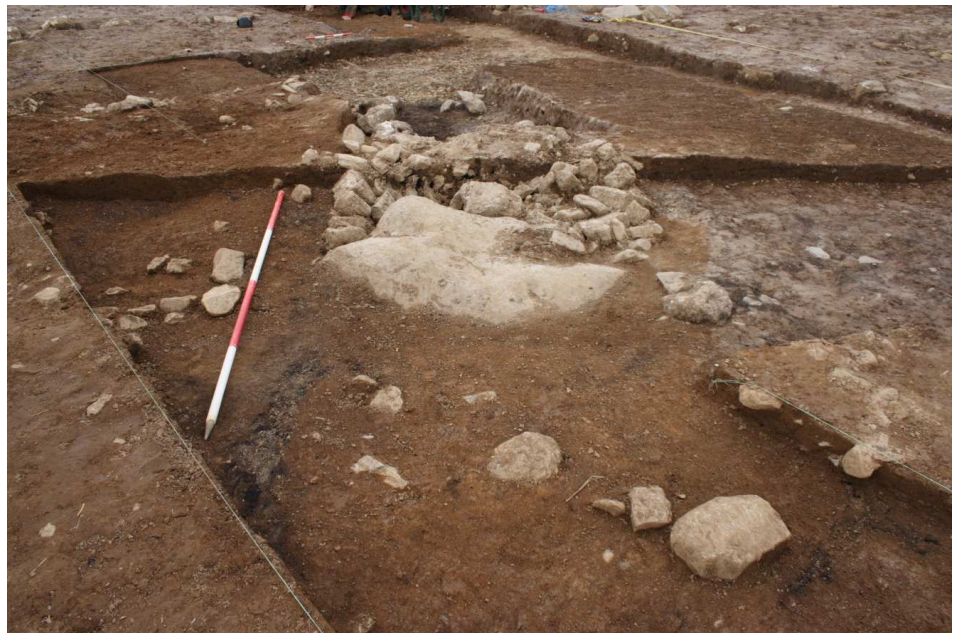
*Photo 8. After the removal of mound material (32) small areas of burnt wood and charcoal were exposed, including what appeared to be the remains of a burnt 'plank' (102) seemingly in the same alignment as the edge of grave cut (43), and that of the burnt 'plank' (23) recorded in 2009. Photograph taken looking northwest.*

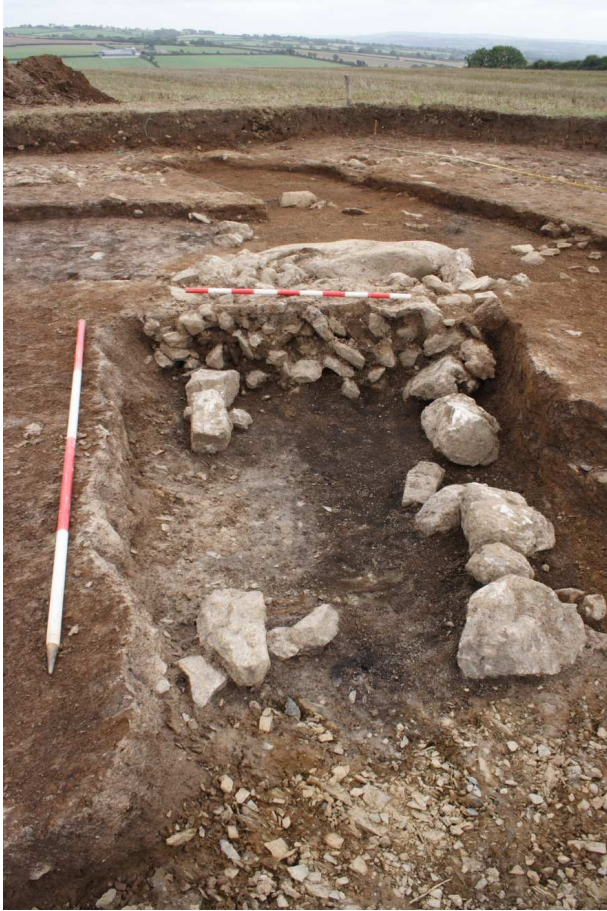
*Photo 9. The western half of grave cut (43) after the removal of stone fill (44). The large quartz stones (46) that lined the long edges of the grave can be seen and lying at the bottom of the grave cut upon the bedrock and butting up against the stones is a very thin dark organic layer (45). Photograph taken looking east.*

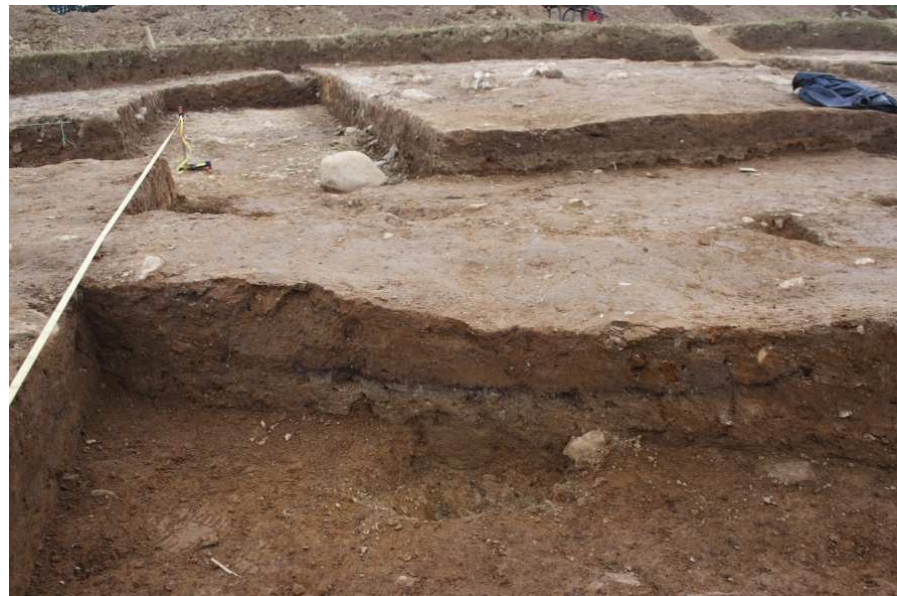
*Photo 12. Part of east facing section of baulk south of grave cut (43) showing how areas of burnt material lay immediately above the lighter coloured turf layer (26). Photograph taken looking west.*

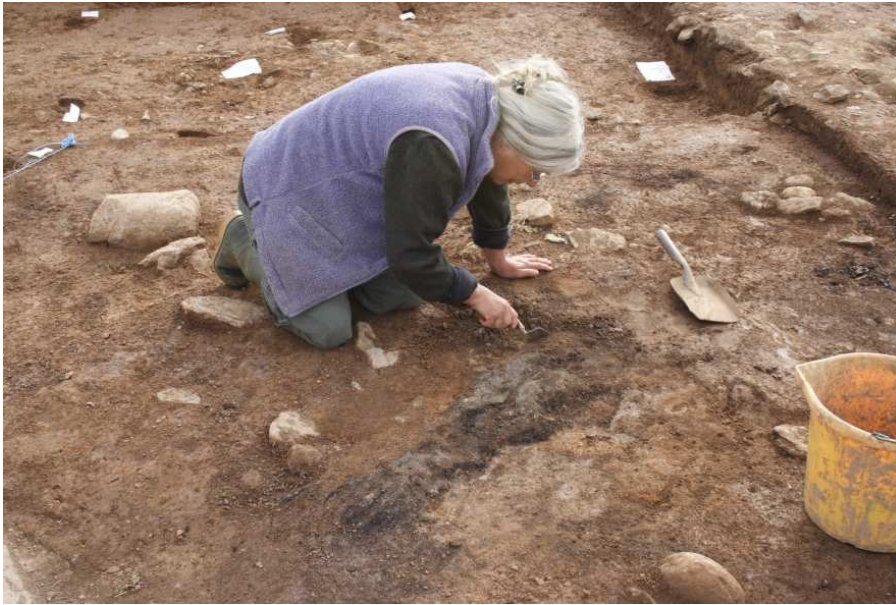
*Photo 13. Exposing the burnt wooden 'plank' (101). Photograph taken looking east.*

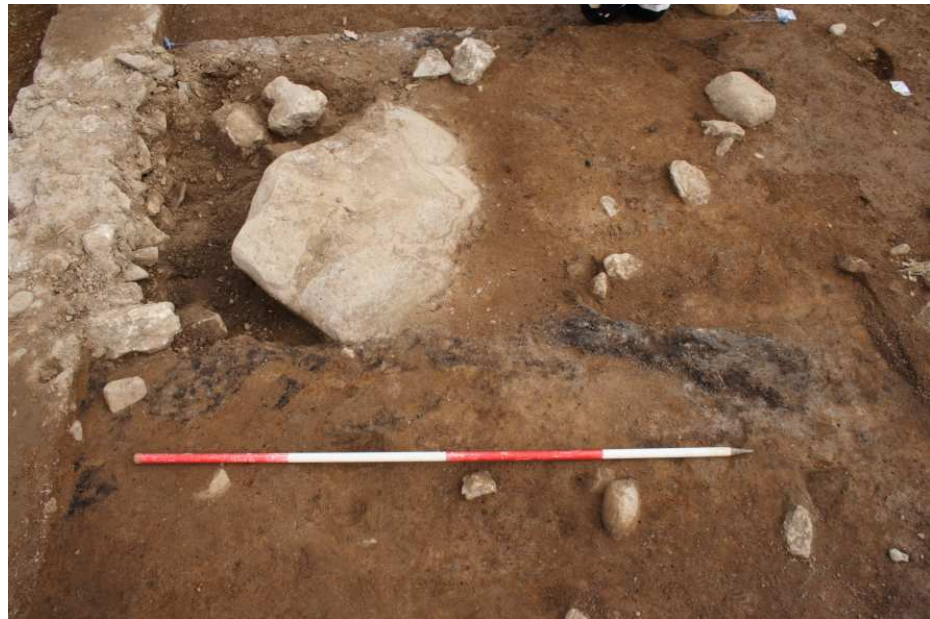
*Photo 14. The burnt wooden 'plank' (101) fully uncovered. Photograph taken looking north.*

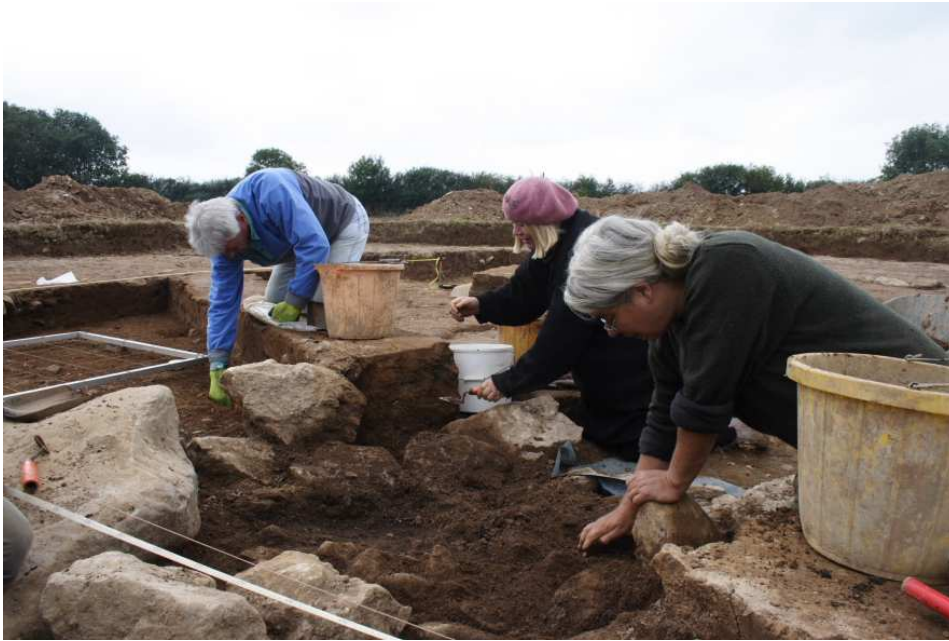
*Photo 15. Removing the eastern half of stone fill (44) of grave cut (43)  
Photograph taken looking southwest.*

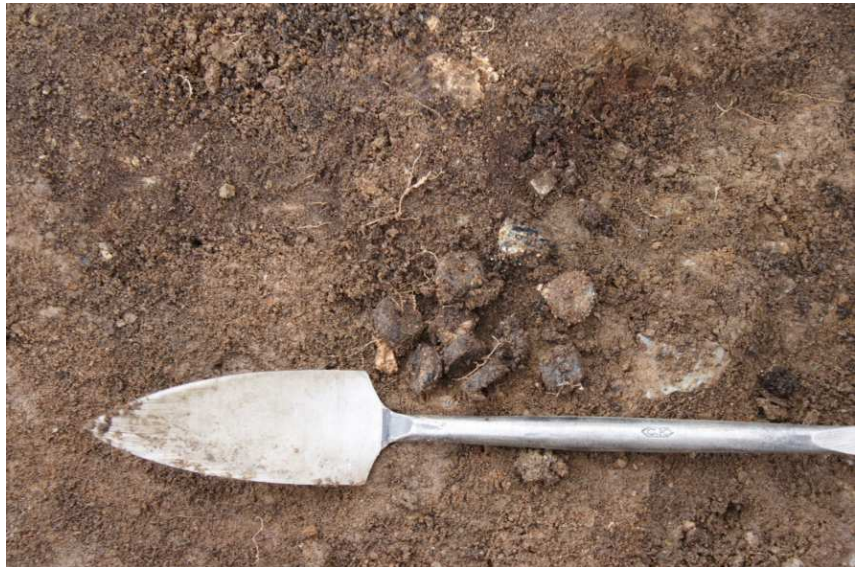
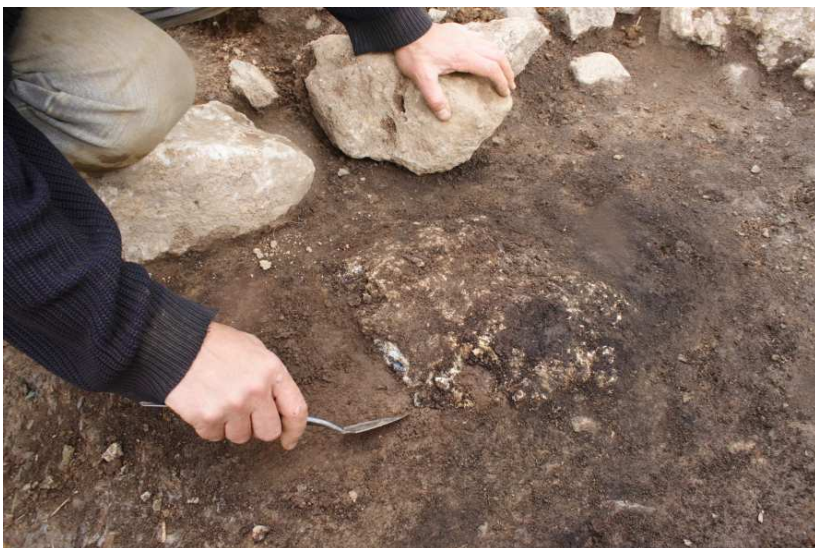
*Photos 19-21. The cremation deposit (108) during excavation and the beads (SF 121) as they appeared within the deposit.*

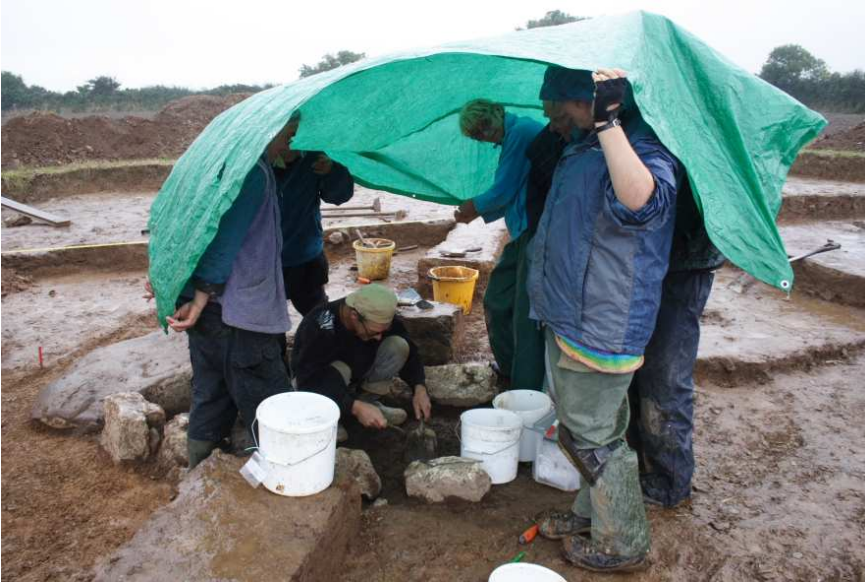
*Photo 22. Above – excavating the cremation deposit (108) in rather wet conditions.*
