ARCHAEOLOGICAL

WATCHING BRIEF

WB01/BR/07

Site at Canal Bank Brecon

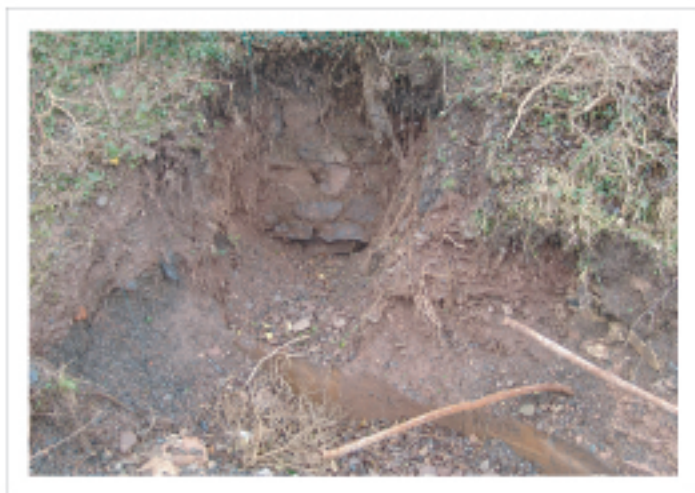
Plate 01: Cast iron gas holder rim.

This feature comprised a rectangular brick structure out of which protruded four 40mm iron bars *plate 12*. Its position was aligned with the outside iron rim of the eastern gas holder, shown in *plate 1*. *Plate 1*, also shows two of the iron bars which appear in *plate 12*.

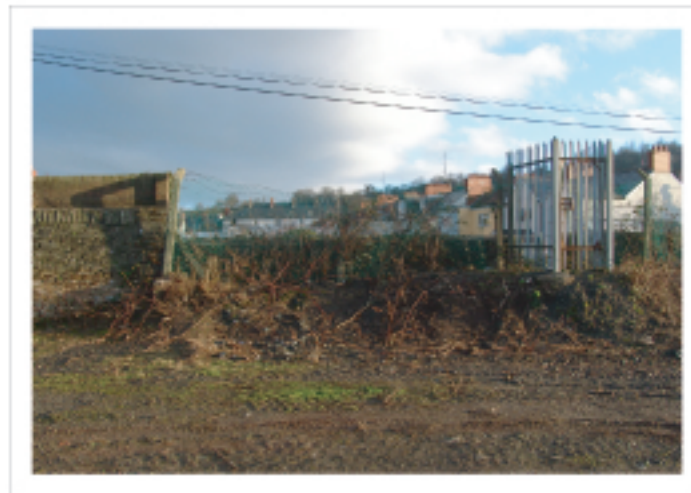
Plate 06: Gated access to upper terrace

At the start of the watching brief, a masonry wall formed the boundary to the north east and south of the site, *fig 4*. The western 23m, of the northern section of wall stood to a height of 3m; the bottom 2.5 of which were masonry and mortar construction with the top 0.5 m being 8 courses of brick *plate 05*. At approx 23m from the western end, the brick course ended and the masonry wall reduced to about 1.9m. Approximately, 30 m from its western edge, the remains of an access gate to the upper terrace level remained *plate 6*.

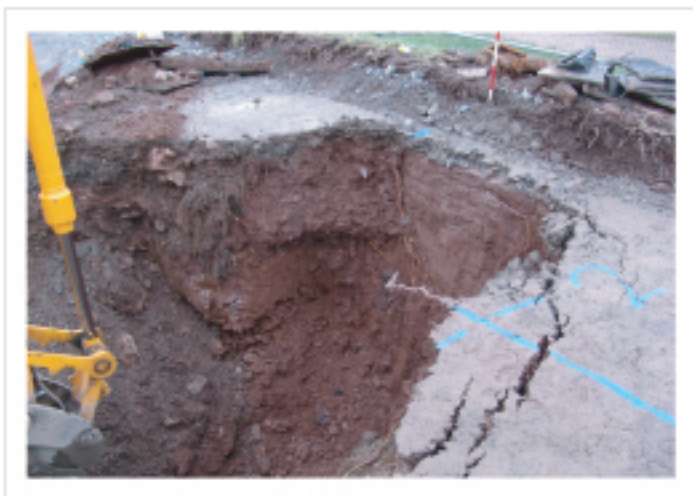
Plate 07: North wall foundation)

An anomaly; both colour and construction width, can be seen running unevenly along the inside of the wall, about 1 m below the top of the masonry edge *plate 05*. This entire section of wall, separating the site from the canal, was removed to surface level. A section of the wall foundation was exposed during Phase 3 (*below*) and was observed to extend at least a further 2m' to a double course of dressed stone *Plate 07*. Unfortunately, it was not possible to examine the exposed foundation in any detail.

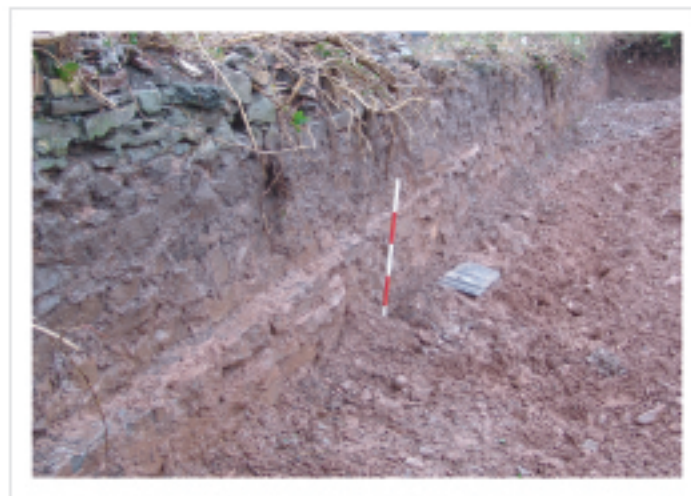
Plate 08: East wall, width reduction

The east section of wall; of similar above surface masonry construction, was exposed to a height of 1.5m above ground level. Approximately, 1m below the surviving top of the wall and 0.8m above the ground level, the wall has a 0.22m width reduction along its entire length, *plate 08*.

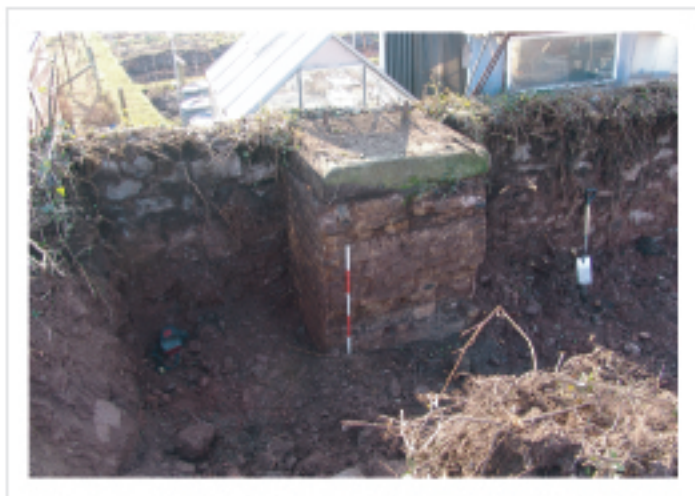
Plate 11: Feature (3)

This feature comprised a brick pillar built against the south boundary wall, *plate 11*. The pillar stood 1.5m above ground level and 18m from the south east boundary. Its length, parallel to the wall, reached 1.4m and its width 1.16. The top of the pillar was capped with a bevelled slab of stone 0.25m thick and drilled with four holes through which protruded 40mm iron bars.

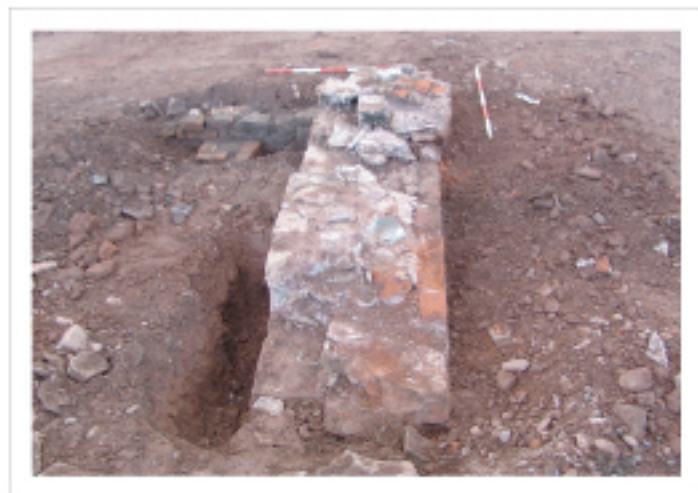
Plate 13: Wall, feature (4)

The wall, *plate 13*, survived to a length of 2.6m at 0.7m wide and ran roughly NNE by SSW. Its construction was brick on the western side, *plate 14* and dressed stone on the eastern side *plate 15*. It stood to a height of 0.35m above the present surface and a small test pit, *plates 13 & 15*, revealed its depth beneath the surface as a further 0.4m. The north eastern end of feature (4) also revealed some brick tumble at its base but this extended beyond the limit of excavation *plate 16*.

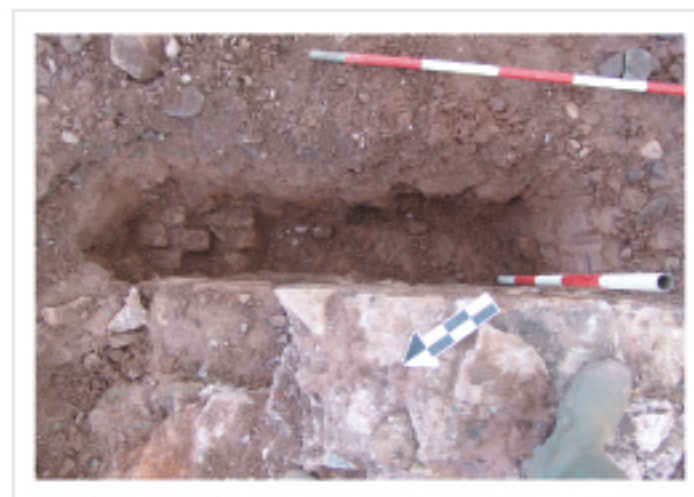
Plate 16: Features (4) with underlying tumble

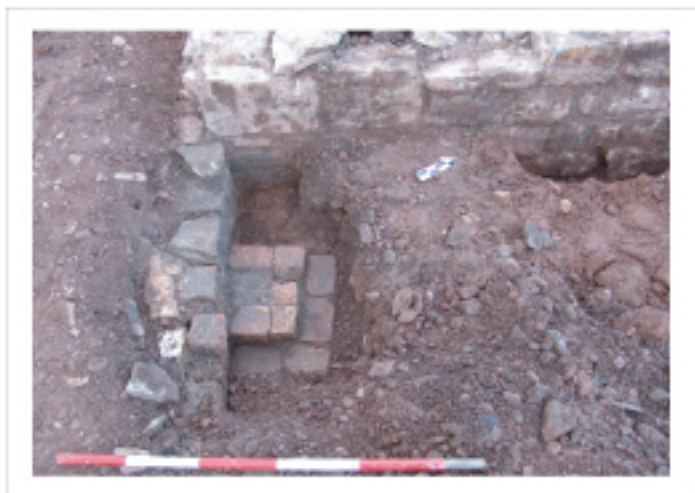
Plate 17: Wall, features (4), (5) & (6)

Feature 5, *plate 17*, was a short length of wall constructed of stone and brick and butted to feature (4) at right angles to its southern end. There was no evidence of mortar within the wall or between (4) & (5). The wall survived to a length of 1.2m at 0.28m wide.

Feature (6) was uncovered during the excavation of [006] and comprised a plinth of bricks underlying feature (5) *plate 13*. The feature did not extend beyond feature (5) and as can be seen in *plate 17* posed no rational alignment to it which could suggest a contemporary use *plate 18*.

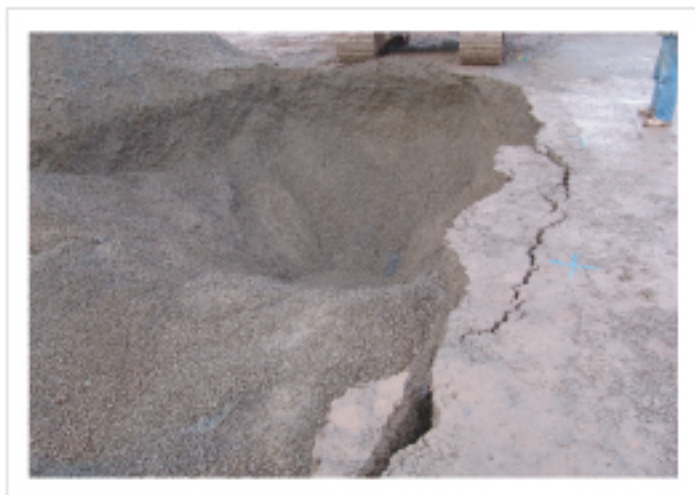
Plate 19: East tank position

This phase of the work was heavily restricted by health and safety concerns. The remains of the gas holder were around 1.5m below the present ground surface, and covered by very unstable aggregate fill. The instability of the ground can be seen in *plate 19, grid N4*.

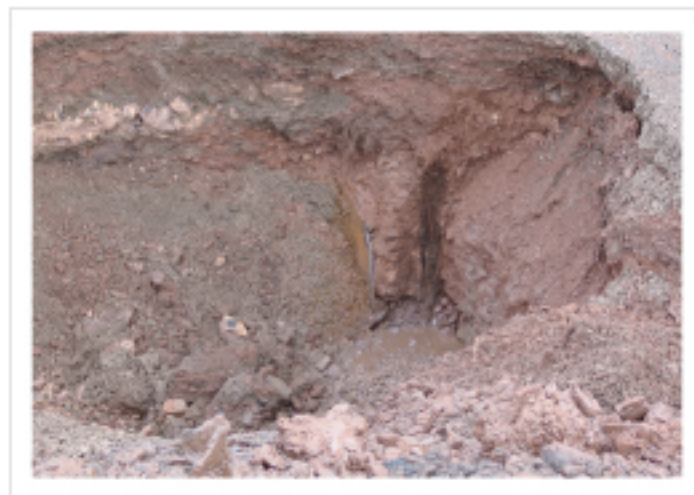
Plate 20: Wall and liner, feature (12)

The iron tank liner of the eastern tank appeared to be substantially intact below the 1.5m mark. It comprised vertical sections of iron plate surrounded by a retaining strap and vertical brick wall *plate 20*. The cast iron base was also substantially complete and still held liquid residues *plate 21*.

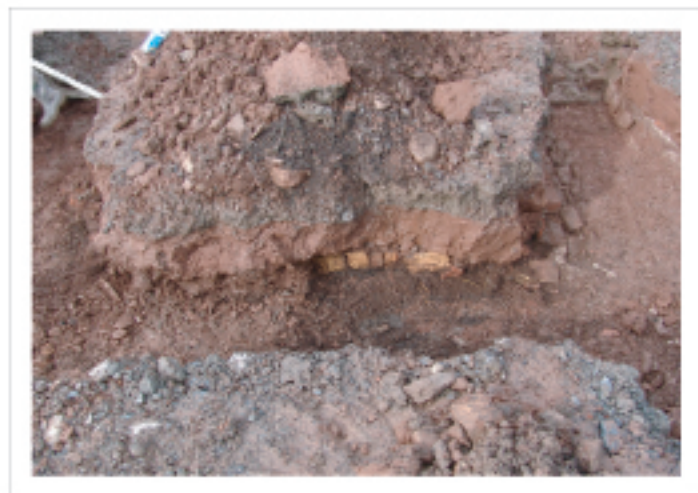
Plate 25: East edge, feature (8)

The eastern exposure of (8), shown in plate 25, shows as a line of yellow brick which differs from any other part of this feature. The unexposed section to the left shows a different context of darker clay with root and small stone inclusions [009]. This can be seen more clearly in plate 26 which has been annotated.
