A.P.A.C. Ltd.

**ARCHAEOLOGICAL
RECORDING & WATCHING BRIEF**

WB/GOV/10

Old Corn Mill, Govilon

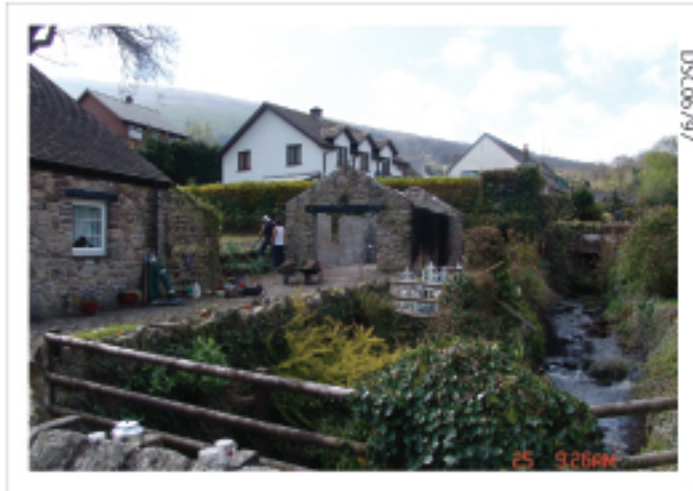
Plate 01: General view of the house.

Old Corn Mill; consists of a long, two storey building, formally a corn mill, which has been converted to a single dwelling house, Plate 01 with a detached garage, Plate 02. The house has retained its waterwheel, Plate 03 as well as some of the internal mechanisms which now form part of a lounge feature. The garage, a recent build and sympathetic to its surroundings, unfortunately, had to be demolished to provide the building plot for the annex, fig 02.

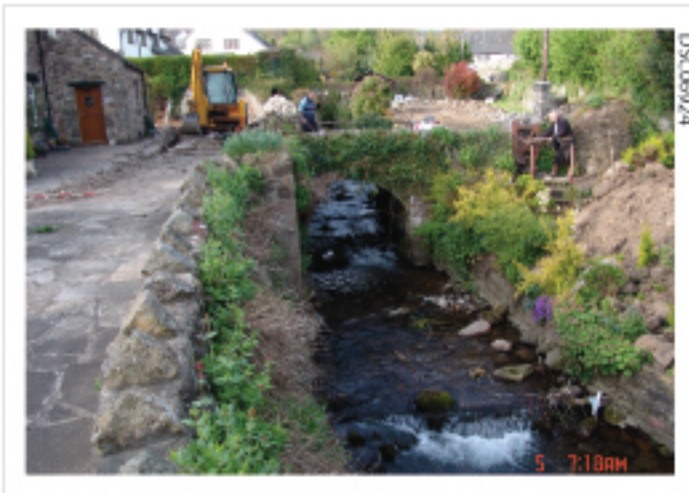
Plate 07: The northern end of the site.

The garage site is bounded to the south by a high retaining wall for the property next door Plate 04. To the east is a raised patio Plate 05 which stands at the base of the old wheel race Plate 06. To the west is a walled stream Plate 01 and to the north the mill house and a paved area Plate 07.
