**Grade II, BUILDING RECORDING SURVEY**

**Ty Ambrose Farm, Sebastopol.**

**Planning Application: 11/P/00576**

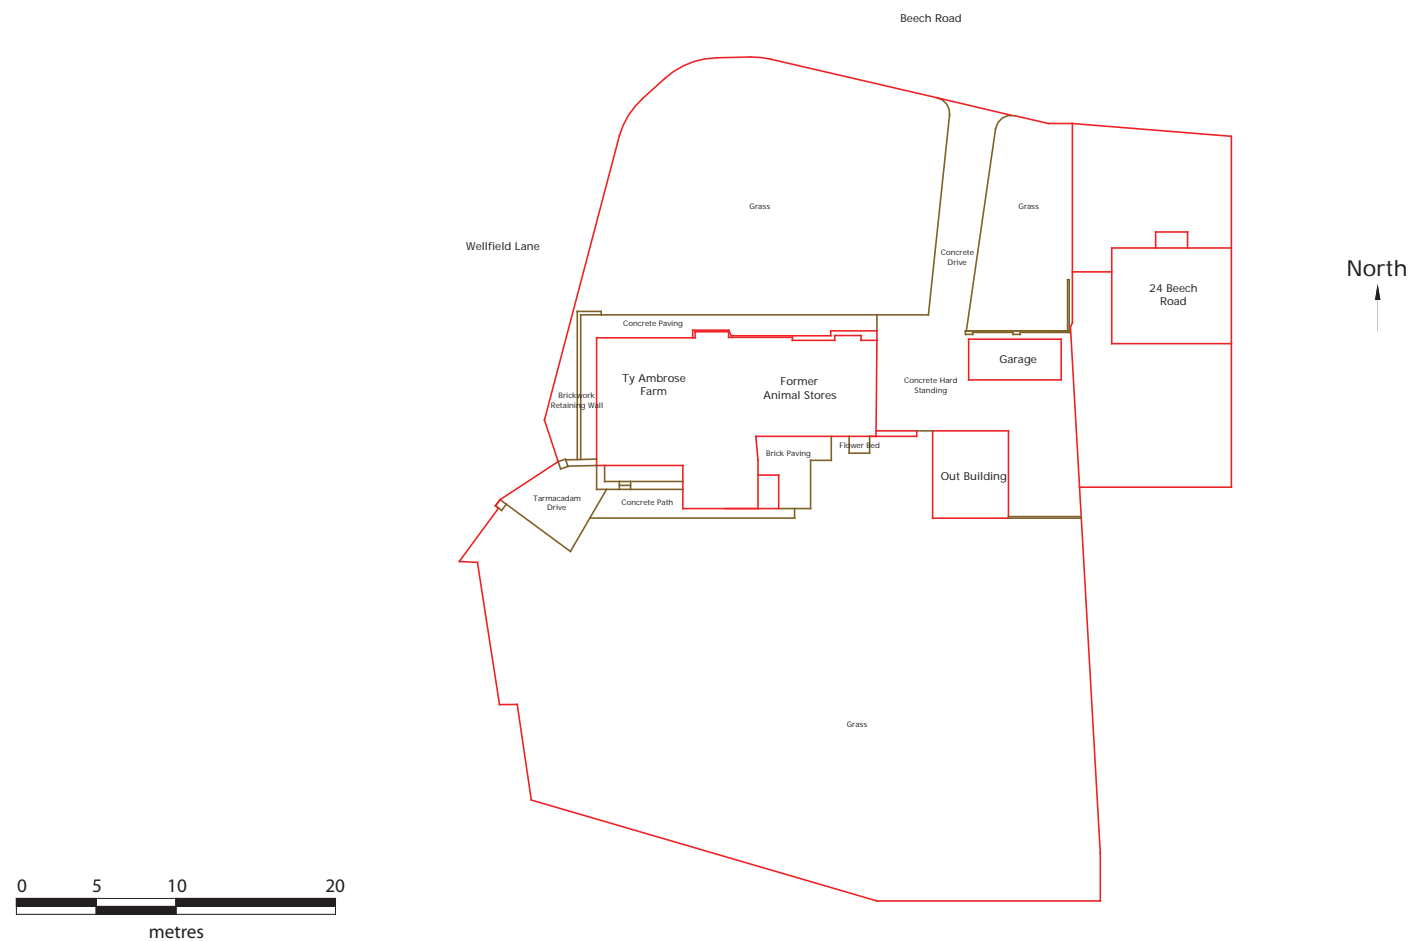
Figure 04: Existing footprint of building

Both maps show the presence of a barn to the south/west; a single wall of which still exists as part of the present boundary wall, plate 01. Also noted on both maps is the curved boundary wall to the south and west; also still in existence. The boundary wall encloses the southern curtilage; locally remembered as a former orchard and landscaped garden, it is now just rough ground with debris from the renovation, *fig 04*.

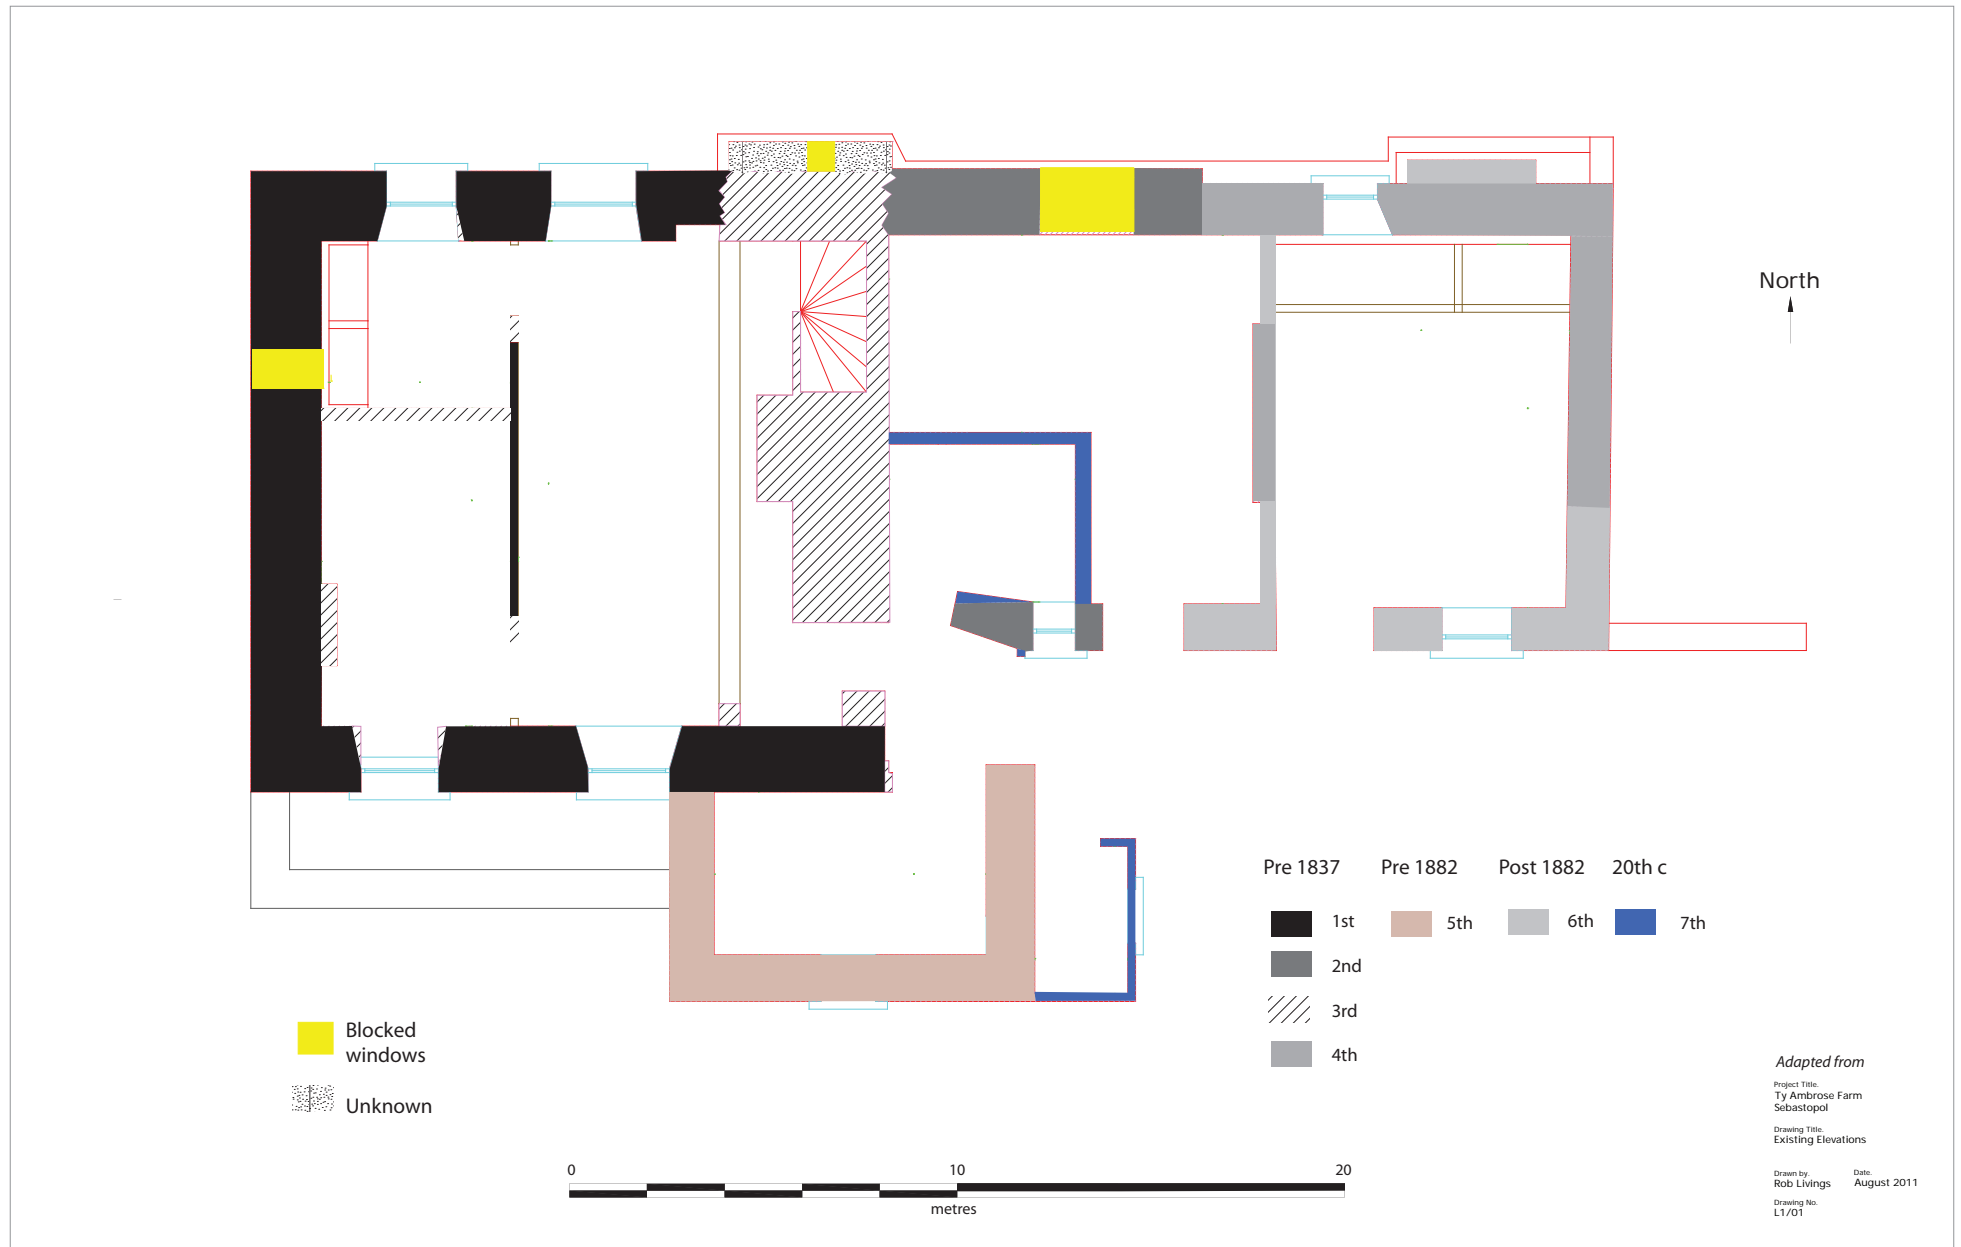
Figure 08: Phasing, ground floor

The majority of the phasing however has been teased from measurement, alignment and observation with some typological comparison. Fig 08 gives a schematic of the relative phasing of the house, explained below:

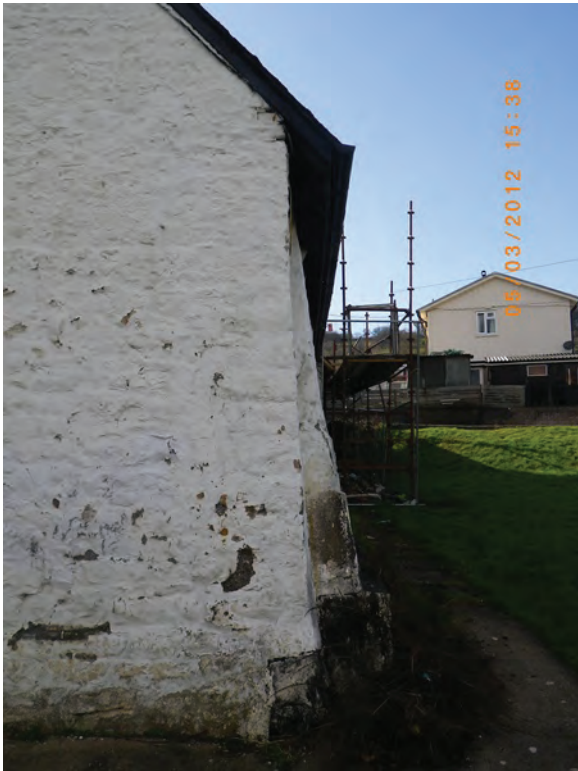
Externally, **4** has an irregular buttress which has been added to the north wall, running from the bottom of the east gable end to the eaves, Plates 14 and 15.

Reason for image    Detail of NE gable corner showing batter and butress

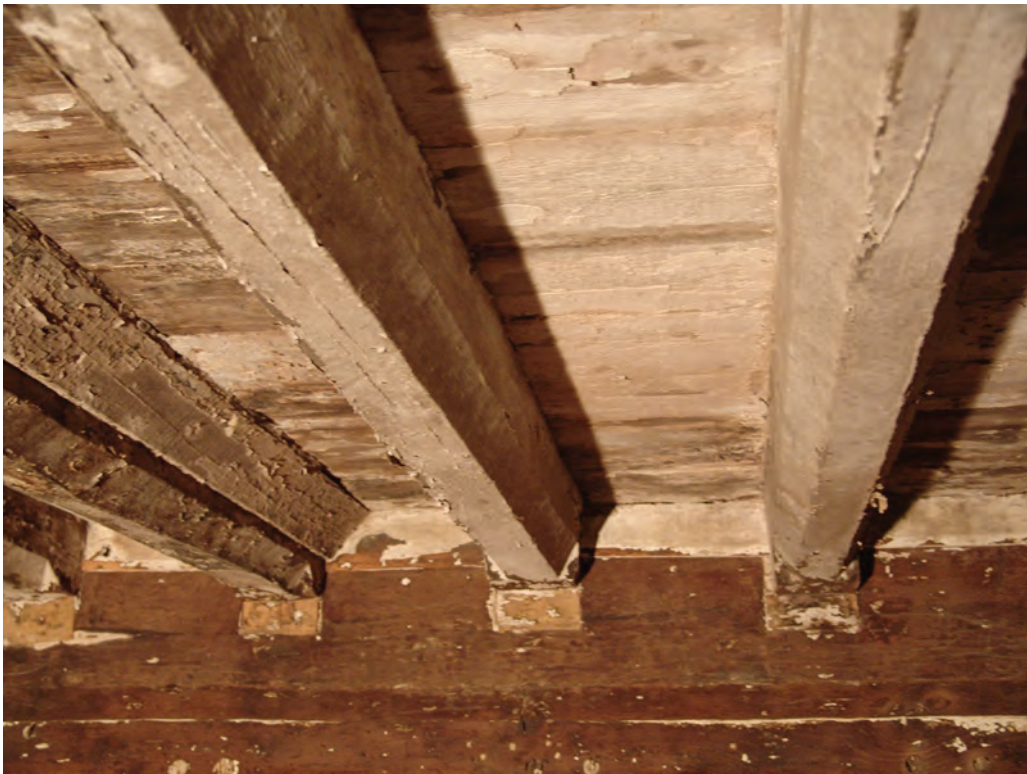
Plate 24 shows the oak partition looking south west with D14 to the left and D4 to the right whilst Plate 07 is the same view looking north west.

Reason for image    Detail of beam and raised/renewed joists? Diagonal cut stop mouldings

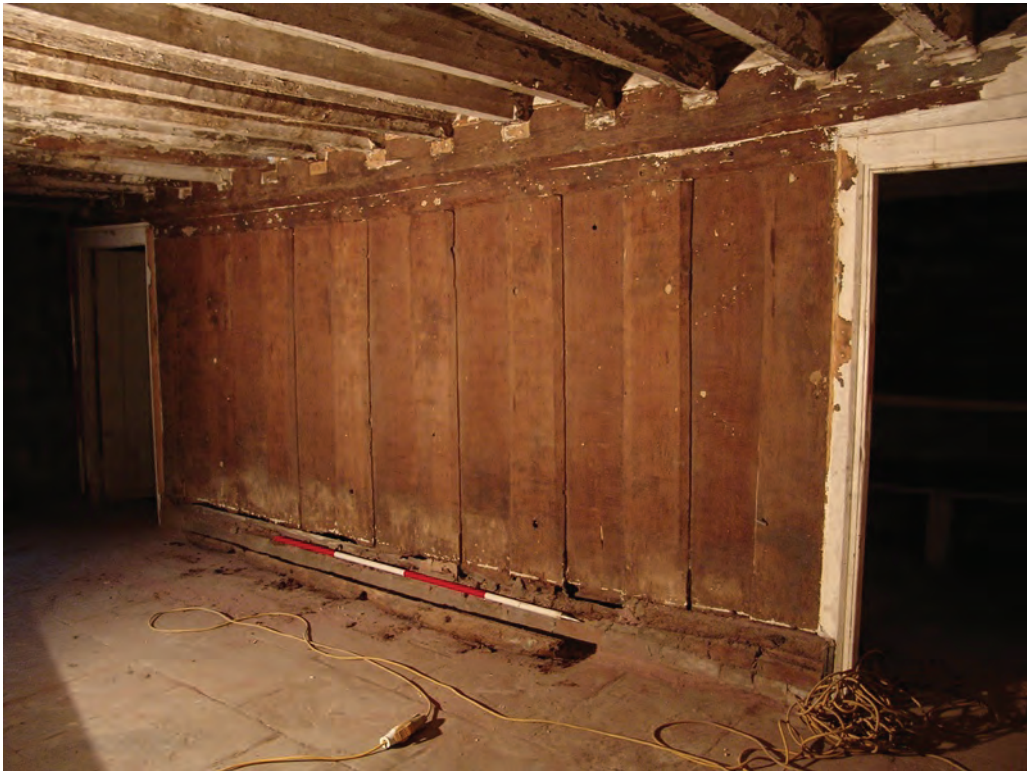
The oak panel partition is not 'stud and panel' as has been listed but an overlapping plank partition with each plank being housed in top and bottom, in slotted plates. The bottom plate itself rests upon two courses of brick work and the bricks appear to resting on flagstones which continue unbroken under the wall into the rear rooms. Plate 25 shows the partition bottom adjacent to D4.

However, the centre 2.7m of brick coursing rest upon the remains of a beam containing peg holes, possibly for an earlier muntin and panel partition, Plate 25. Furthermore, the lower beam sits in a recess formed when the flagstones were cut to fit around it.

Reason for image   Plank Partition, chamfered side.

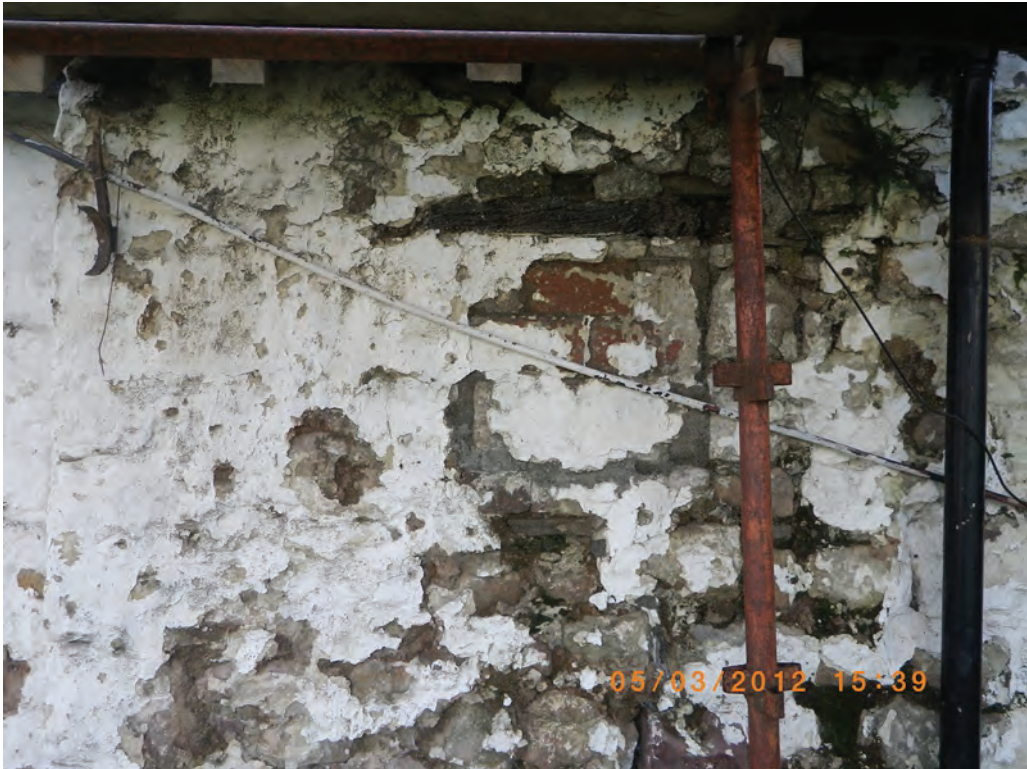
Site Ty Ambrose	Site code BS/TYA/12	Grid Ref: ST 28849800	Camera Pentax W-1G	Format Digital	File JPG	Dimensions 4288x3216	Size 4.2mb	Date 05/03/2012	Image no: IMGP1492	PLATE 28
Direction of view: West

The north wall of **2a** has a window W6, 0.89m wide which has no window seat recess and is splayed only on the west side, but this has been repaired in brick, Plate 29. This is the second window with 'angled dripstones' (ibid.).

Reason for image    Detail of north wall of house showing blocked window of stairwell

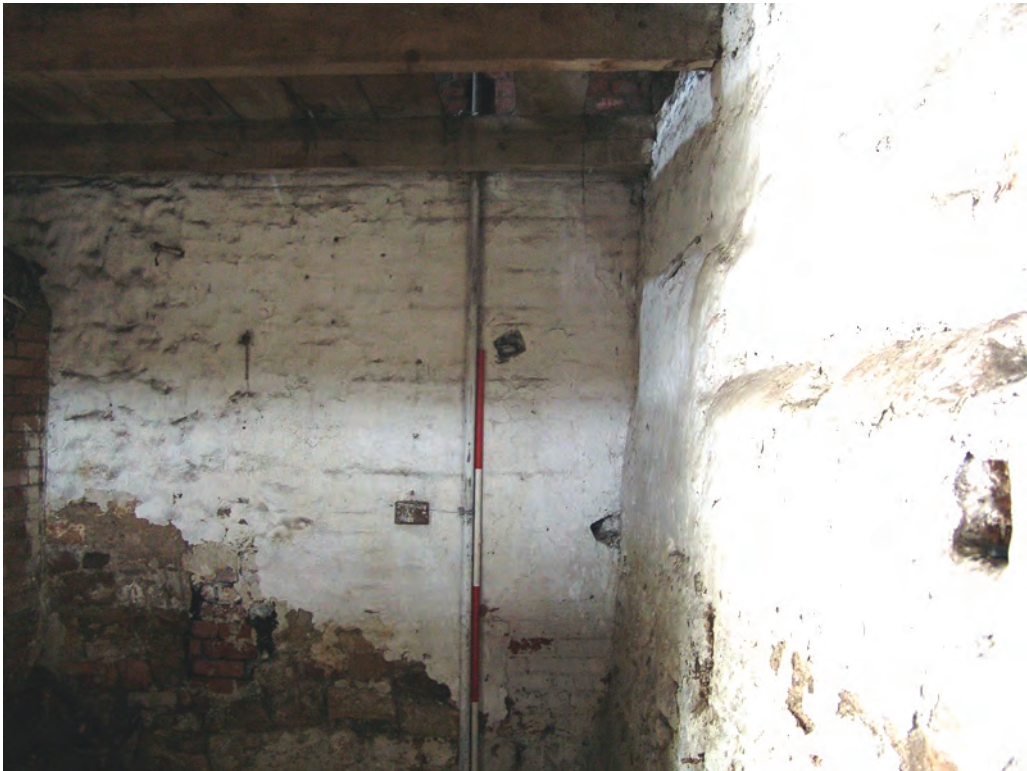
Site Ty Ambrose	Site code BS/TYA/12	Grid Ref: ST 28849800	Camera Sony DSC F28	Format Digital	File RAW	Dimensions 2048 x1536	Size 17mb	Date 12/03/2012	Image no: DSC02682	PLATE 31
Direction of view: West

The west wall of **3**, beyond the intrusion of **6**, is shared with **1**; the back of the fireplace and stairwell. Plate 31 shows that the majority of the wall is brick with occasional stone incursions most notable the large curved stone shown in Plate 32. It was not possible to assign any structure to the various patches other than random repairs.

The three square holes in the wall, Plate 31, were identifiable along with a matching set on the east wall, as a raised hay feeder.

Plate 31 also shows two of the joists which carry the loft floor, housed into the top of the slightly curving batter of the north wall.

Reason for image   Internal batter of N wall, Lintel of blocked door. Three holes for raised feeder

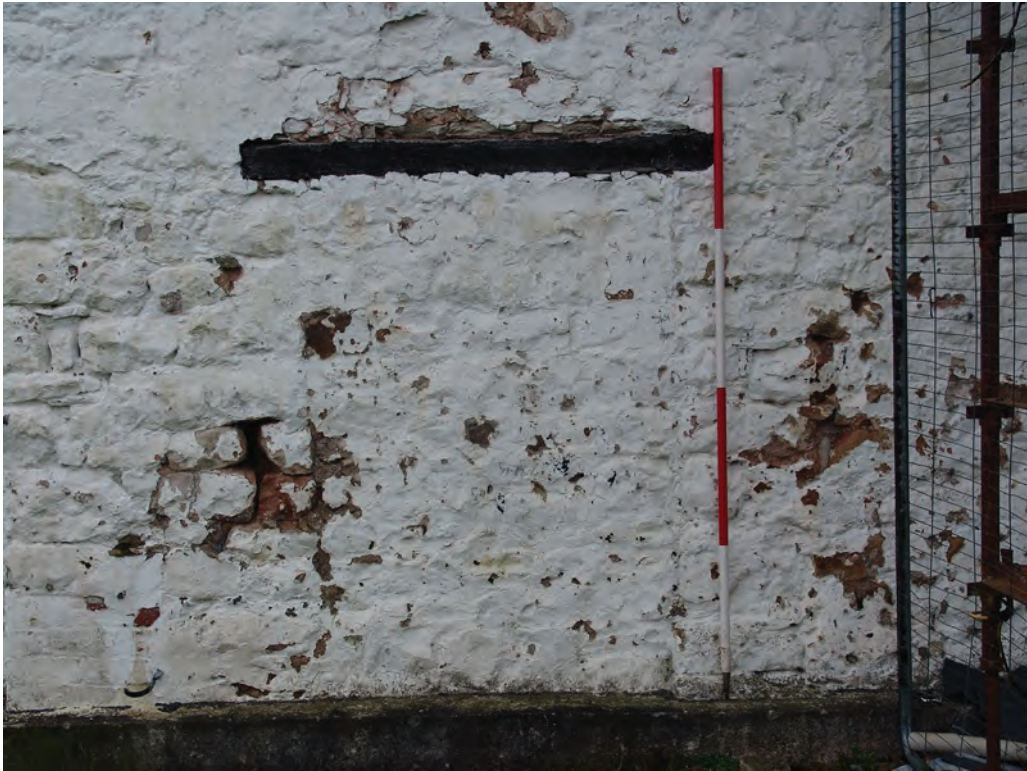
Site Ty Ambrose	Site code BS/TYA/12	Grid Ref: ST 28849800	Camera Sony DSC F28	Format Digital	File RAW	Dimensions 2048 x1536	Size 17mb	Date 12/03/2012	Image no: DSC02727	PLATE 33
Direction of view: South

Within the projected part of the wall, 0.8m from the eastern edge is a wooden lintel; 1.473m x 0.118m. The lintel stands 1.66m above the surrounding concrete wall platform and spans the scar of a stone blocked doorway, just over 1m in width, Plate 33.

The north wall of **3** has a large doorway, Plate 33; now blocked which may have formed a cross passage with D8, Plate 13, but if so it would be unusual for both doorways not to be directly opposite.

Reason for image    Detail of Cross-passage door

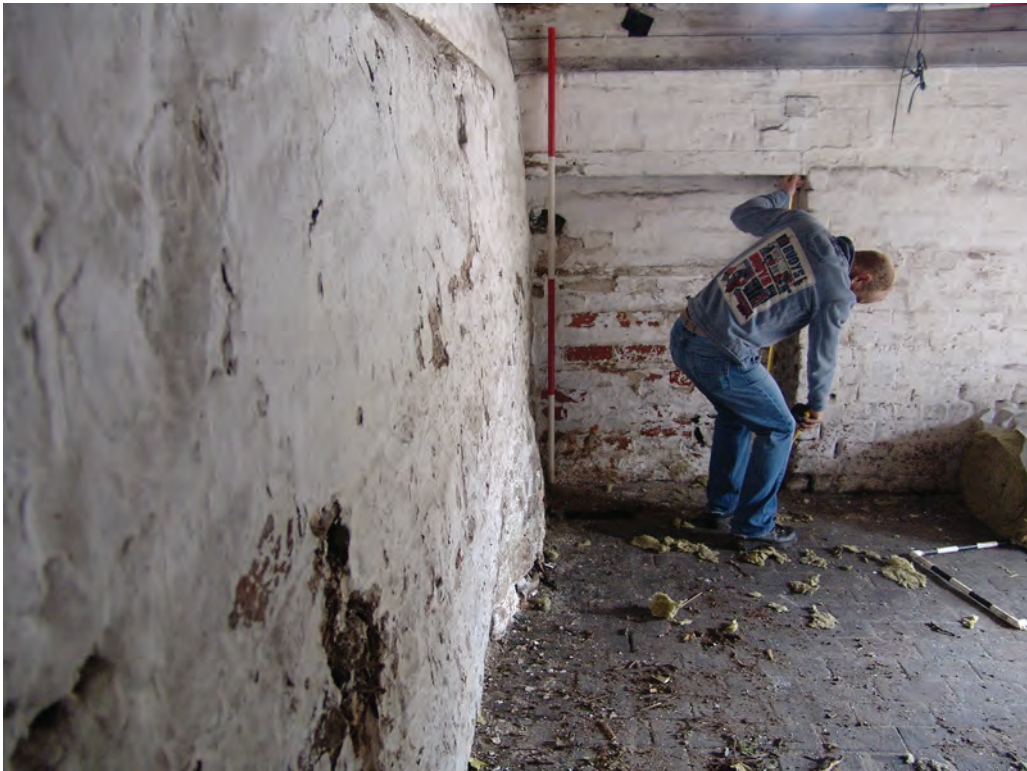
Site Ty Ambrose	Site code BS/TYA/12	Grid Ref: ST 28849800	Camera Sony DSC F28	Format Digital	File RAW	Dimensions 2048 x1536	Size 17mb	Date 12/03/2012	Image no: DSC02683	PLATE 34
Direction of view: East

Internally the area of the blocked doorway can be picked out in profile as a bulge in the wall, Plate 34; but it's not very clear. At the bottom of the bulge is an overhang where the wall curves inwards, Plates 35 & 36 again not very clear and difficult to interpret.

Reason for image Internal batter of N wall, Lintel of blocked door. Two holes for raised feeder

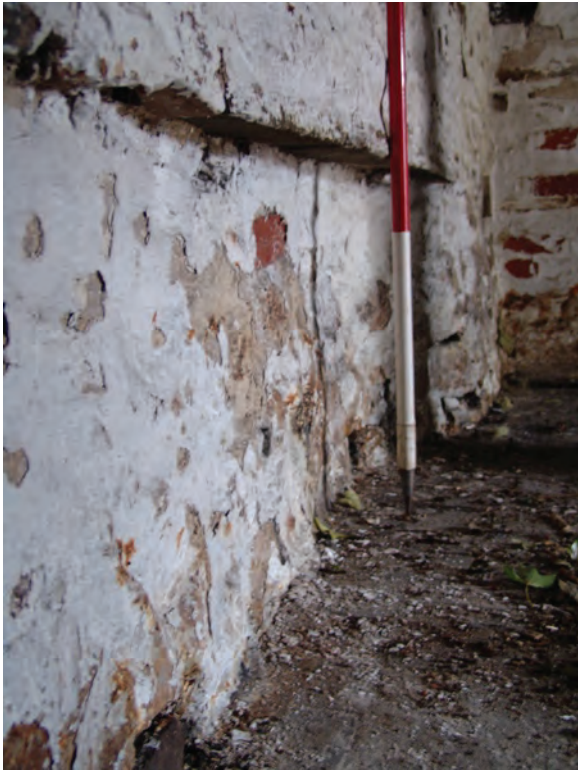
Site Ty Ambrose	Site code BS/TYA/12	Grid Ref: ST 28849800	Camera Sony DSC F28	Format Digital	File RAW	Dimensions 1536x2048	Size 17mb	Date 12/03/2012	Image no: DSC02726	PLATE 36
Direction of view: North east

Reason for image    Detail of undercut N wall at blocked cross-passage door

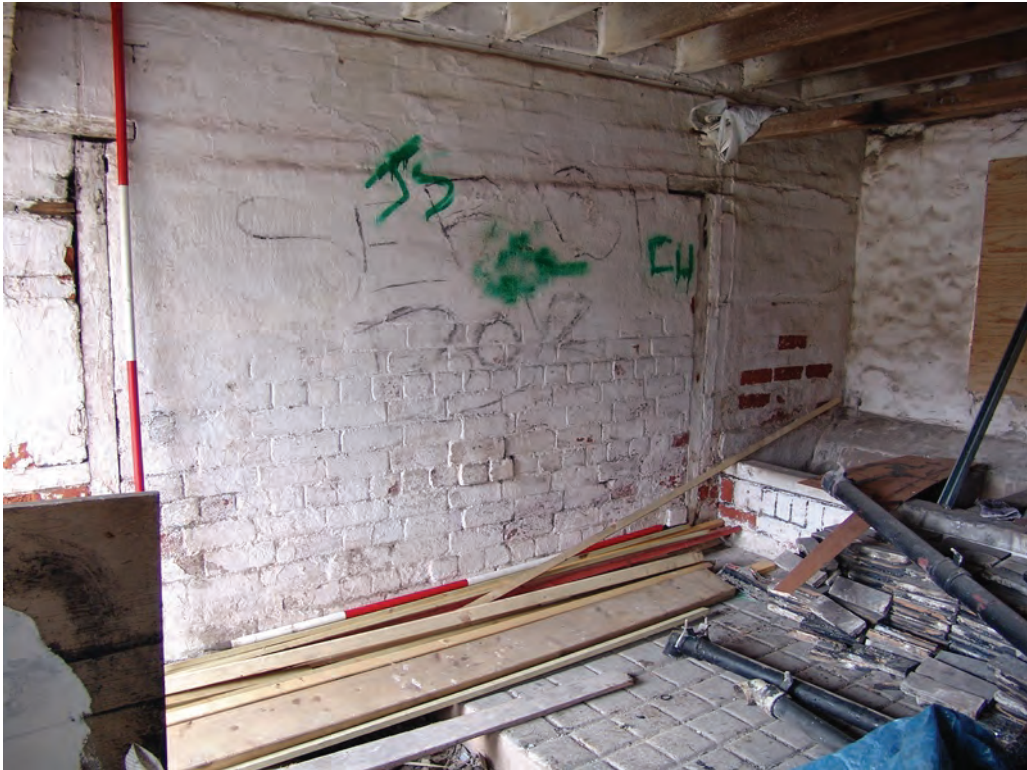
Site Ty Ambrose	Site code BS/TYA/12	Grid Ref: ST 28849800	Camera Sony DSC F28	Format Digital	File RAW	Dimensions 2048 x 1536	Size 17mb	Date 12/03/2012	Image no: DSC02662	PLATE 38
Direction of view: North west

The western wall is the brick partition described in **3** above. The wall in **4** reveals wooden noggins within the brick construction, Plate 38.

In between **3** and **4** are two blocked doors in a brick partition, Plate 38. These can be explained in that pre 1837 the northern door may have given access to the enclosed part of **4** whilst the southern door would have accessed the open yard. Both doors would have become redundant when **4** became one covered room allowing for them to be blocked off. A feeding trough was then built in **4**, Plate 38 and the high level straw feeder erected in **3**, Plate 31.

Reason for image    Detail of 4 Cowshed, Brick partition between 3/4 cowshed/barn

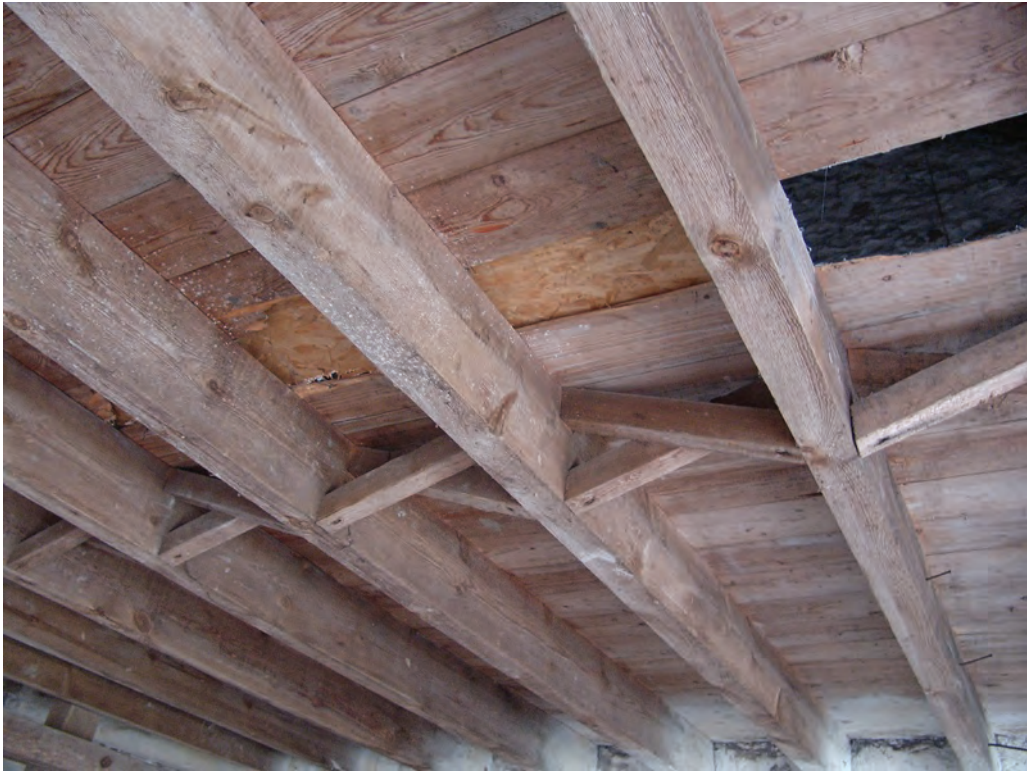
Site Ty Ambrose	Site code BS/TYA/12	Grid Ref: ST 28849800	Camera Sony DSC F28	Format Digital	File RAW	Dimensions 2048 x 1536	Size 17mb	Date 12/03/2012	Image no: DSC02665	PLATE 39
Direction of view: South

The ceiling has an interesting run of herringbone strutting, Plate 39.

Reason for image    Detail of ceiling in 4 Cowshed

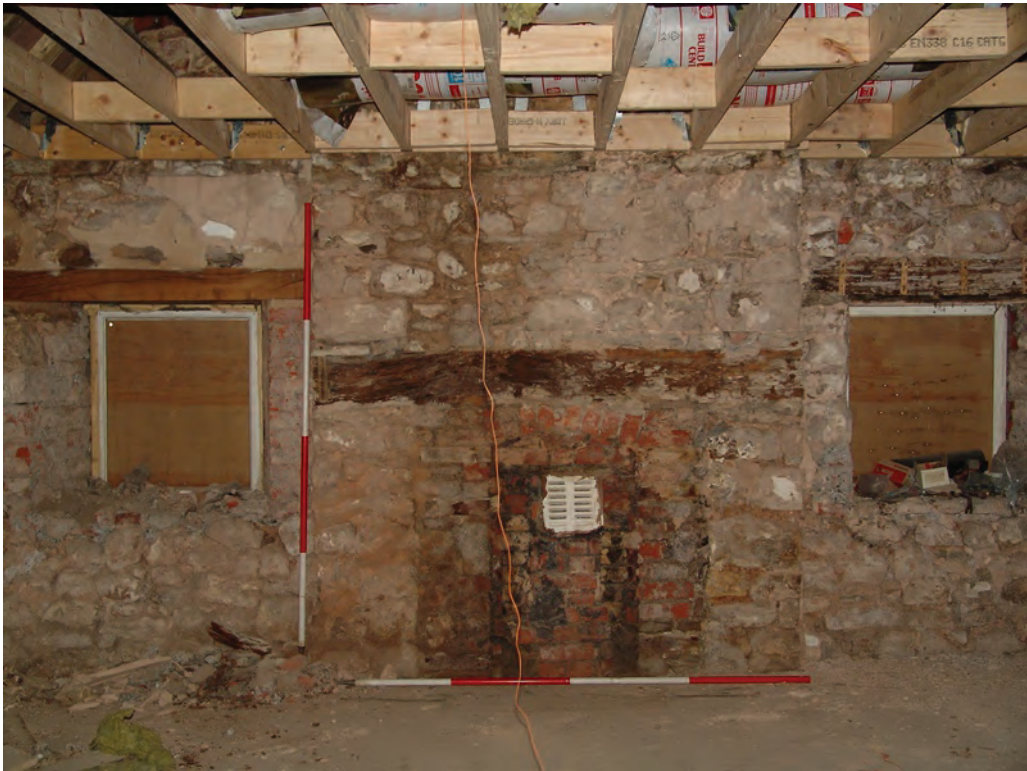
Site Ty Ambrose	Site code BS/TYA/12	Grid Ref: ST 28849800	Camera Sony DSC F28	Format Digital	File RAW	Dimensions 2048 x 1536	Size 17mb	Date 12/03/2012	Image no: DSC02720	PLATE 40
Direction of view: West

Internally, most of the gable end appears to be of stone construction and the position of the 1<sup>st</sup> floor fireplace for which the chimney breast was created; can be clearly seen Plate 40. The view of the west gable shows at least two phases of fireplace surmounted by a wooden lintel which supports the entire, internal chimney breast.

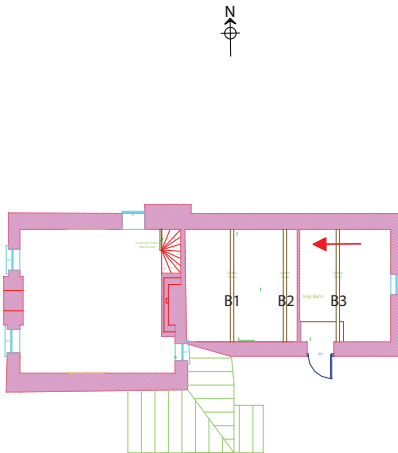
Site Ty Ambrose	Site code BS/TYA/12	Grid Ref: ST 28849800	Camera Sony DSC F28	Format Digital	File RAW	Dimensions 048x1536	Size 17mb	Date 12/03/2012	Image no: DSC02673	PLATE 44
Direction of view: West

B2 which would appear to be an upper cruck truss with tie beam and collar and trenched purlins. Plates 44 & 45 show close ups of each end of the blades showing the curve to the tie beam. Unlike B3 there are unused purlin notches suggestive of re-use.

B2 is all together different in that it appears to be an 'upper cruck' of the type described (Brunskill 125. 1994). The curvature of the foot of each blade is noticeable and the knott pattern and grain on both appear to be identical, suggesting a split pair, Plates 44 & 45.

Reason for image   Detail Oak upper cruck truss , collar an tie beam. measured B2n

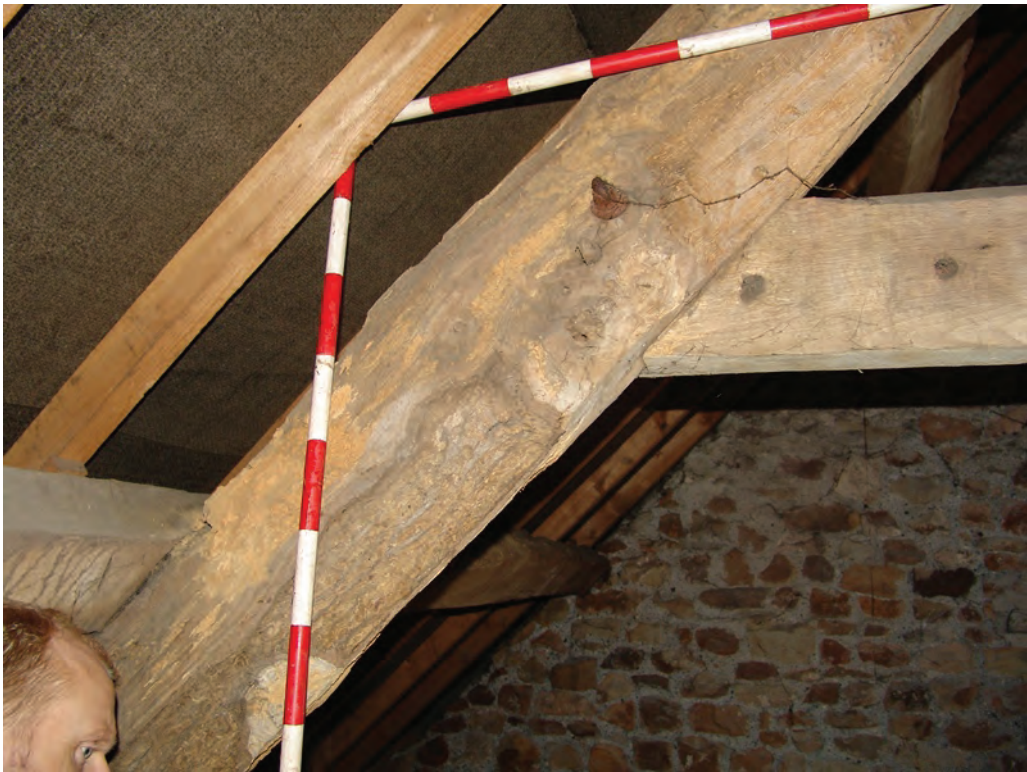
Site Ty Ambrose	Site code BS/TYA/12	Grid Ref: ST 28849800	Camera Sony DSC F28	Format Digital	File RAW	Dimensions 048x1536	Size 17mb	Date 12/03/2012	Image no: DSC02668	PLATE 47
Direction of view: East

B1 springs from the top of the wall as with B2 and B3, Plate 46 but has less worked joints. The collar is fixed with metal screw-treaded bolts Plates 47 & 48, whilst the tie beams have wooden fish plates, Plate 46.

The 0.7m lower floor of U4 planked and has one single closed truss with a substantial tie beam which is lap jointed with an oak fish plate in the south, Plate 46. The collar of B1 is pinned with metal pins Plates 47 & 48. The purlins from the east gable to B1 are scarfed within the joint, Plate 52, the continuation running to the new notches on B2 and then to B3.

Reason for image    Overview Oak truss and collar B1n

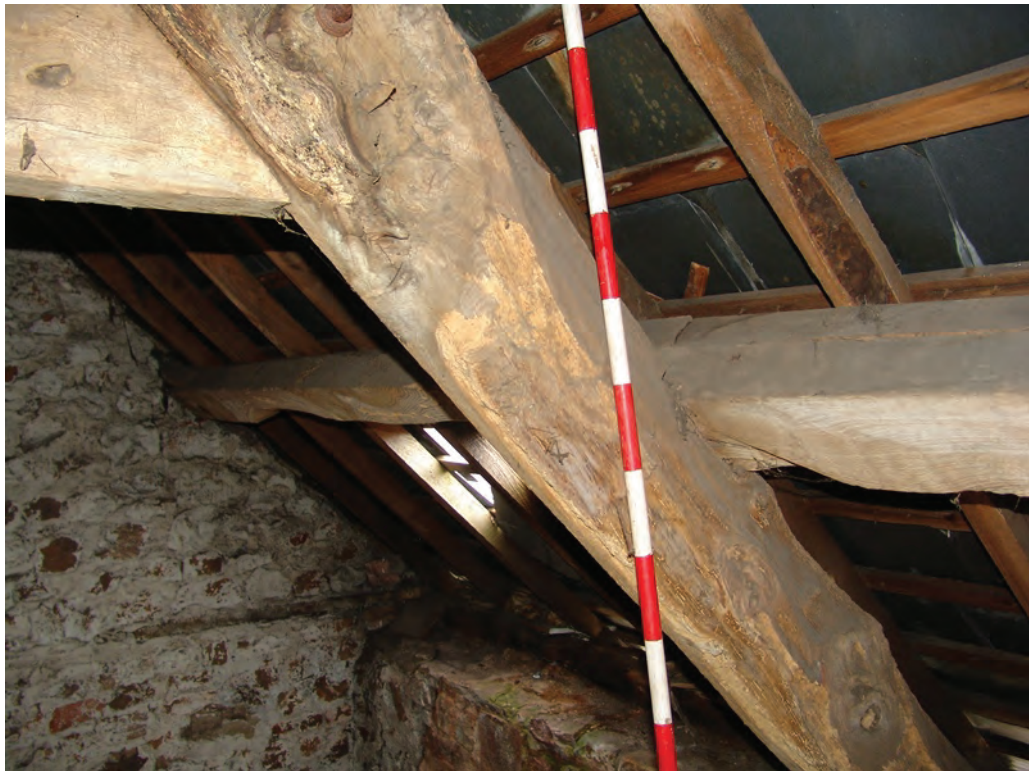
Site Ty Ambrose	Site code BS/TYA/12	Grid Ref: ST 28849800	Camera Sony DSC F28	Format Digital	File RAW	Dimensions 048x1536	Size 17mb	Date 12/03/2012	Image no: DSC02669	PLATE 48
Direction of view: East

Reason for image Overview Oak truss and collar with lap joint, wooden peg and later Iron pin B1s

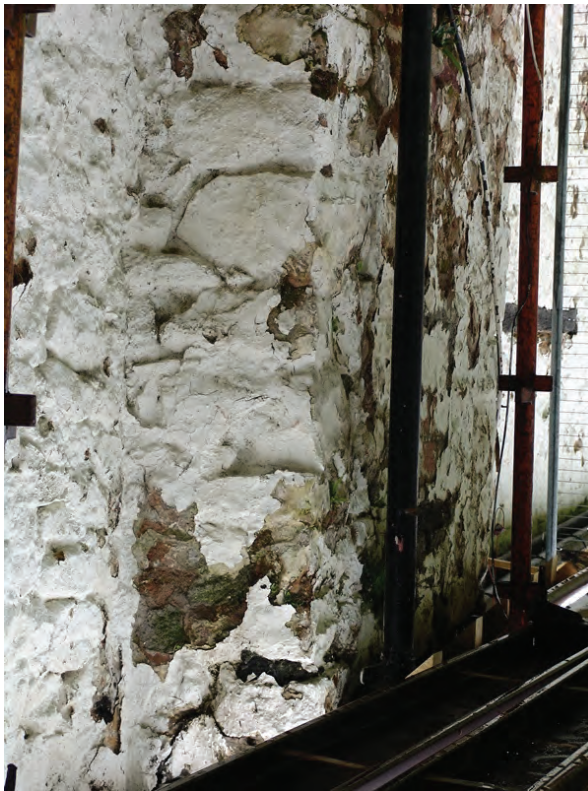
Site Ty Ambrose	Site code BS/TYA/12	Grid Ref: ST 28849800	Camera Sony DSC F28	Format Digital	File RAW	Dimensions 2448x3264	Size 17mb	Date 09/05/2012	Image no: DSC03005	PLATE 49
Direction of view: South

The projecting stairwell appears on the plan after 1837 but before 1882 dating it as mid to late 19<sup>th</sup> century. On close inspection of the outer wall at the joint, it would appear that the stairwell projection has been butted to the north wall. Plates 49 & 50 show some of the joints which admittedly are difficult to clearly, assess, due to the render.

Reason for image    Close up of stairwell projection 3

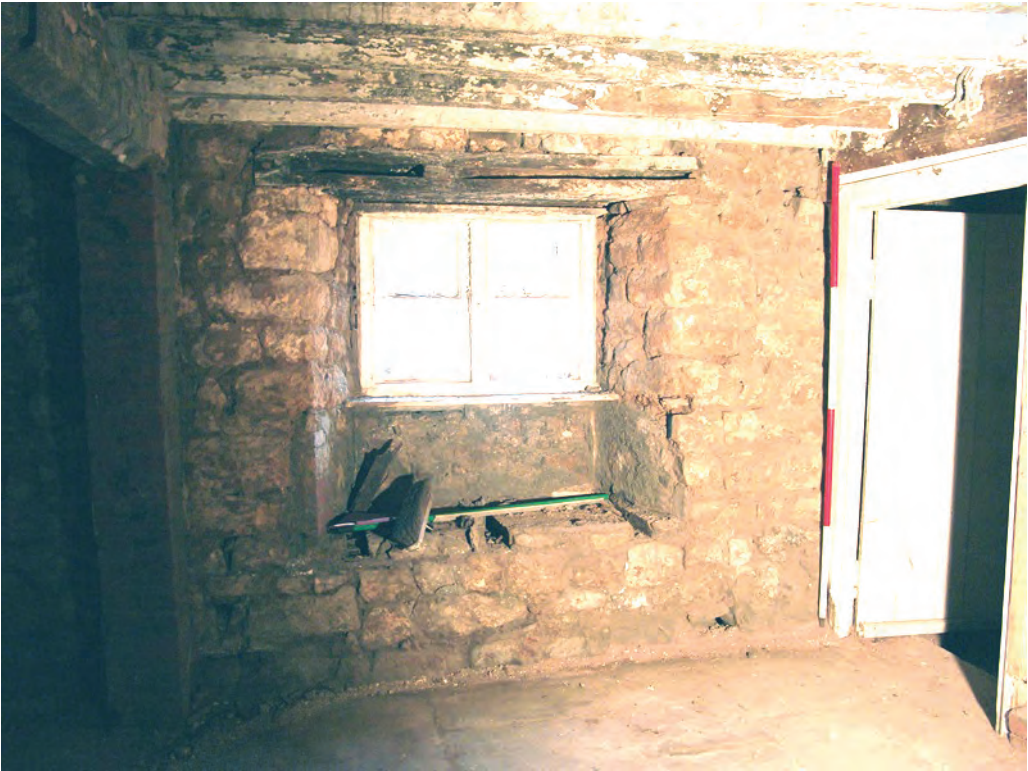
South window setting, Re used window lintel
