# CASTELL LLWYD FARM, LLANFABON, CAERPHILLY, GLAMORGAN

WATCHING BRIEF ON GROUNDWORKS RELATING TO THE  
INSTALLATION OF A SINGLE WIND TURBINE

February 2016

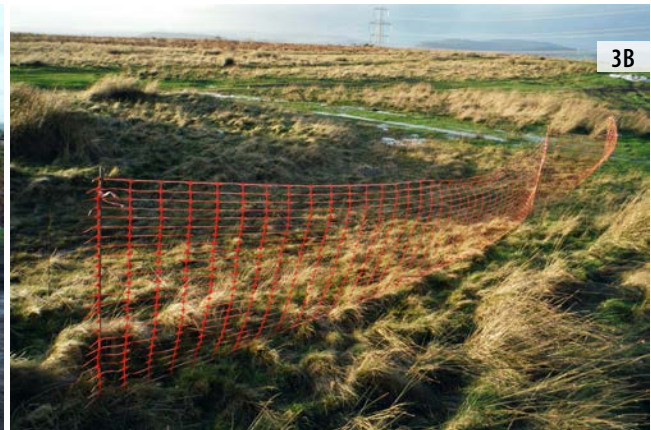
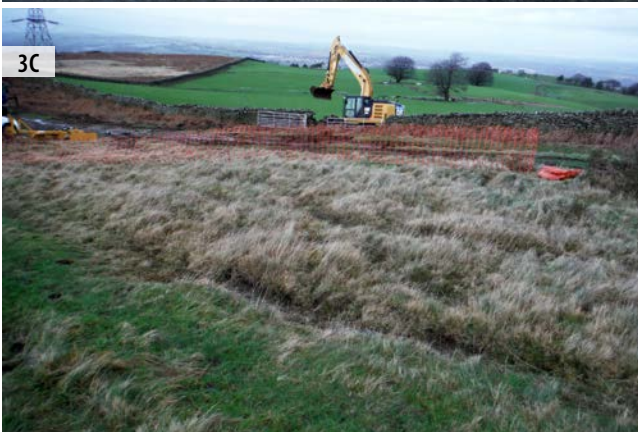
**ILLUS 3A** Cairn Cluster 1 at the edge of the drystone wall field boundary, facing north-east    **ILLUS 3B** Cairn Cluster 2 behind welfare units, facing west  
**ILLUS 3C** Cairn Cluster 3 at the edge of the access area, facing south-west

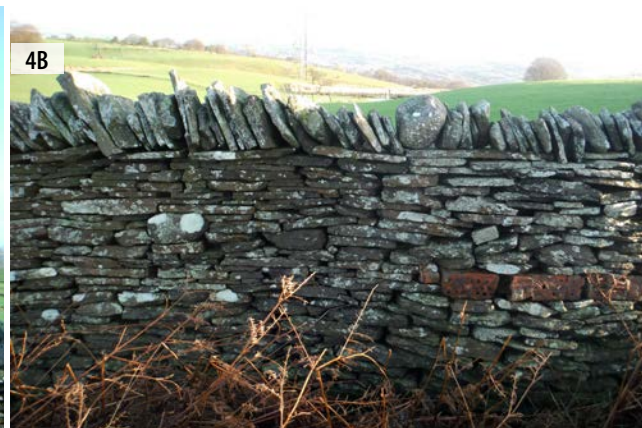
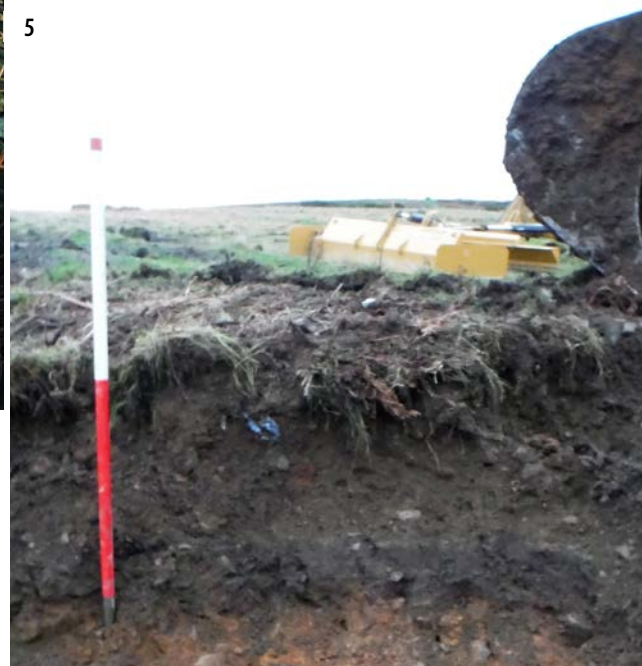
The wall was recorded as standing 1.63m high (1.40m without the top coping stones) and 0.48m wide. It was standard construction, with larger footing or foundation stones slightly sunk into the topsoil (1002). The wall narrowed toward its top, with banding or through-stones providing support throughout. The facing stones were packed around a core of hearting stones.

The wall showed signs of previous repair and reconstruction (ILLUS 4), with modern vented red bricks being used as through-stones in certain places and some parts of the wall showing some collapse of the structure. Disused red brick footings were recorded in one place by the foot of the wall, suggestive of a smaller, subsequently demolished, structure being there at some point.

**ILLUS 4A–B** Drystone wall [1001] showing clear signs of reconstruction, facing north-east

Numerous historic repairs and reconstructions of the drystone wall were noted along its length, but none were readily visible in the section that was breached. It is a possible concern that the drystone wall might need further consolidation, either side of the access, to stabilise it and prevent any collapse in the future.

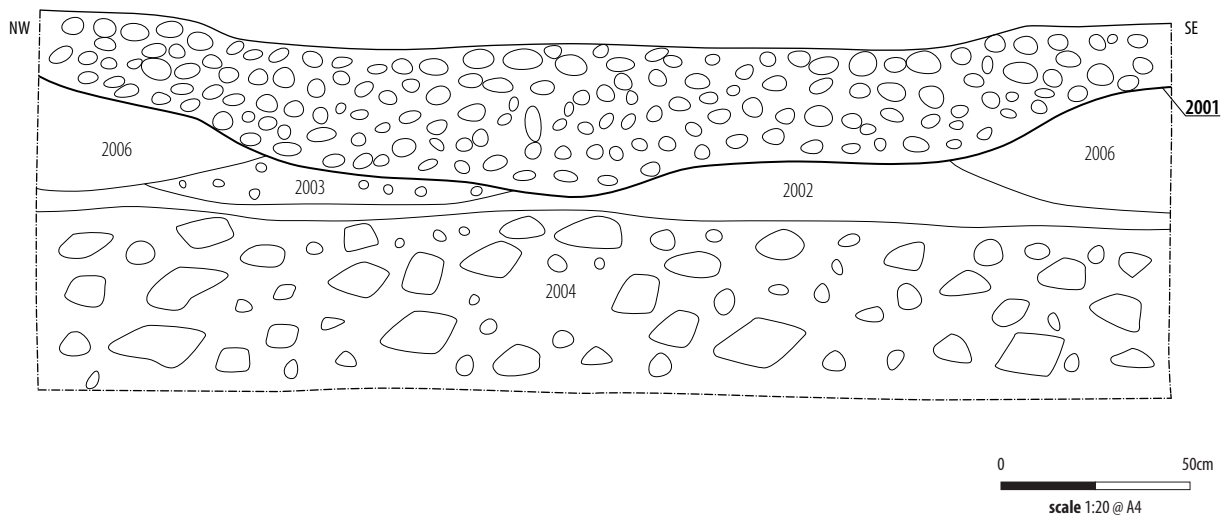
**ILLUS 6** South-east facing section of post-medieval trackway [2001] in Trench 2

Trackway is thick and comes down onto a fine sand in the centre, and hard clay at the sides. The trackway has a slight depression to it and seems like it has sunk over use rather than been constructed that way forming a proto-Holloway. Under clay and sand is a small linear of organic material, seems like it could be decayed bracken, clearance of vegetation before construction or even a previous hedge-line/boundary. Below track is a hard stony geological surface.

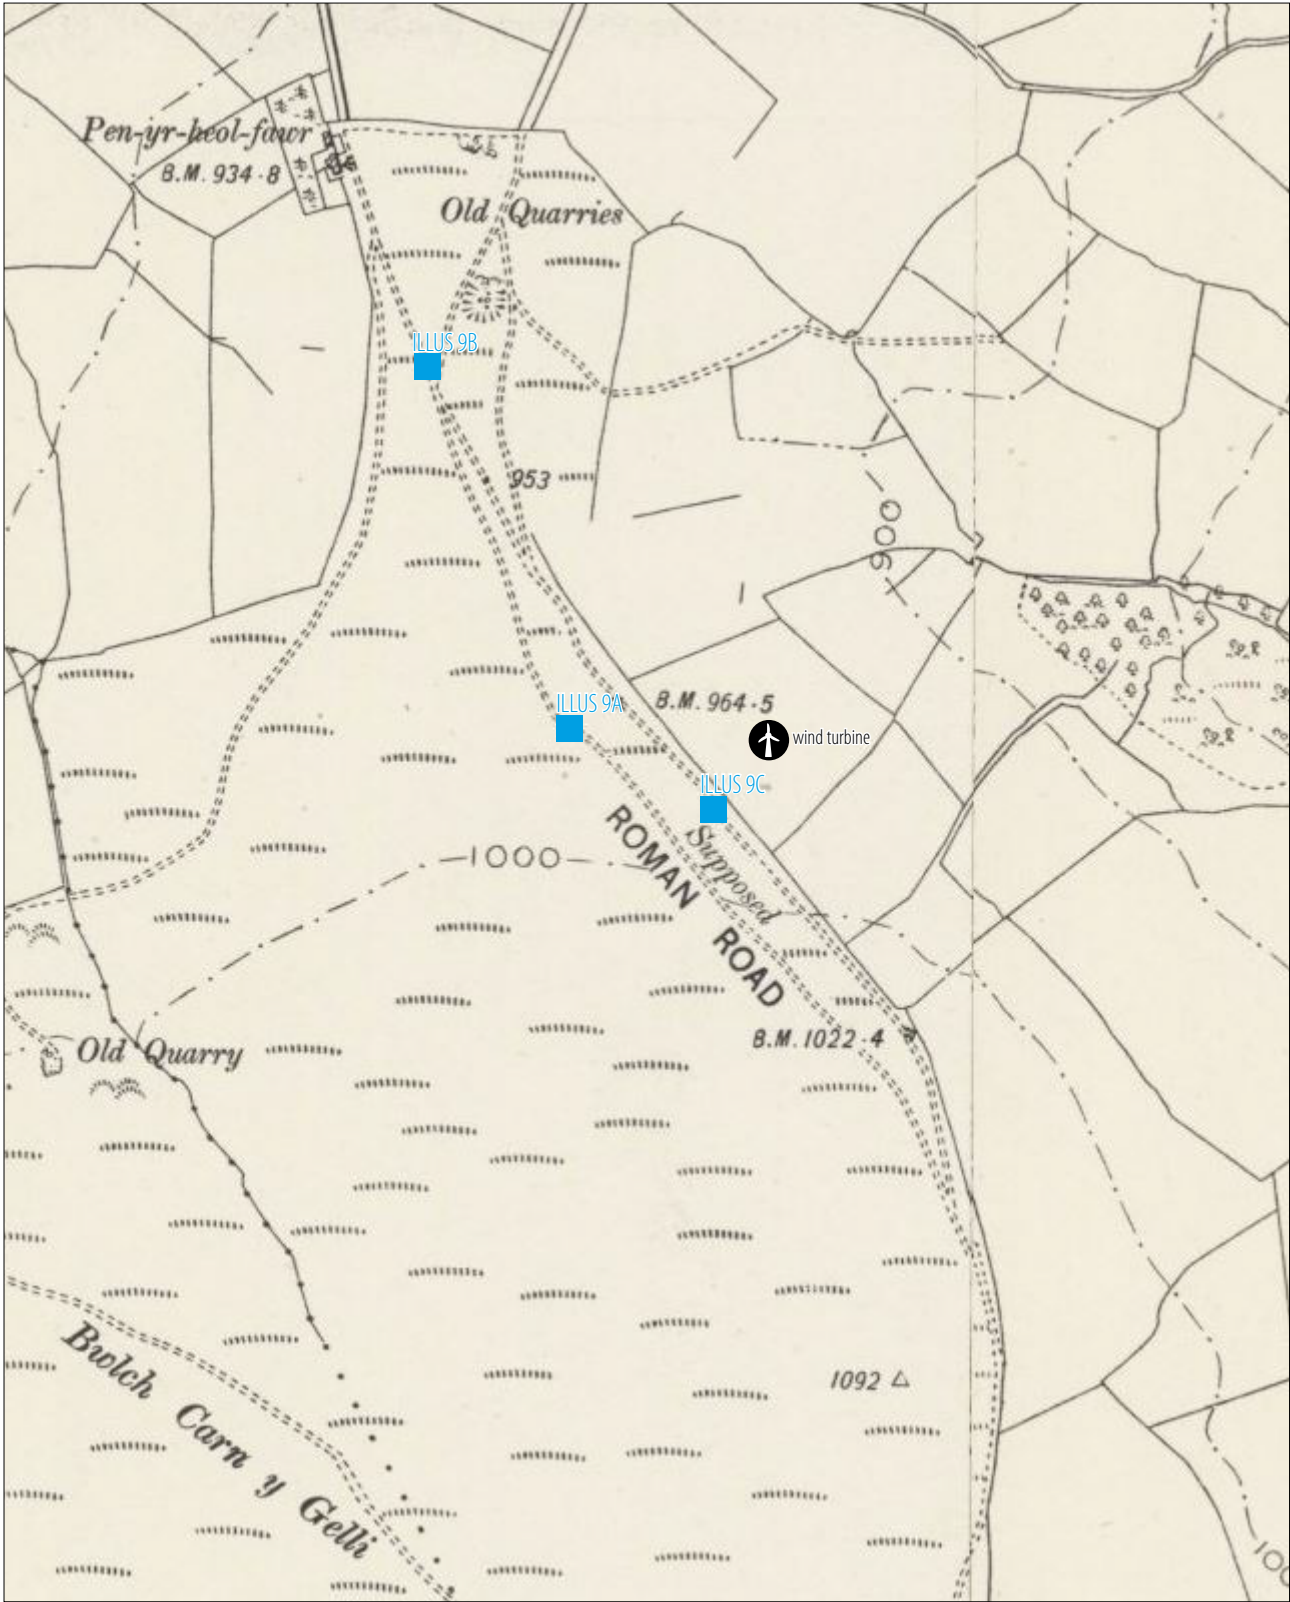
ILLUS 8 Ordnance Survey 2nd edition (1905) map showing trackways and locations of Illus 9A-C

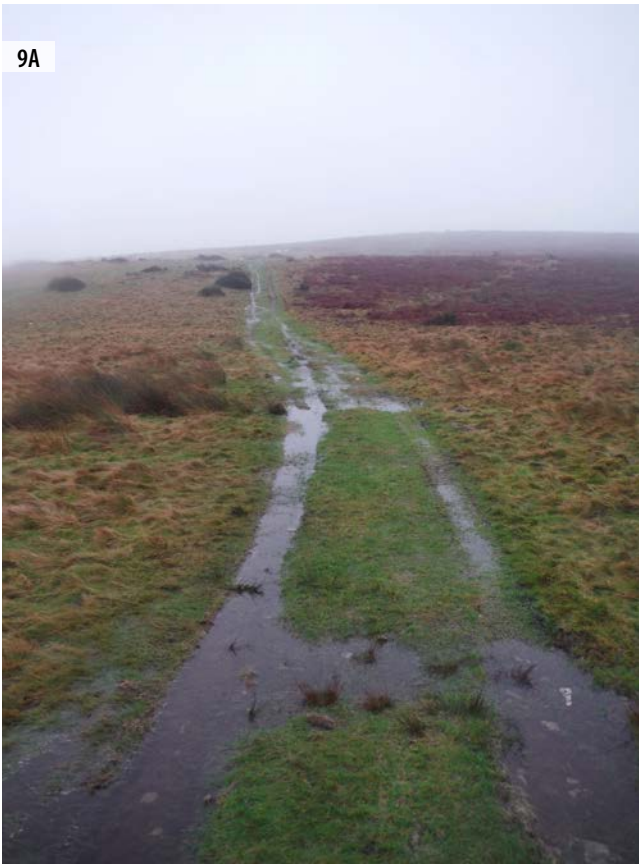
**ILLUS 9A** Possible Romano-British trackway facing south-east (2022)

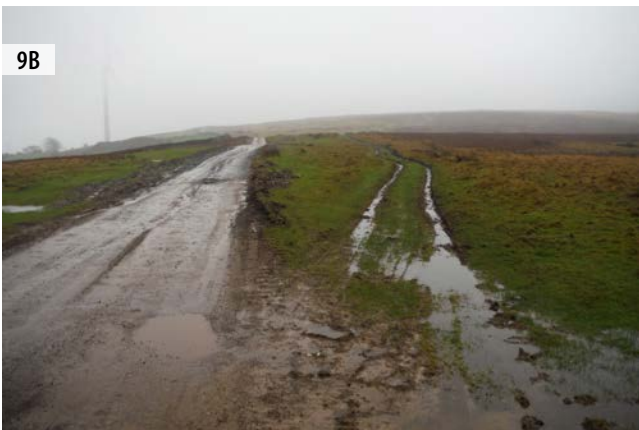
**ILLUS 9B** Possible Romano-British trackway, shown to left of track way [2001] at intersection to north of 9A
