**WATCHING BRIEF DURING
GROUNDWORKS
FOR REPAIRS TO BOUNDARY WALLS
AROUND THE CHURCHYARD OF ST
ELLYWE'S CHURCH, LLANELIEU
15/12456/FUL and 15/12457/LBC**

For: RV Williams Associates

April 2020

Trysor Project No. 2018/596

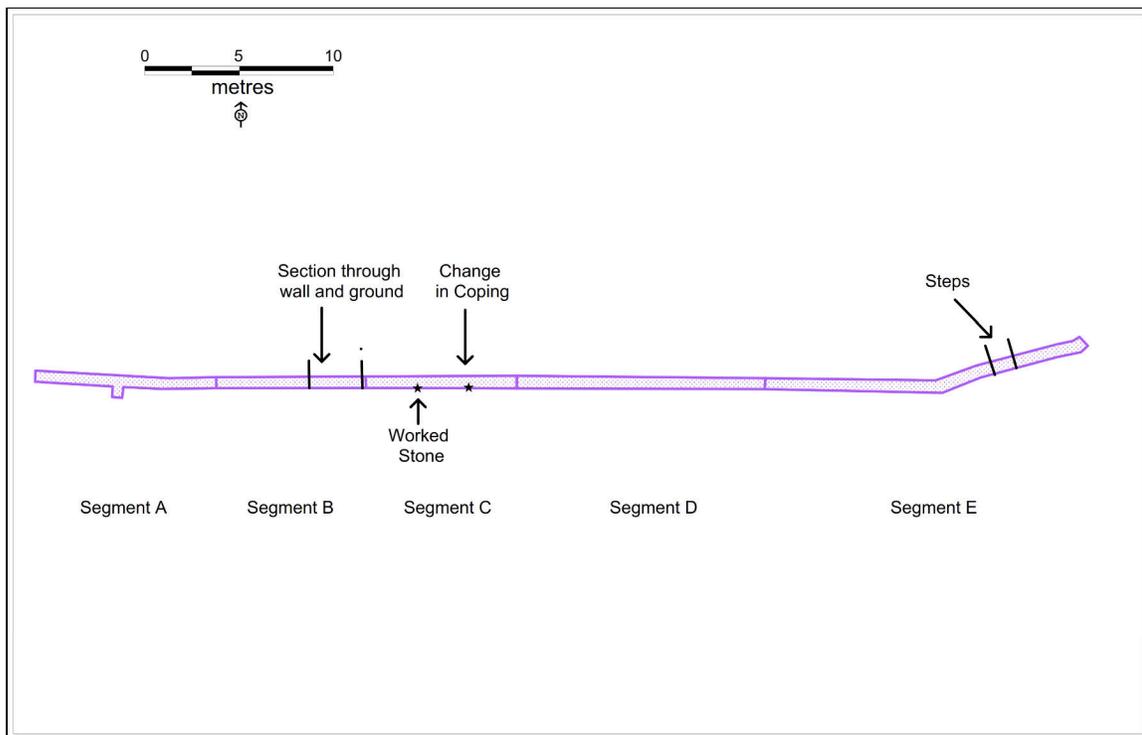
Figure 4: The location of the segments of the south wall defined by the work programme and notable features.

6.12.1 A 44 metre segment of wall centred on SO1852834148, was in poor condition and was rebuilt. This wall was rebuilt over several days and Figure 4 and Table 1 describes the 5 segments.

Date	Location	Comments
17/05/2018	Segment A 0 metres to 9.6 metres from east of the current gateway in the western end of the southern boundary. Centred on SO1846034129	Plates 102, 107 to 108, 111 to 114. This segment was free standing. It was largely drystone construction but there was mortar containing coal fragments in the lower parts of the southern side of the wall. The wall construction was of two lines of stone wall with a rubble infill. Baler twine was found in the centre of the base of the wall and a concrete block was found within the wall. The stones are fairly homogenous suggesting they are from a local quarry. Where the coping stones remained some were of conglomerate rather than sandstone. A short segment of wall butted the wall on its south side as part of a gate across the access track. This wall contained a piece of roof slate, chunks of concrete and a plastic rawl plug.
30/05/2018	Segment B 9.6 metres to 17.5 metres. Centred on SO1848834127	Plates 116 to 119. This segment was partly revetted into the ground on the inside the churchyard, with only a low freestanding wall above. On the lane side of the wall it stood up to 1.2 metres high in places. Tree roots were removed by machine, including a very large tree between 14.5 metres and 17.5 metres. The boundary wall was in very poor condition in this area and was taken down to ground level. Due to damage to the ground behind it from the tree root and its removal a section was taken across the wall and earth behind it to examine its make-up, see Section 7 – Stratigraphy.

11/06/2018	Segment C 17.5 metres to 25.6 metres. Centred on SO1849634127	Plate 120. At 20.3 metres, in Segment C, was a worked stone in the outer face of the wall. It was similar to the stone used around a blocked doorway adjacent to the church porch, and was reset into the repaired boundary wall at approximately the same location as

it was found. At 22.9 metres the coping on the top of the wall changed from all tall stones to tall, short, tall, short. The wall in this segment was 0.60 to 0.65 metres wide at base narrowing to 0.50 metres wide at the top. The wall was 1.46 metres high in total on the lane side (1.22 metres wall plus coping).
29/06/2019	Segment D, from 25.6 metres to 38.6 metres centred on SO1850734127	Plate 121. Tree root were removed from behind the wall and damaged parts of the wall were taken down. Generally in better repair than the rest of the wall, and needed to be taken down less.
29/06/2018 and 21/09/2018	Segment E from 38.6 metres to 48.3 metres centred on SO1852334127	Plates 122 to 124 and 126 to 132 Trysor recorded the steps through the wall at SO1852634128, and the rest of the southern boundary wall was taken down to a stable level. The four steps were not uniform in size, shape and material. Concrete was found under a grave slab which covered the lowest step. The other steps had been concreted over, but when this was removed crude stone steps were revealed. The steps were approximately 0.90 metres wide. See Section 8 for a description of the gravestone.

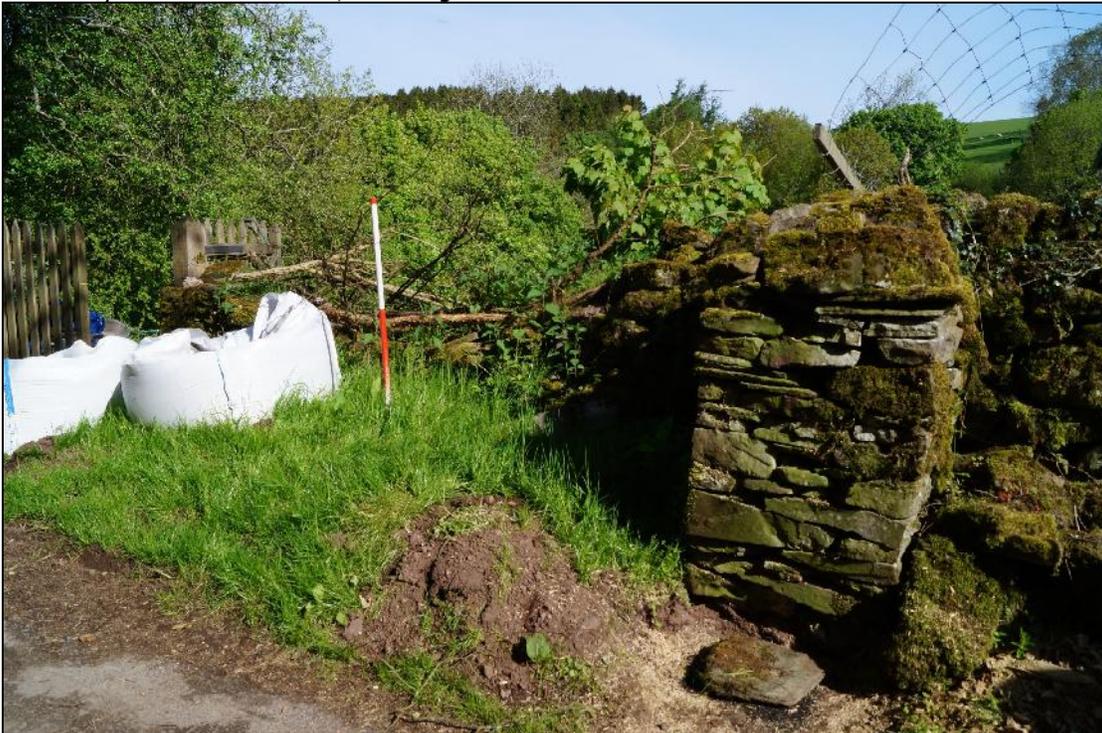
Plate 2: SEL2018_102, Boundary wall, just to the east of the gateway towards the western end of the southern part of the boundary wall, and the short, later, spur, built as part of a gateway across the lane, looking northwest

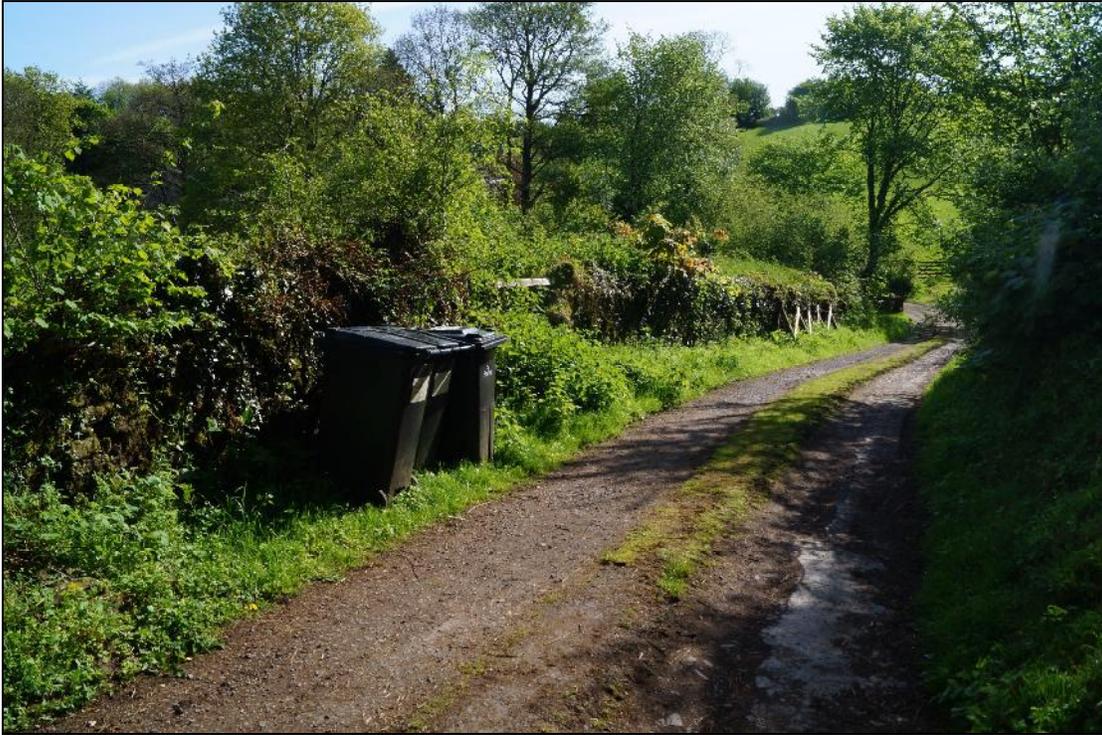
Plate 3: SEL2018_103, The southern part of the boundary wall looking east from the lane to the south.

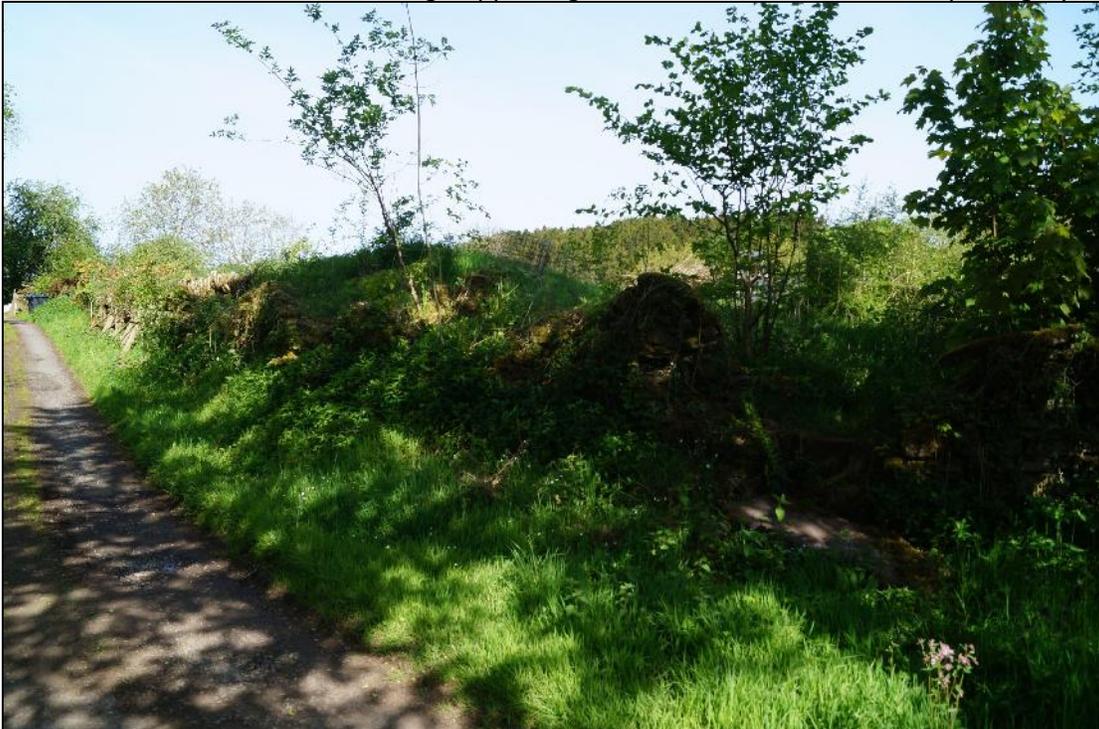
Plate 6: SEL2018_106, The southeast corner of the boundary wall, with the stone stile through the wall in the shadows, looking northwest.

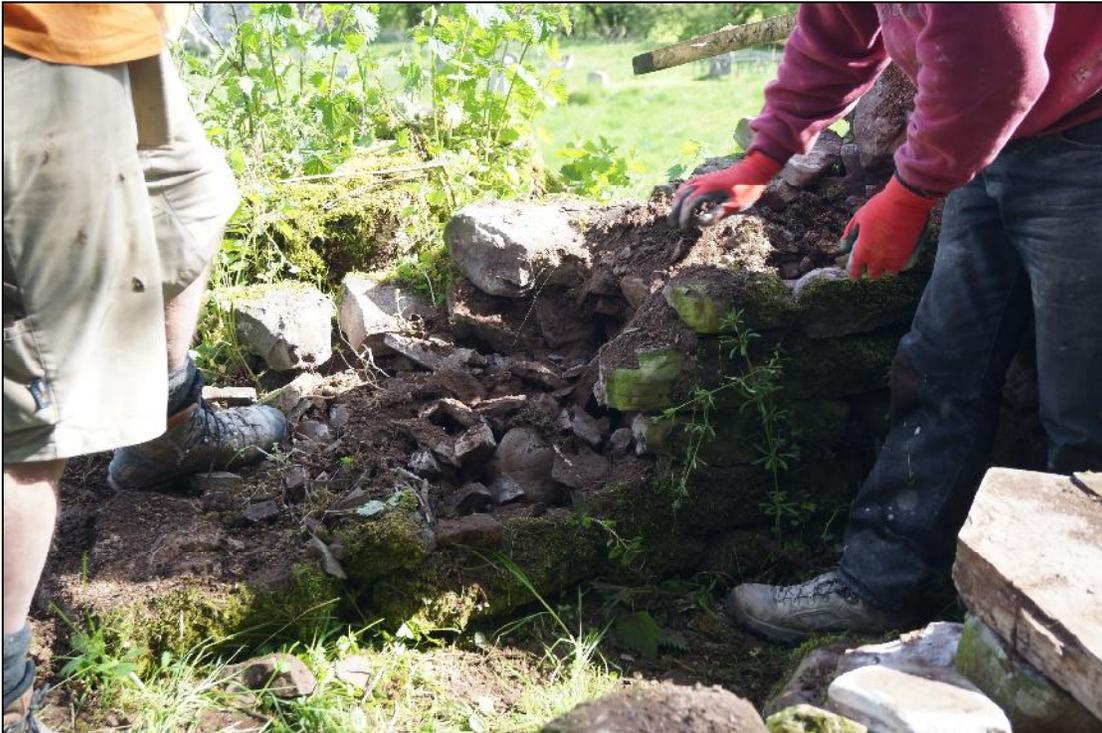
Plate 7: SEL2018_107, dismantling the wall to the east of the gateway in the southern boundary, looking northeast.

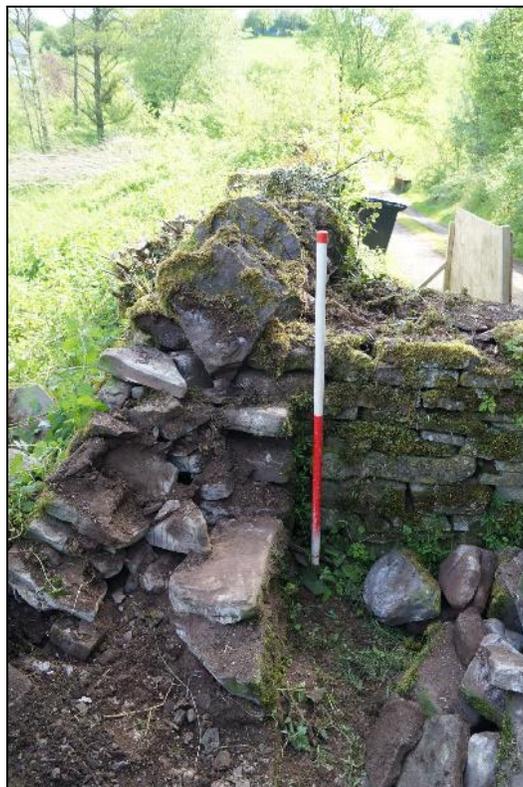
Plate 8: SEL2018_108, Section through the dismantled wall, looking east.

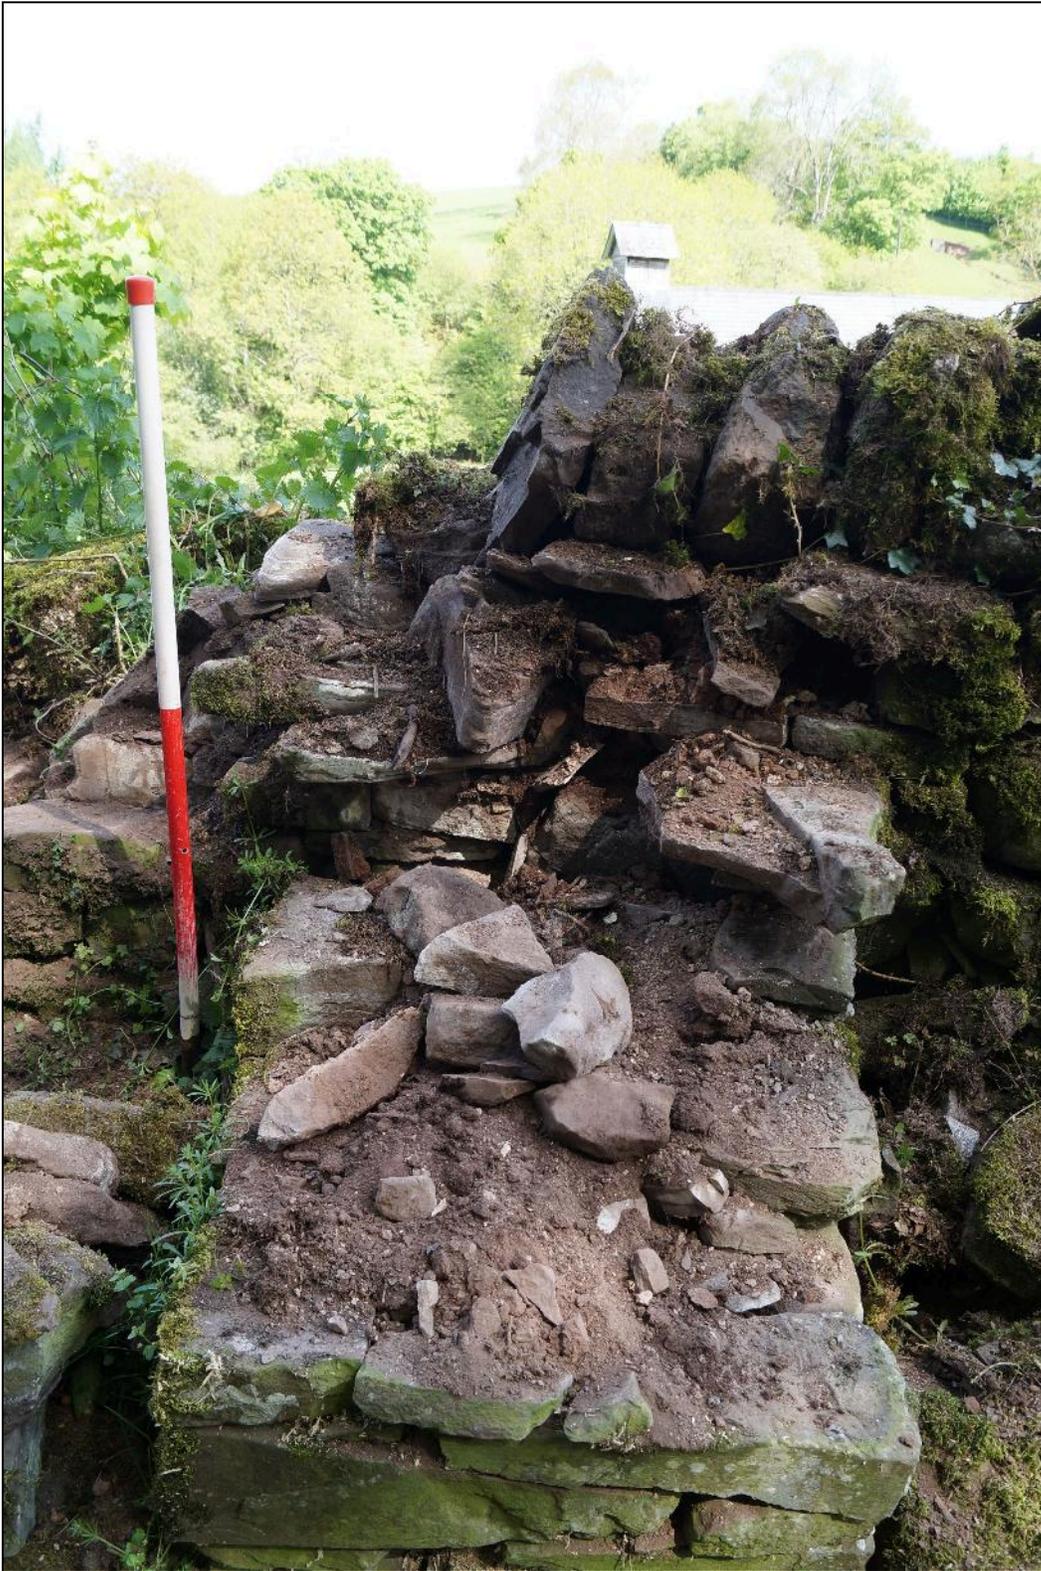
Plate 11: SEL2018_111, Dismantling the short section of wall at right angles to the boundary wall, looking north.

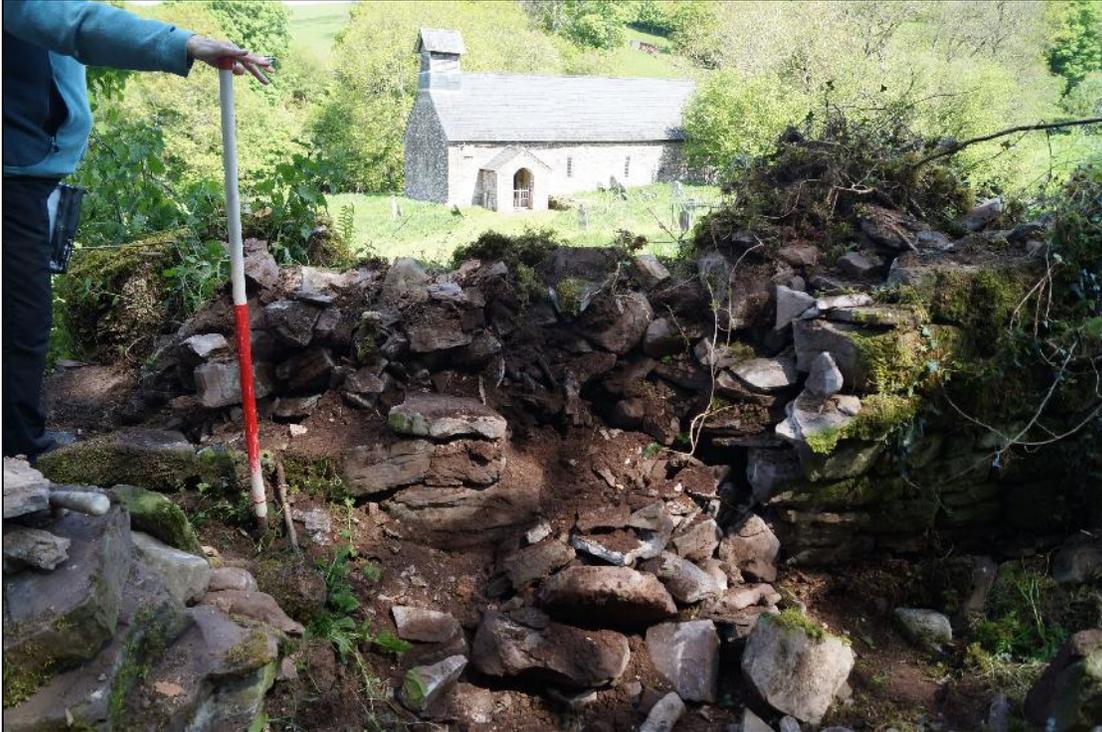
Plate 12: SEL2018_112, The short section of wall at right angles to the boundary wall dismantled, looking north.

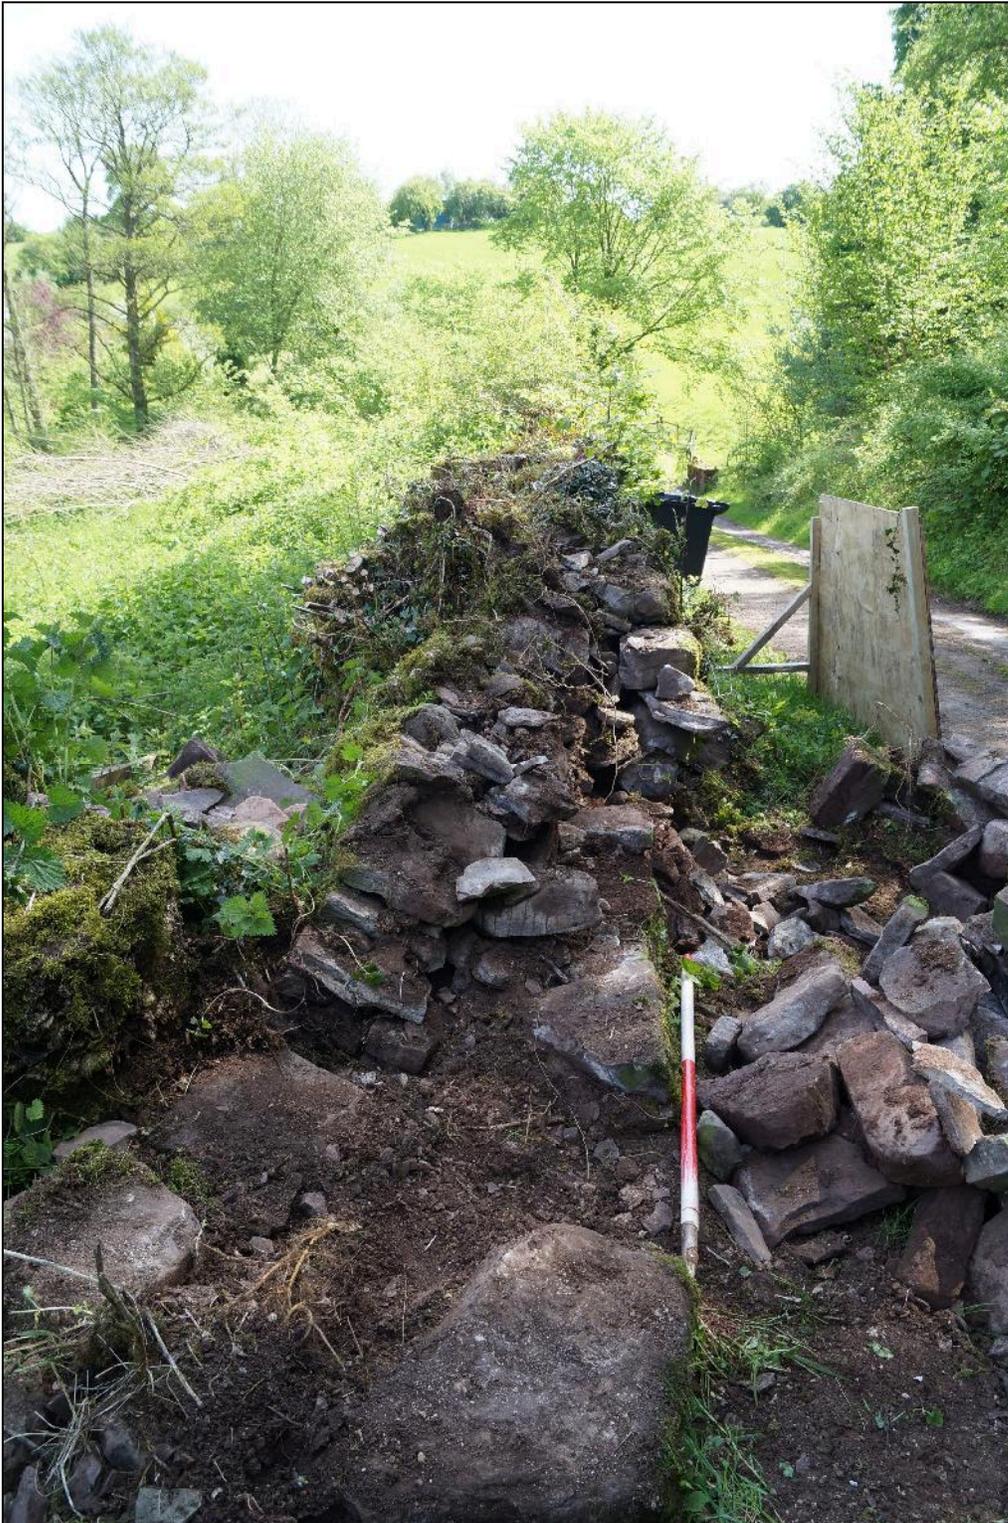
Plate 13: SEL2018_113, Next section of wall dismantled, looking east.

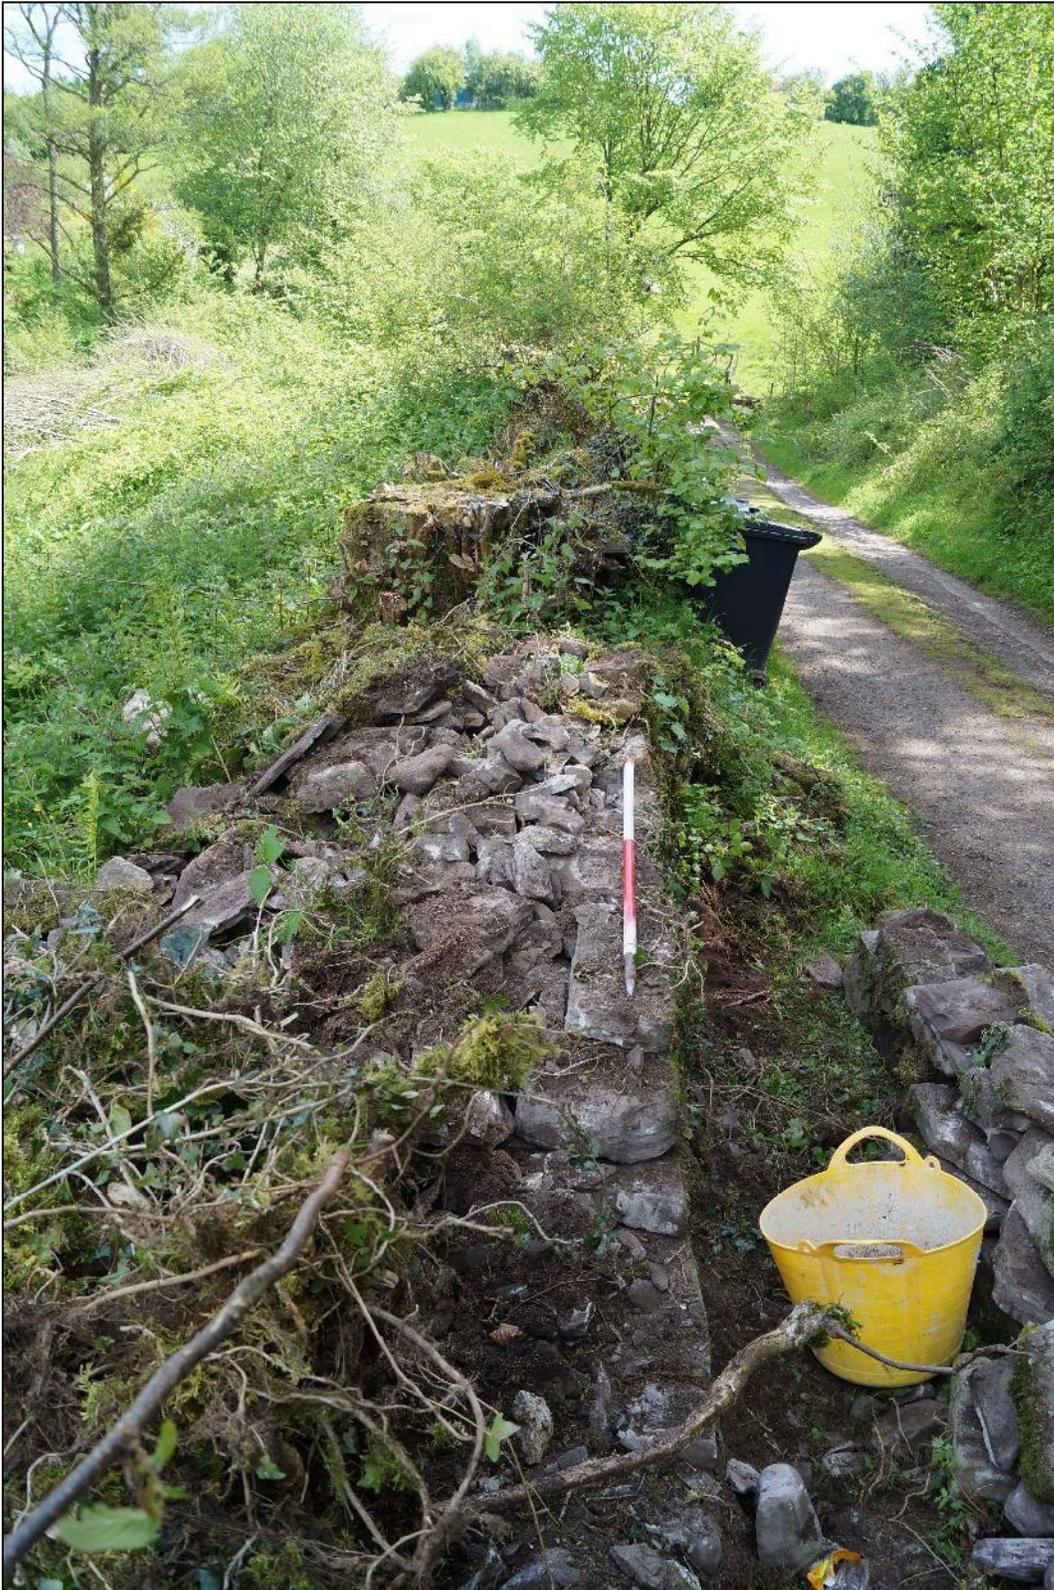
Plate 14: SEL2018_114, Next section of wall dismantled, less material needed to be removed here, looking east.

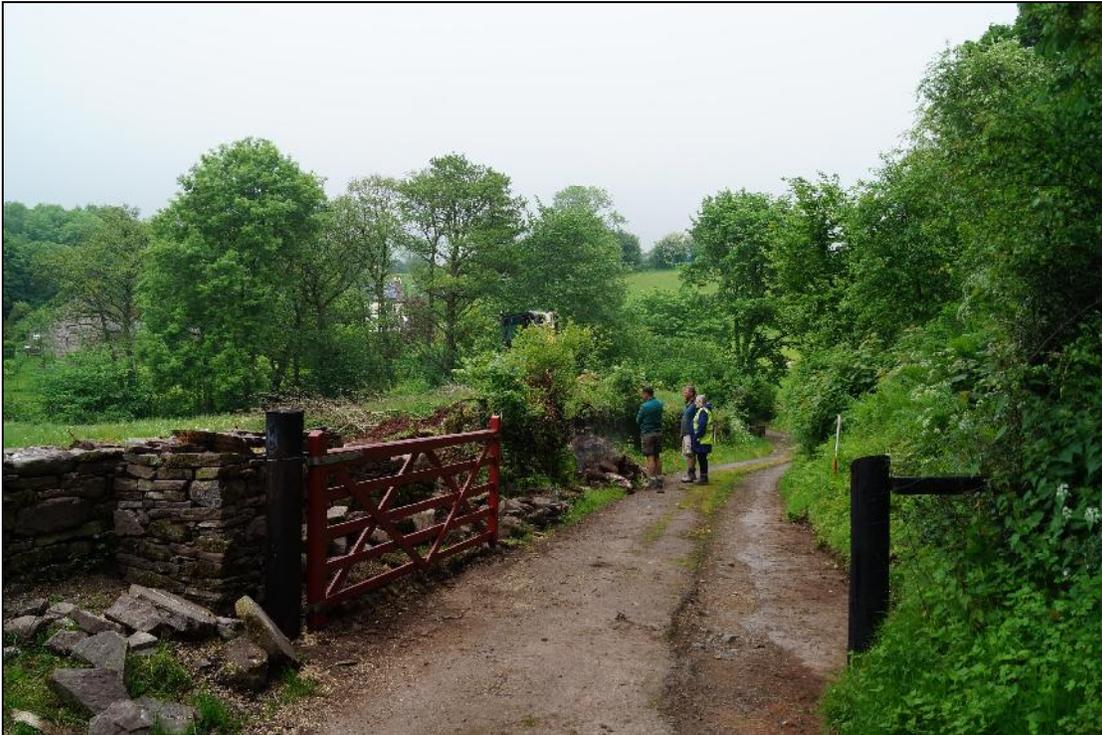
Plate 15: SEL2018_115, General view showing the western section to the east of the gate and the short wall at right angles, both reconstructed, looking east-northeast

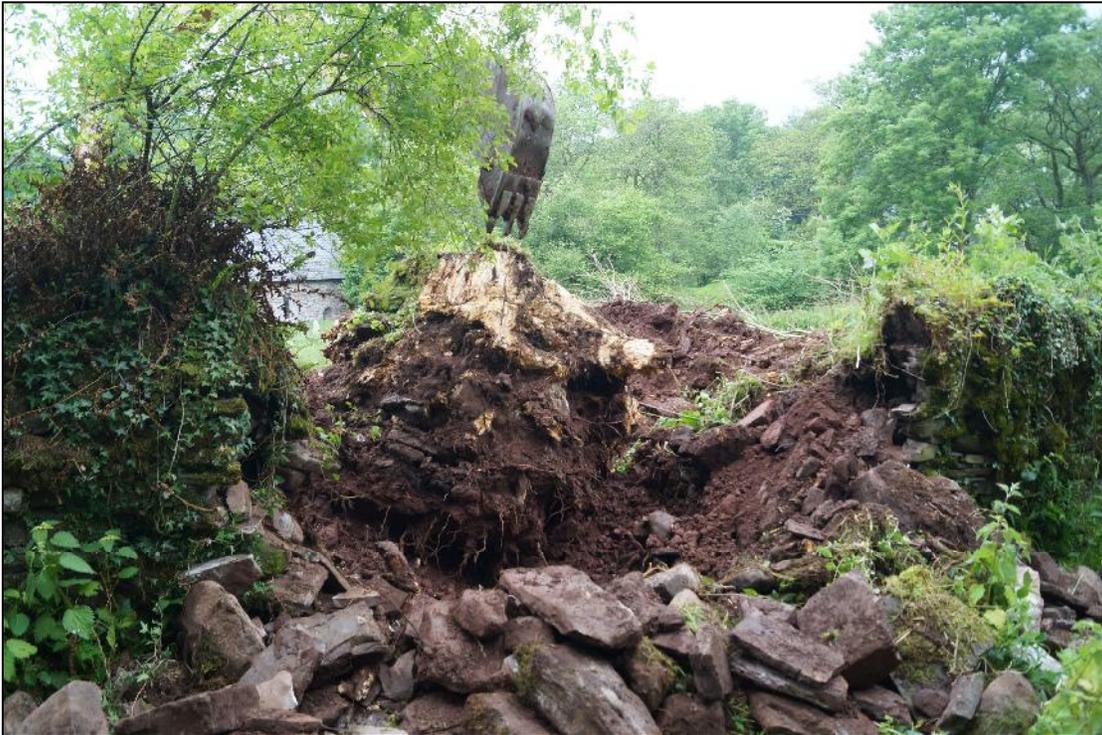
7.1 During works to repair Segment B of the southern part of the boundary wall, a large tree root/bole had severely damaged the wall and removing it created a void in the ground behind the wall. The opportunity to record a section through the wall and the ground to the north of it was taken.

Plate 17: SEL2018_117, Removing the tree bole, looking northeast.

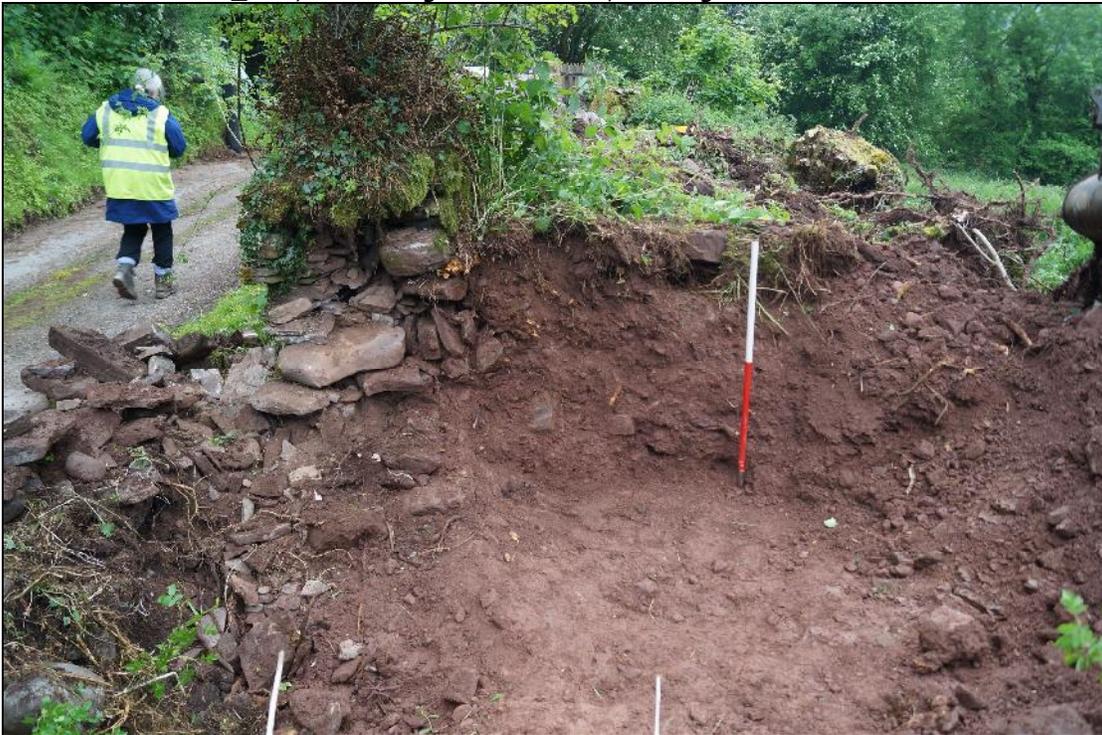
7.3 Three layers were observed. The topsoil (010) was reddish brown clay with few coarse components. It was generally 0.15 metres deep but up to 0.30 metres deep against the southern boundary wall. It overlay a layer (011), a reddish brown sticky clay with some small stones. This overlay a reddish brown clay with more coarse components gravel (012), part of the natural subsoil.

Plate 18: SEL2018_118, Tree bole and roots removed and section through wall and earth behind excavated, looking west.

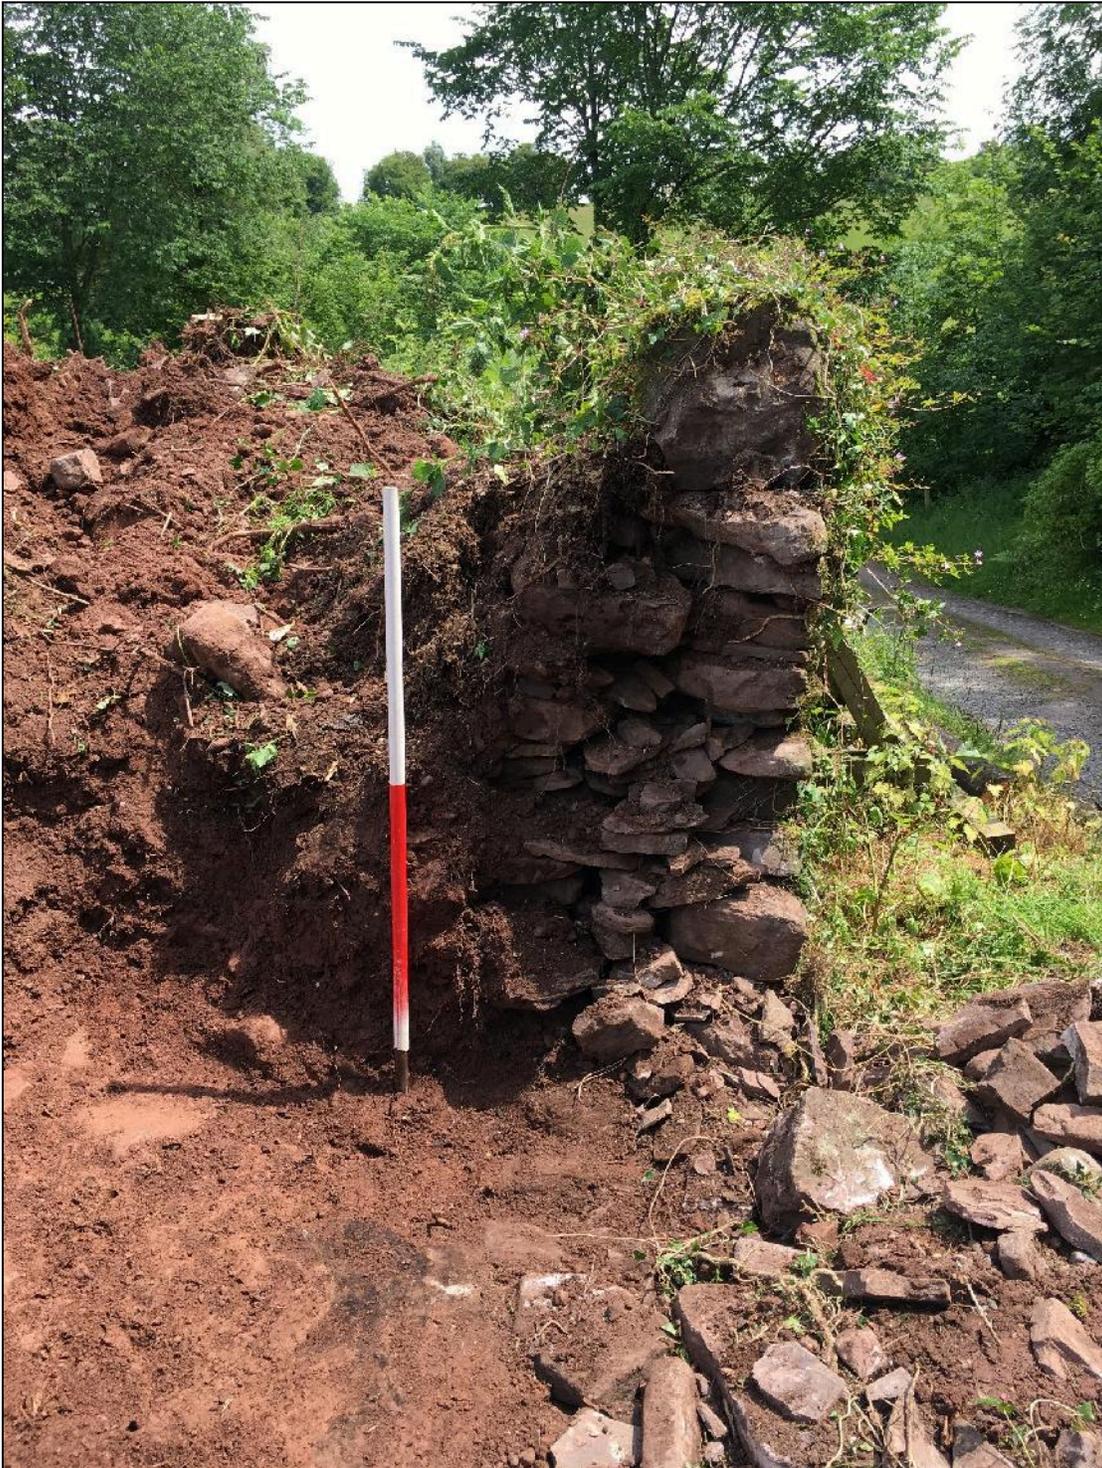
Plate 19: SEL2018_119, Tree bole and roots removed and section through wall and earth behind excavated, looking east.

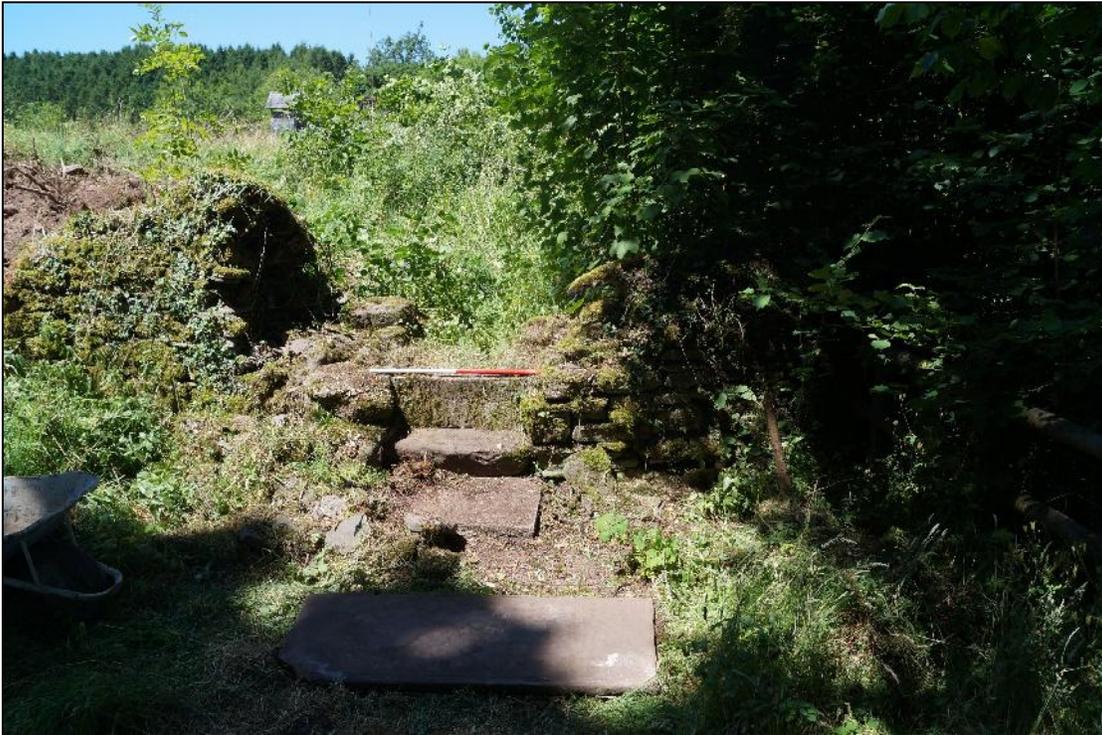
Plate 22: SEL2018_122, The former steps through the eastern end of the southern boundary wall. The large slab, found to be a grave slab, was originally the top step in the wall line, looking north-northwest.

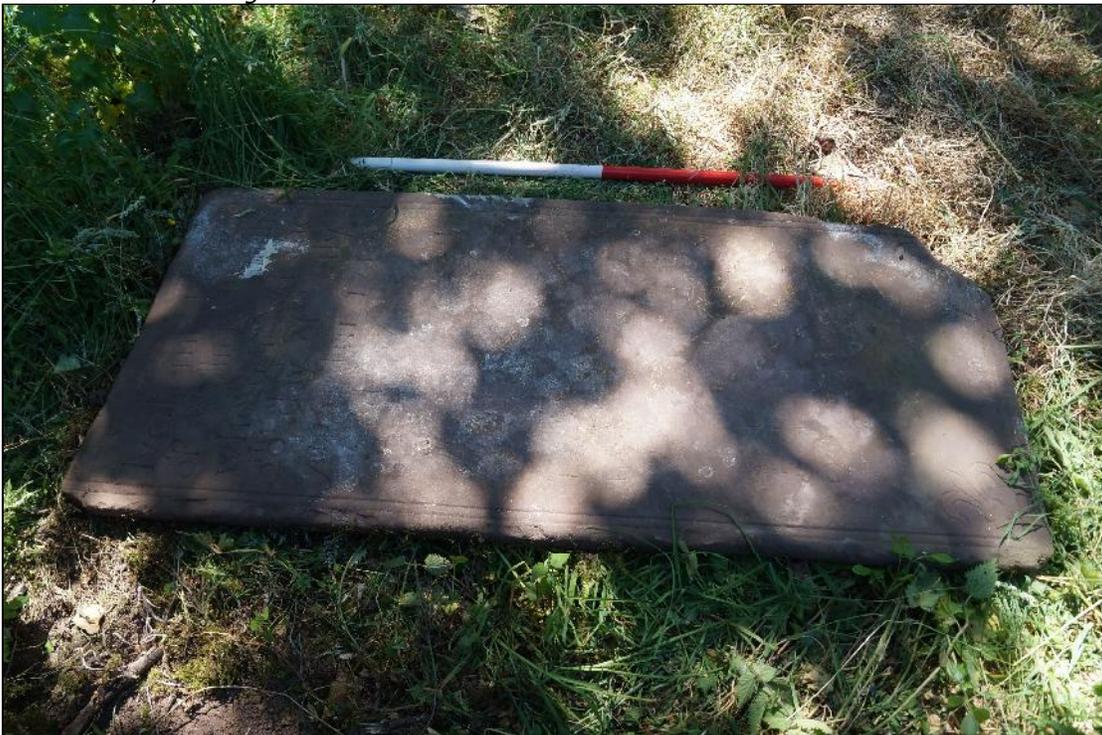
8.3 The stone was decorated with a simple double line border with angled fleur de lis in the bottom corners. The top of the stone was broken and worn so the border design had been lost and only the bottom of two letters of the top line of the inscription visible.

Plate 23: SEL2018_123, The gravestone, looking south-southeast.

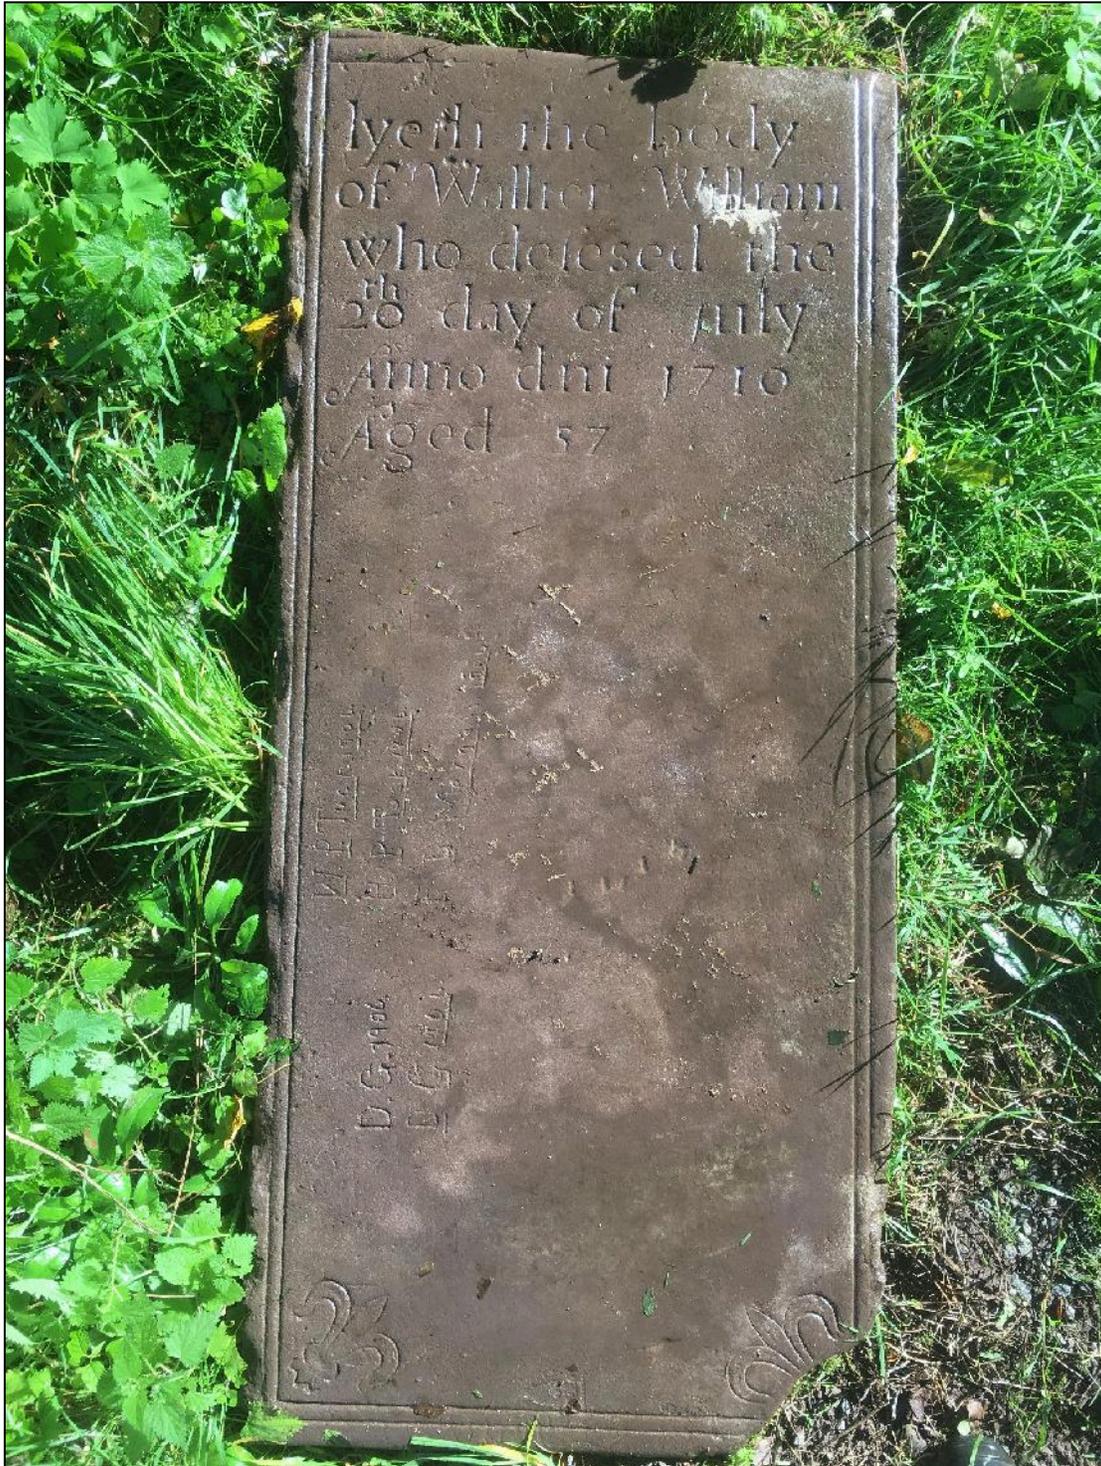
Plate 24: SEL2018_124, Detail of the gravestone, looking east-northeast. Note the graffiti names in the lower left-hand side.

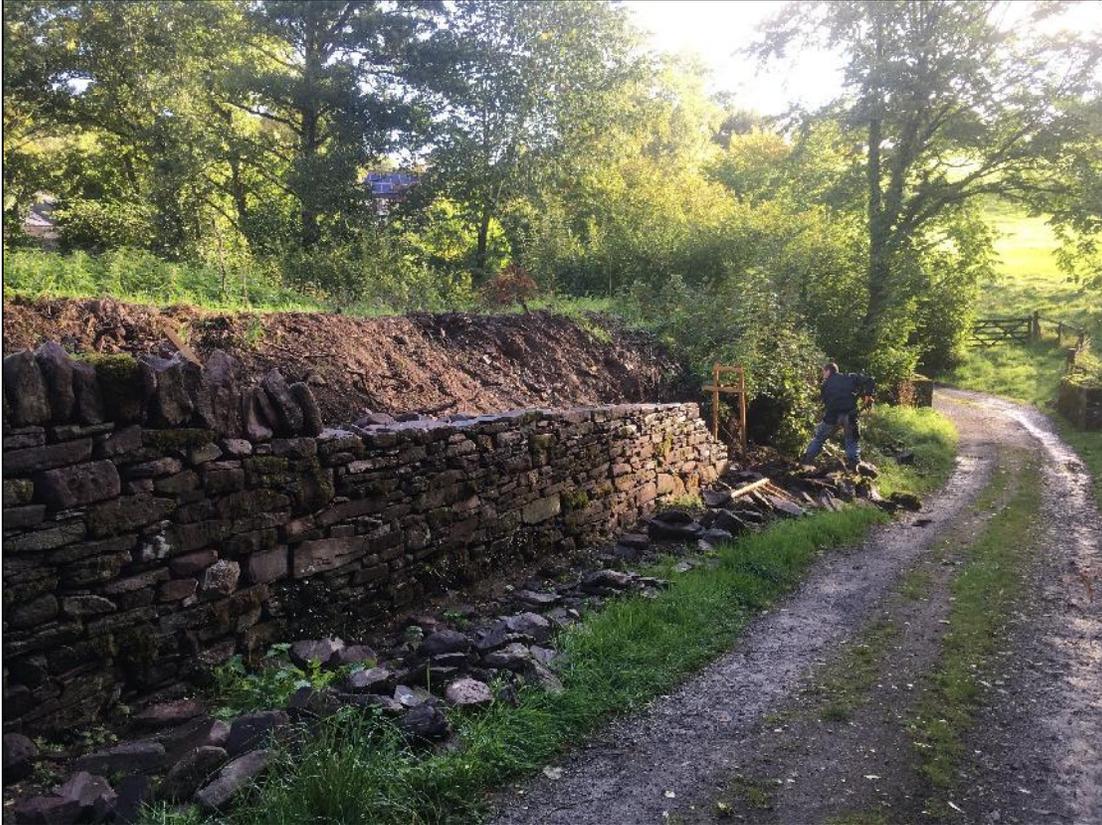
Plate 25: SEL2018_125, Restored section D and starting to take down section E, looking east. The height of the ground can be seen behind section D.

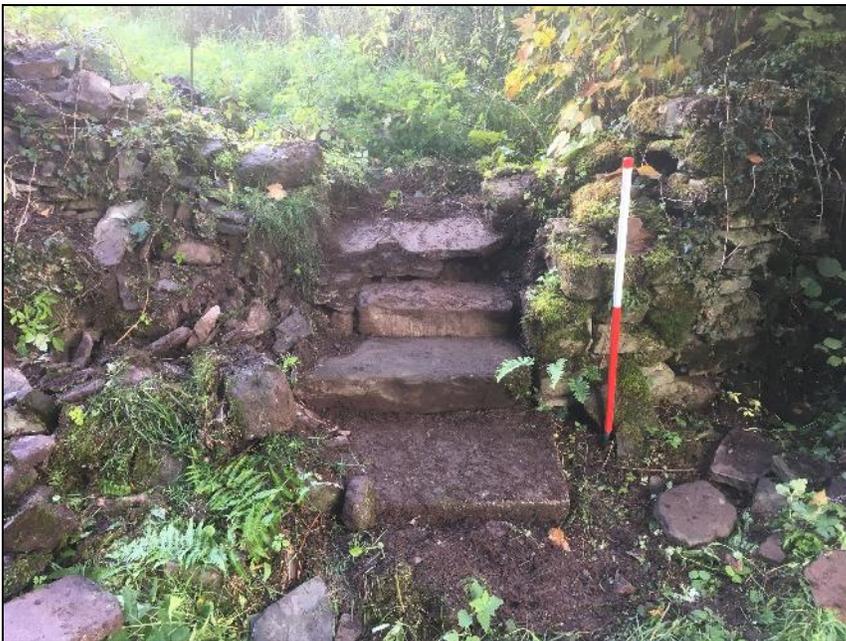
Plate 26: SEL2018_126, The steps through the eastern end of the section E after cleaning of vegetation and soil, looking north.

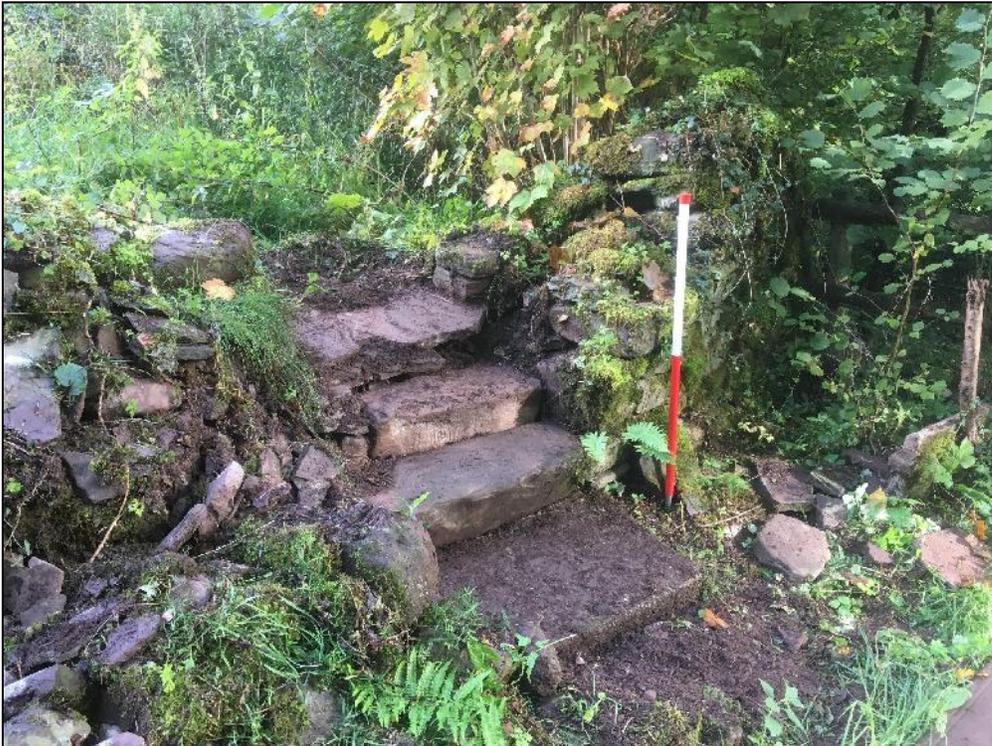
Plate 27: SEL2018_127, The steps through the eastern end of the section E after cleaning of vegetation and soil, looking northeast.

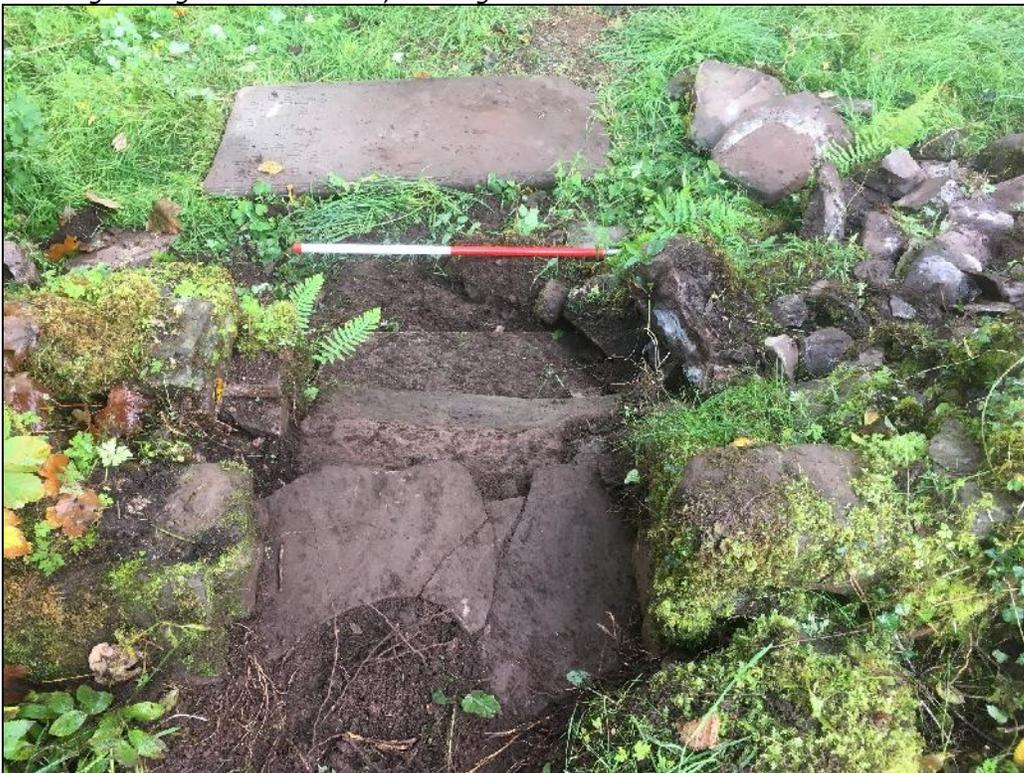
Plate 28: SEL2018_128, The steps through the eastern end of the section E after cleaning of vegetation and soil, looking south-southeast.

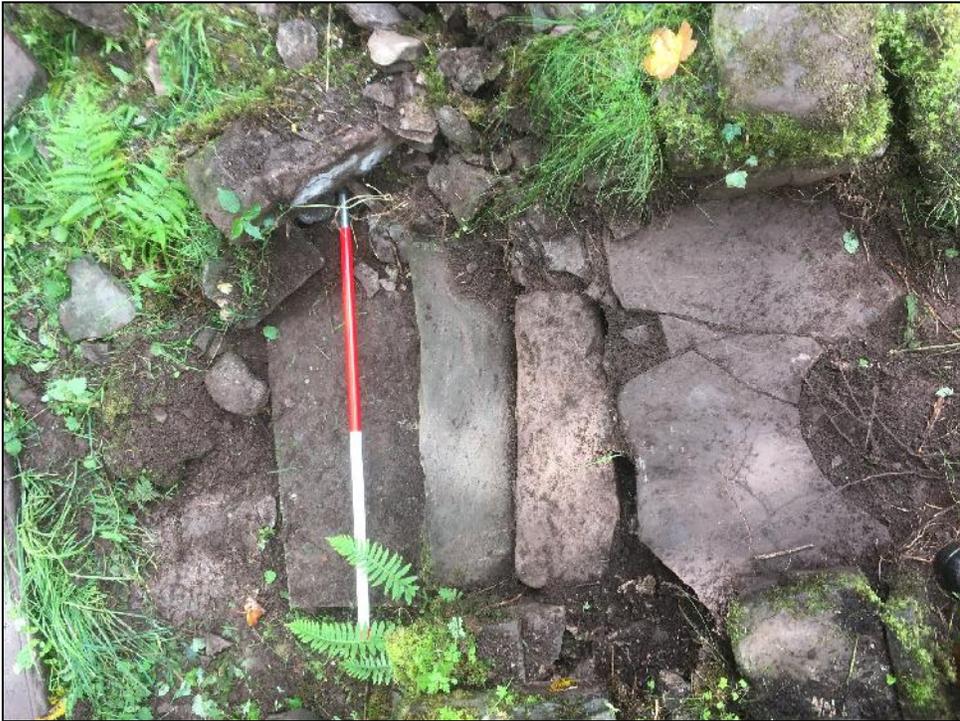
Plate 29: SEL2018_129, The steps through the eastern end of the section E after cleaning of vegetation and soil, looking west-southwest.
