**WATCHING BRIEF DURING
GROUNDWORKS
FOR REPAIRS TO BOUNDARY WALLS
AROUND THE CHURCHYARD OF ST
ELLYWE'S CHURCH, LLANELIEU
15/12456/FUL and 15/12457/LBC**

For: RV Williams Associates

April 2020

Trysor Project No. 2018/596

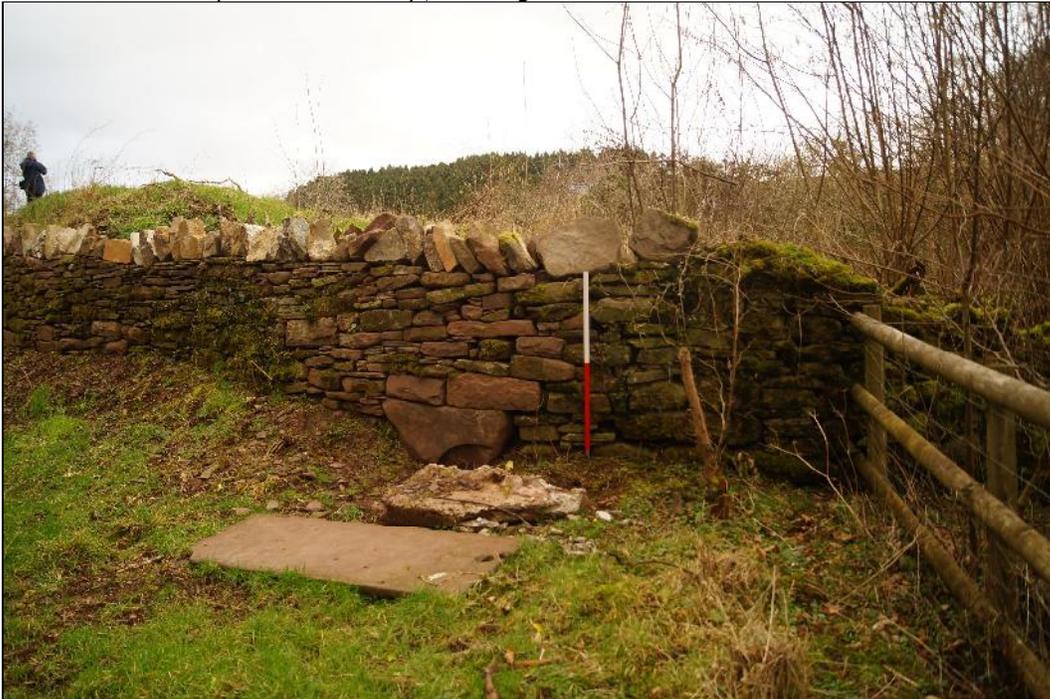
Plate 32: SEL2018_132, After restoration of the wall, with larger stones marking the location of the steps, looking northwest.

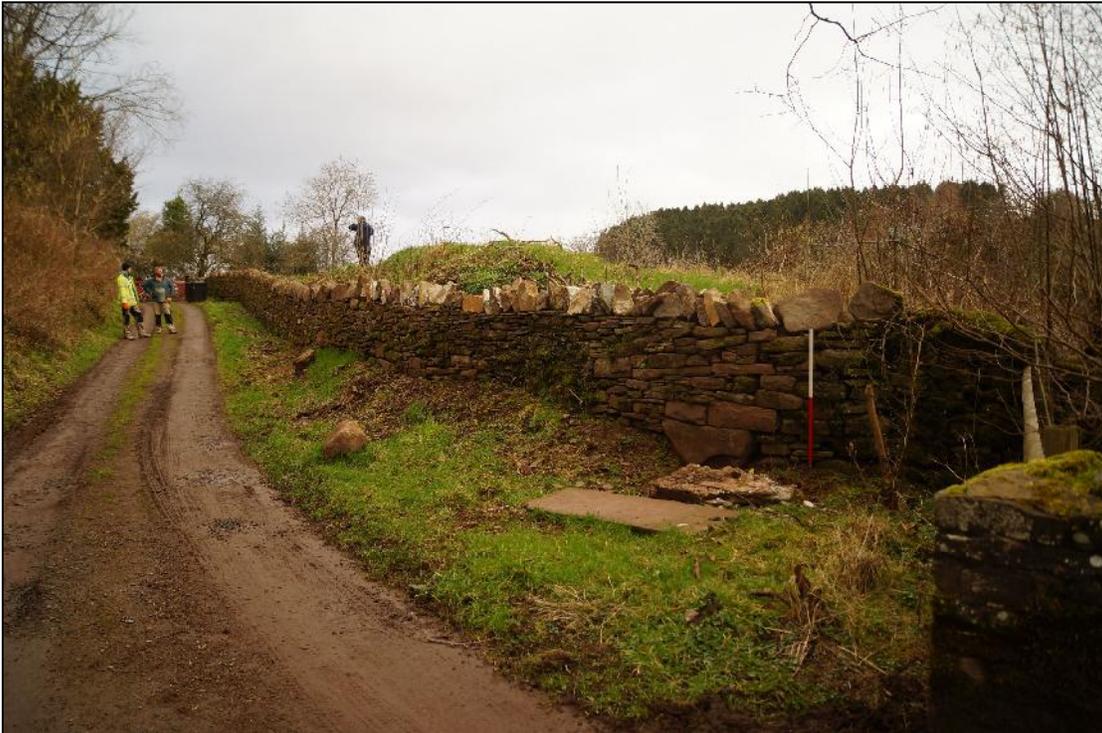
Plate 33: SEL2018_133, Completed restoration of the southern boundary wall, looking west.

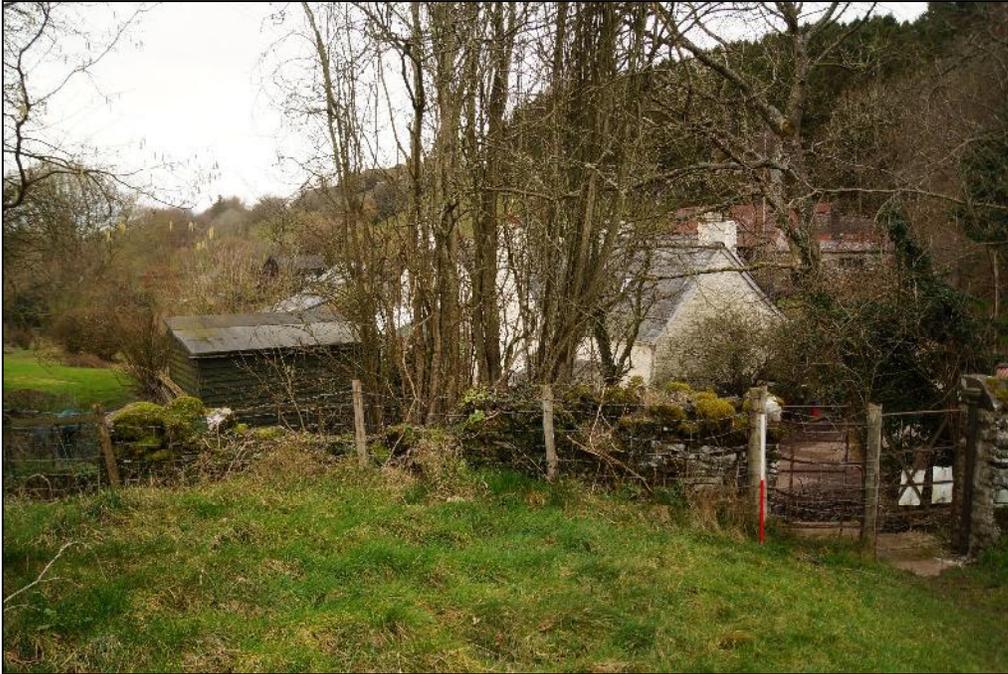
Plate 35: SEL2018_135, Section of the western boundary wall just to the south of the gateway, looking northwest.

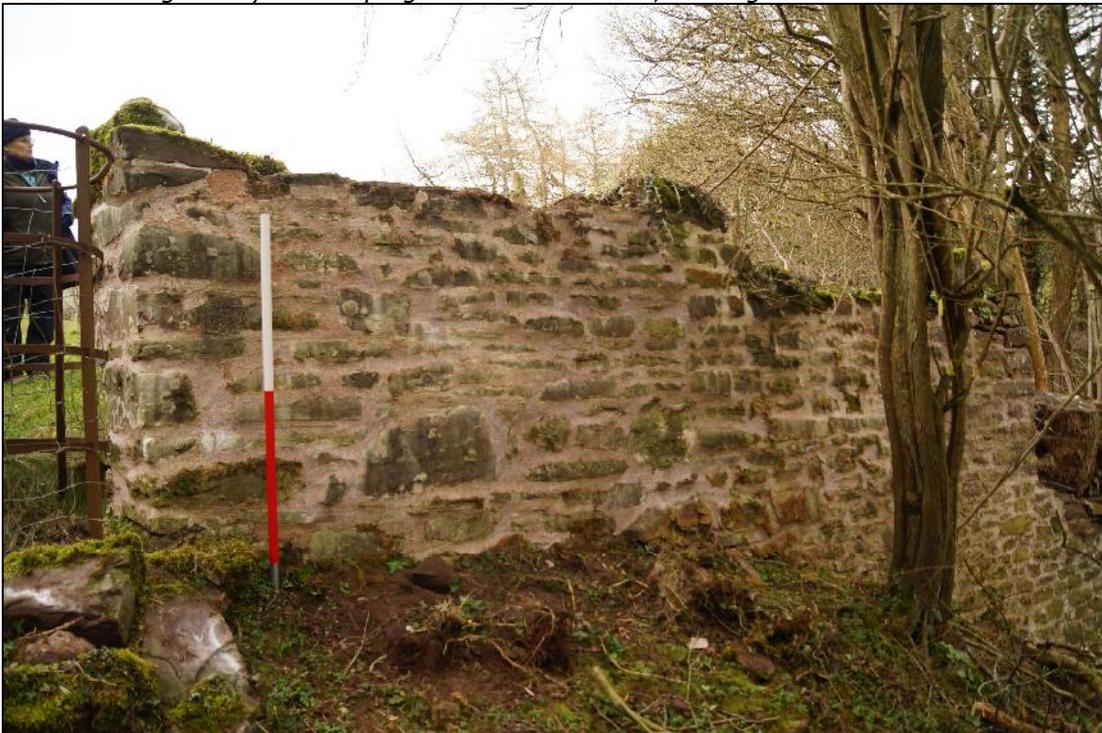
Plate 38: SEL2018_138, Repointed section of the western boundary wall just to the south of the gateway with coping stones removed, looking south-southeast.

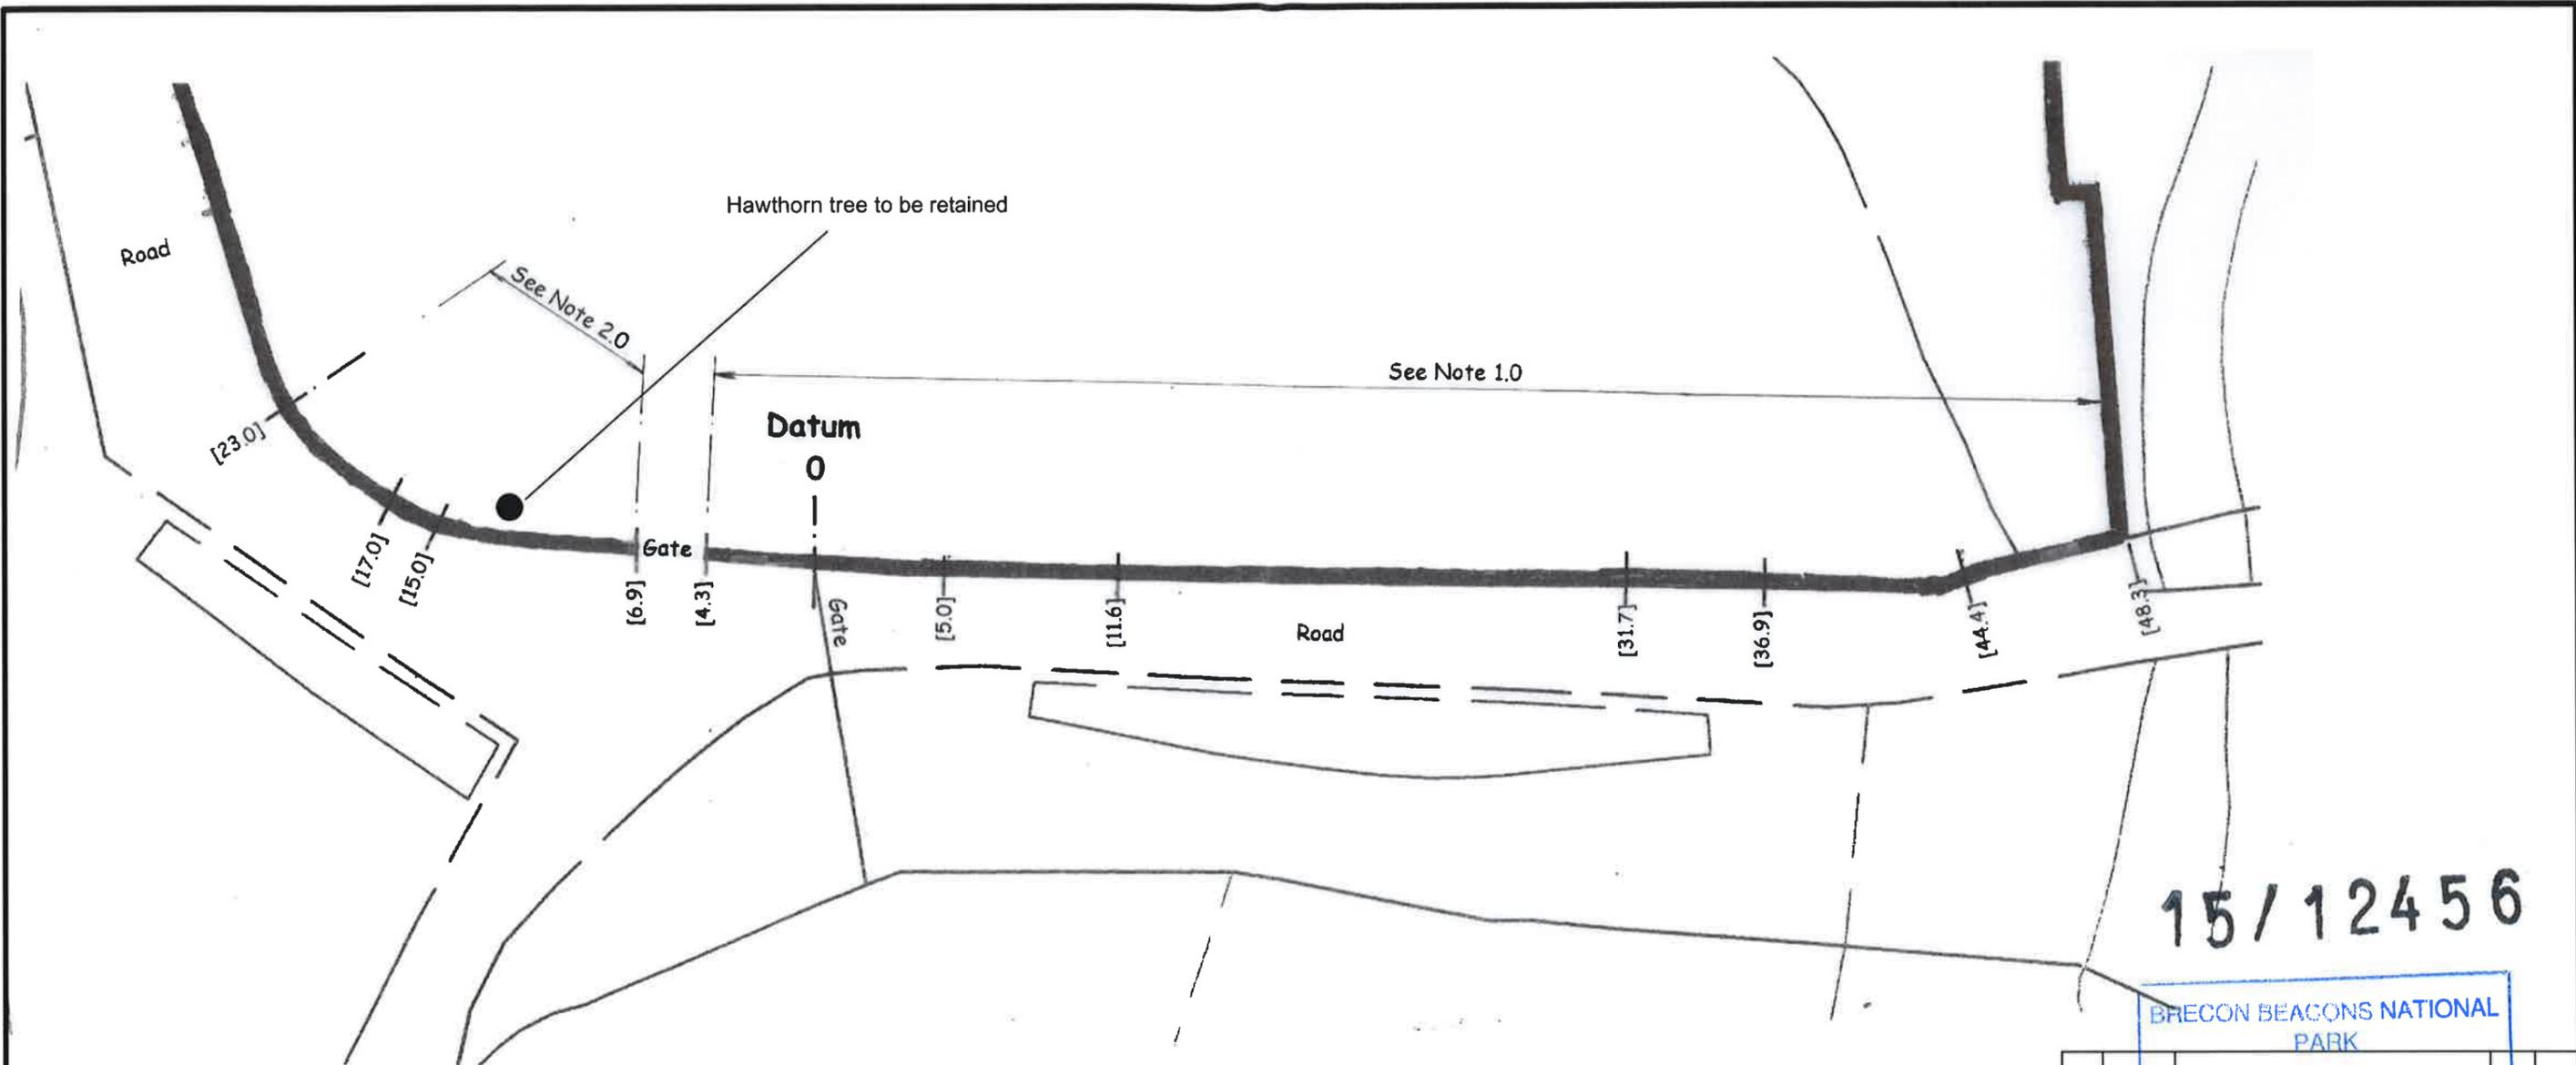
Title: **South Wall**

5.3 South Wall – the southern wall, from the eastern edge of the gateway in the south wall to where it joins the eastern wall at Datum C, is in bad repair and is to be rebuilt (Williams, RV, 2014 Associates, Drawing 3892 – 06). Generally the ground level within the churchyard is higher than that outside, with the difference increasing eastwards (Williams, RV, 2014 Associates, Drawing 3892 – 12). The wall is to be rebuilt with some excavation on the churchyard side to allow working space whilst wall is being rebuilt (Williams, RV Associates, 2014, Drawing 3892 – 13). This will include the removal of several tree

- 1.0 This section of boundary wall in very poor condition and requires re-building. Refer to drawings 3892-12 and 13 for details.
- 2.0 All capping stones will require removal and re-bedding. See also note 8.0 below.
- 3.0 Note deleted.
- 4.0 Note deleted.
- 5.0 Note deleted.
- 6.0 Note deleted.
- 7.0 Dimensions from datum noted thus [10] in metres
- 8.0 Some of these capping stones have already been removed and are stored inside the churchyard gate
