# **Pricaston Farmhouse, Castlemartin, Pembrokeshire**

## **Archaeological Watching Brief & Historic Building Record**

Prepared for  
**JOP Limited**  
on behalf of  
**Landmarc Support Services Ltd**  
By  
**Black Mountains Archaeology Ltd**  
18<sup>th</sup> November 2022  
Report No.273

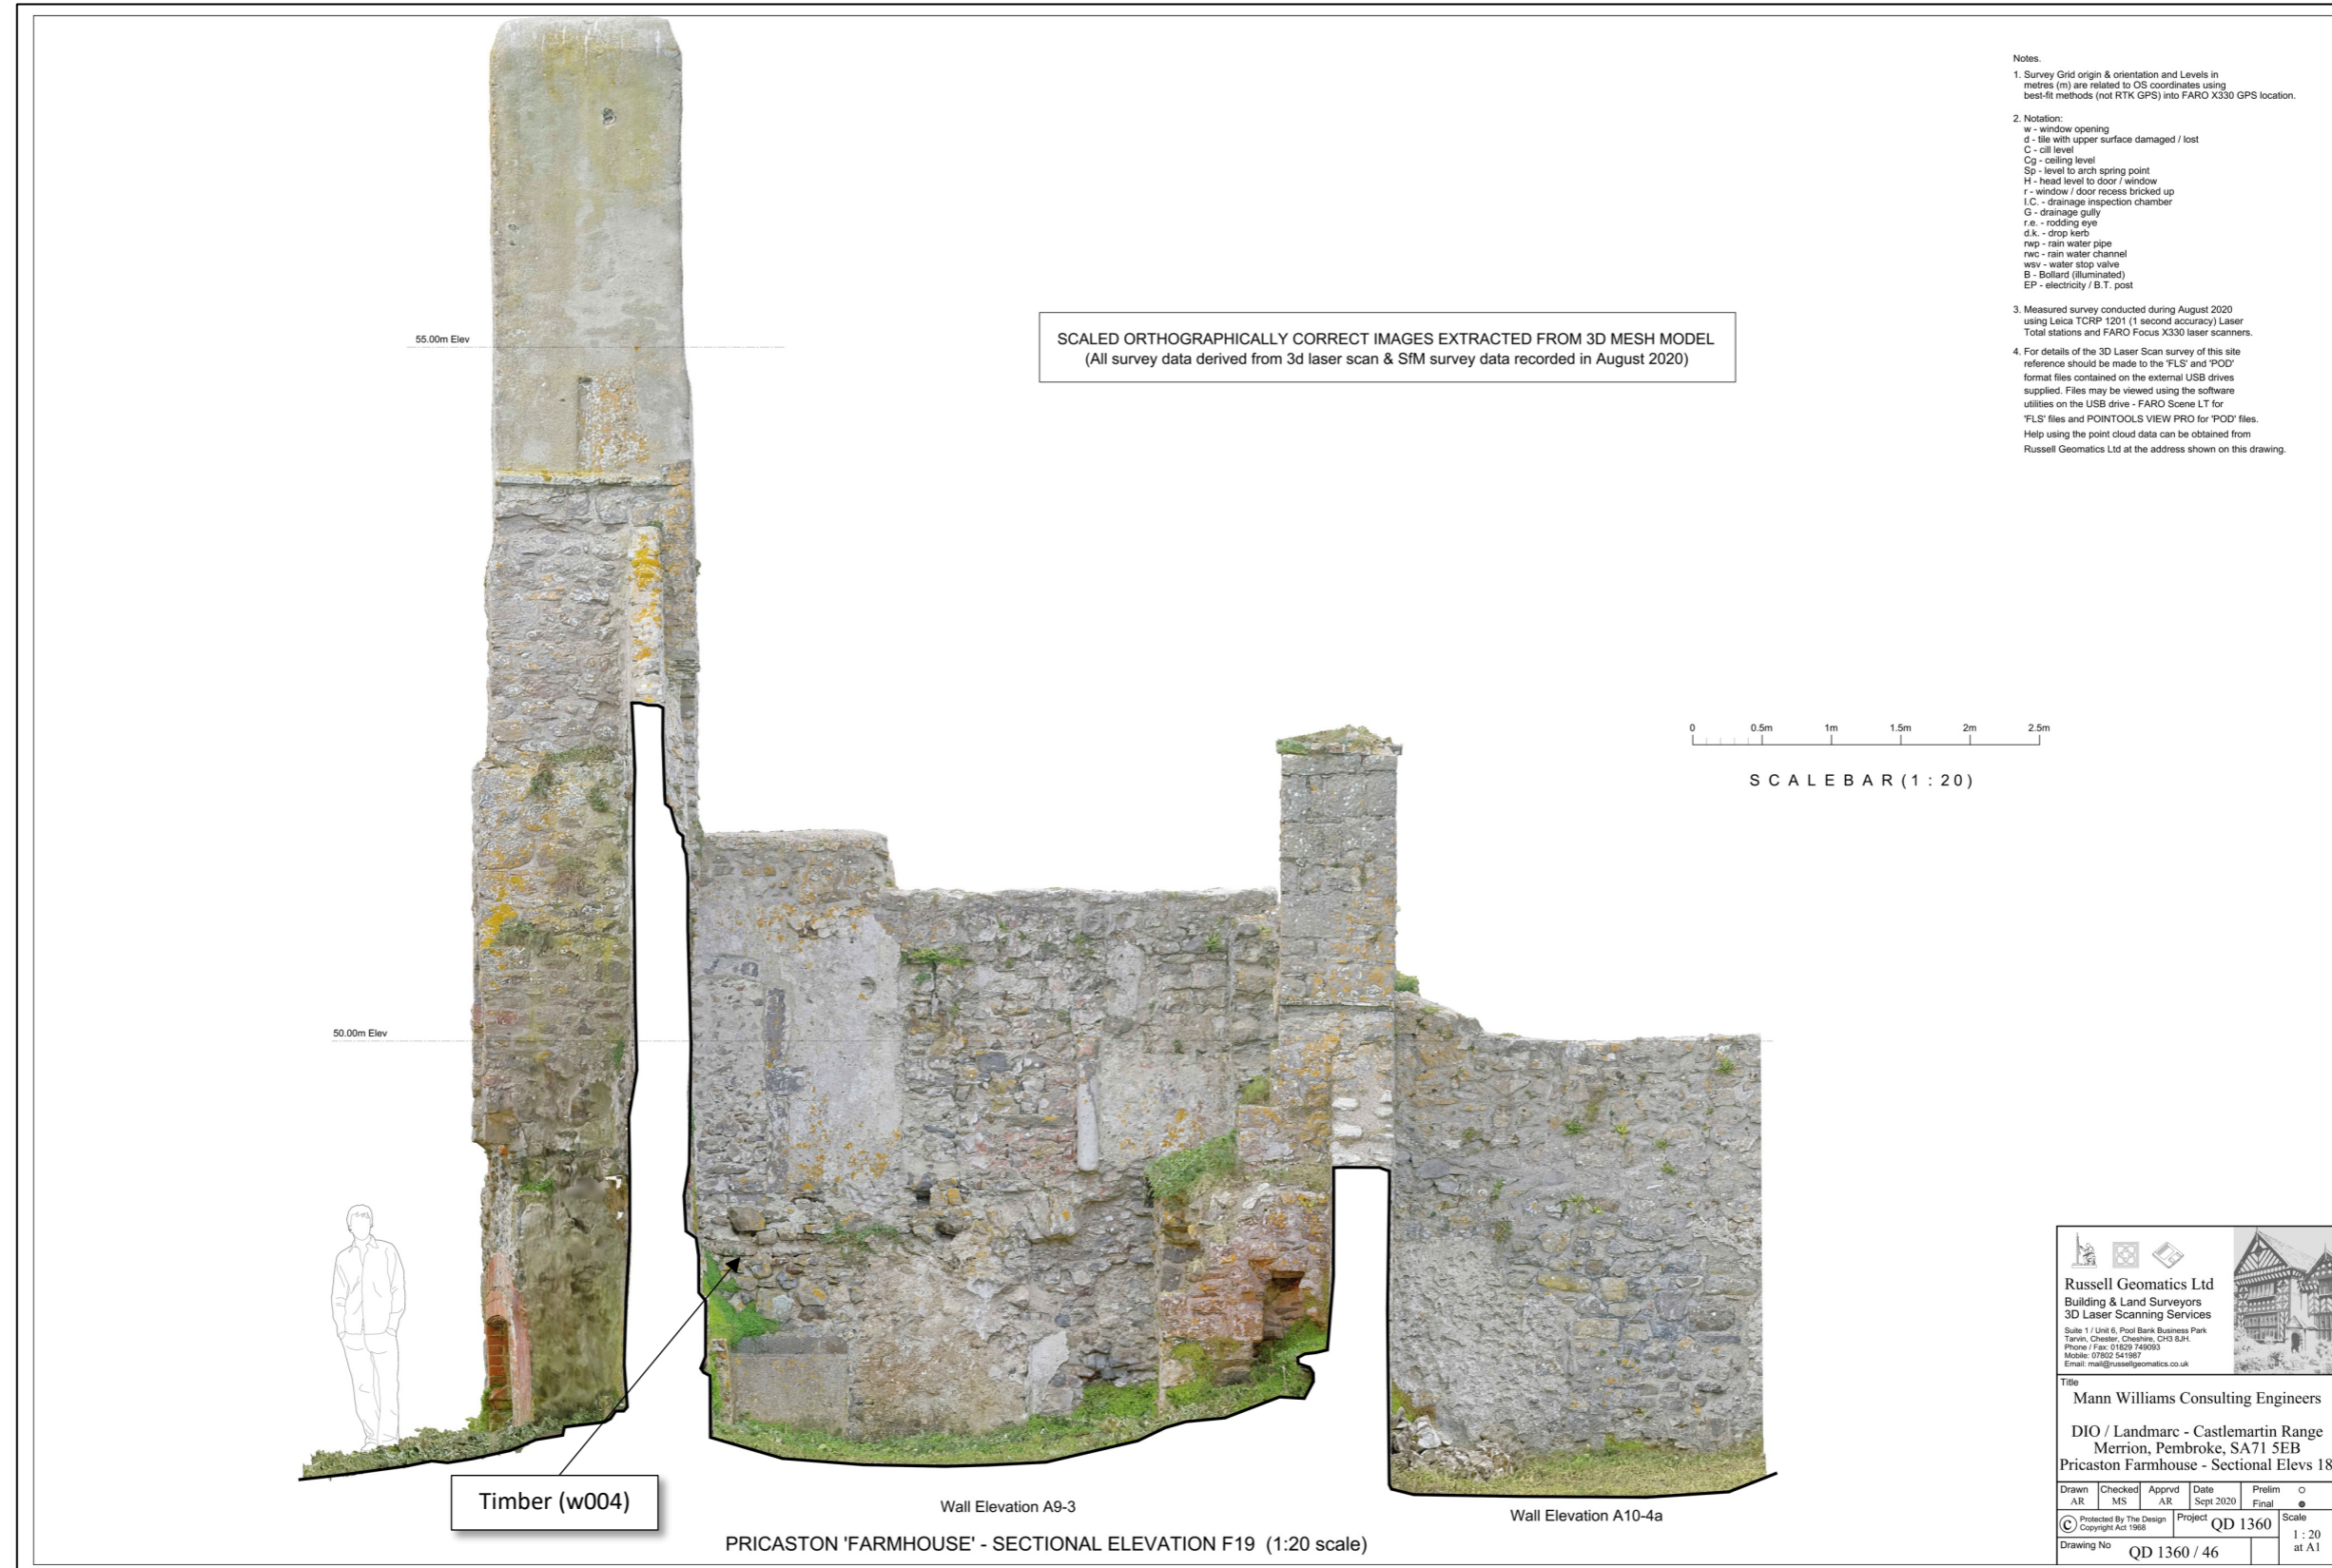
Figure 3. Laser and photogrammetric sections of Location 15, the medieval Tower ) before timber removal. (c) Russell Geomatics 2021.

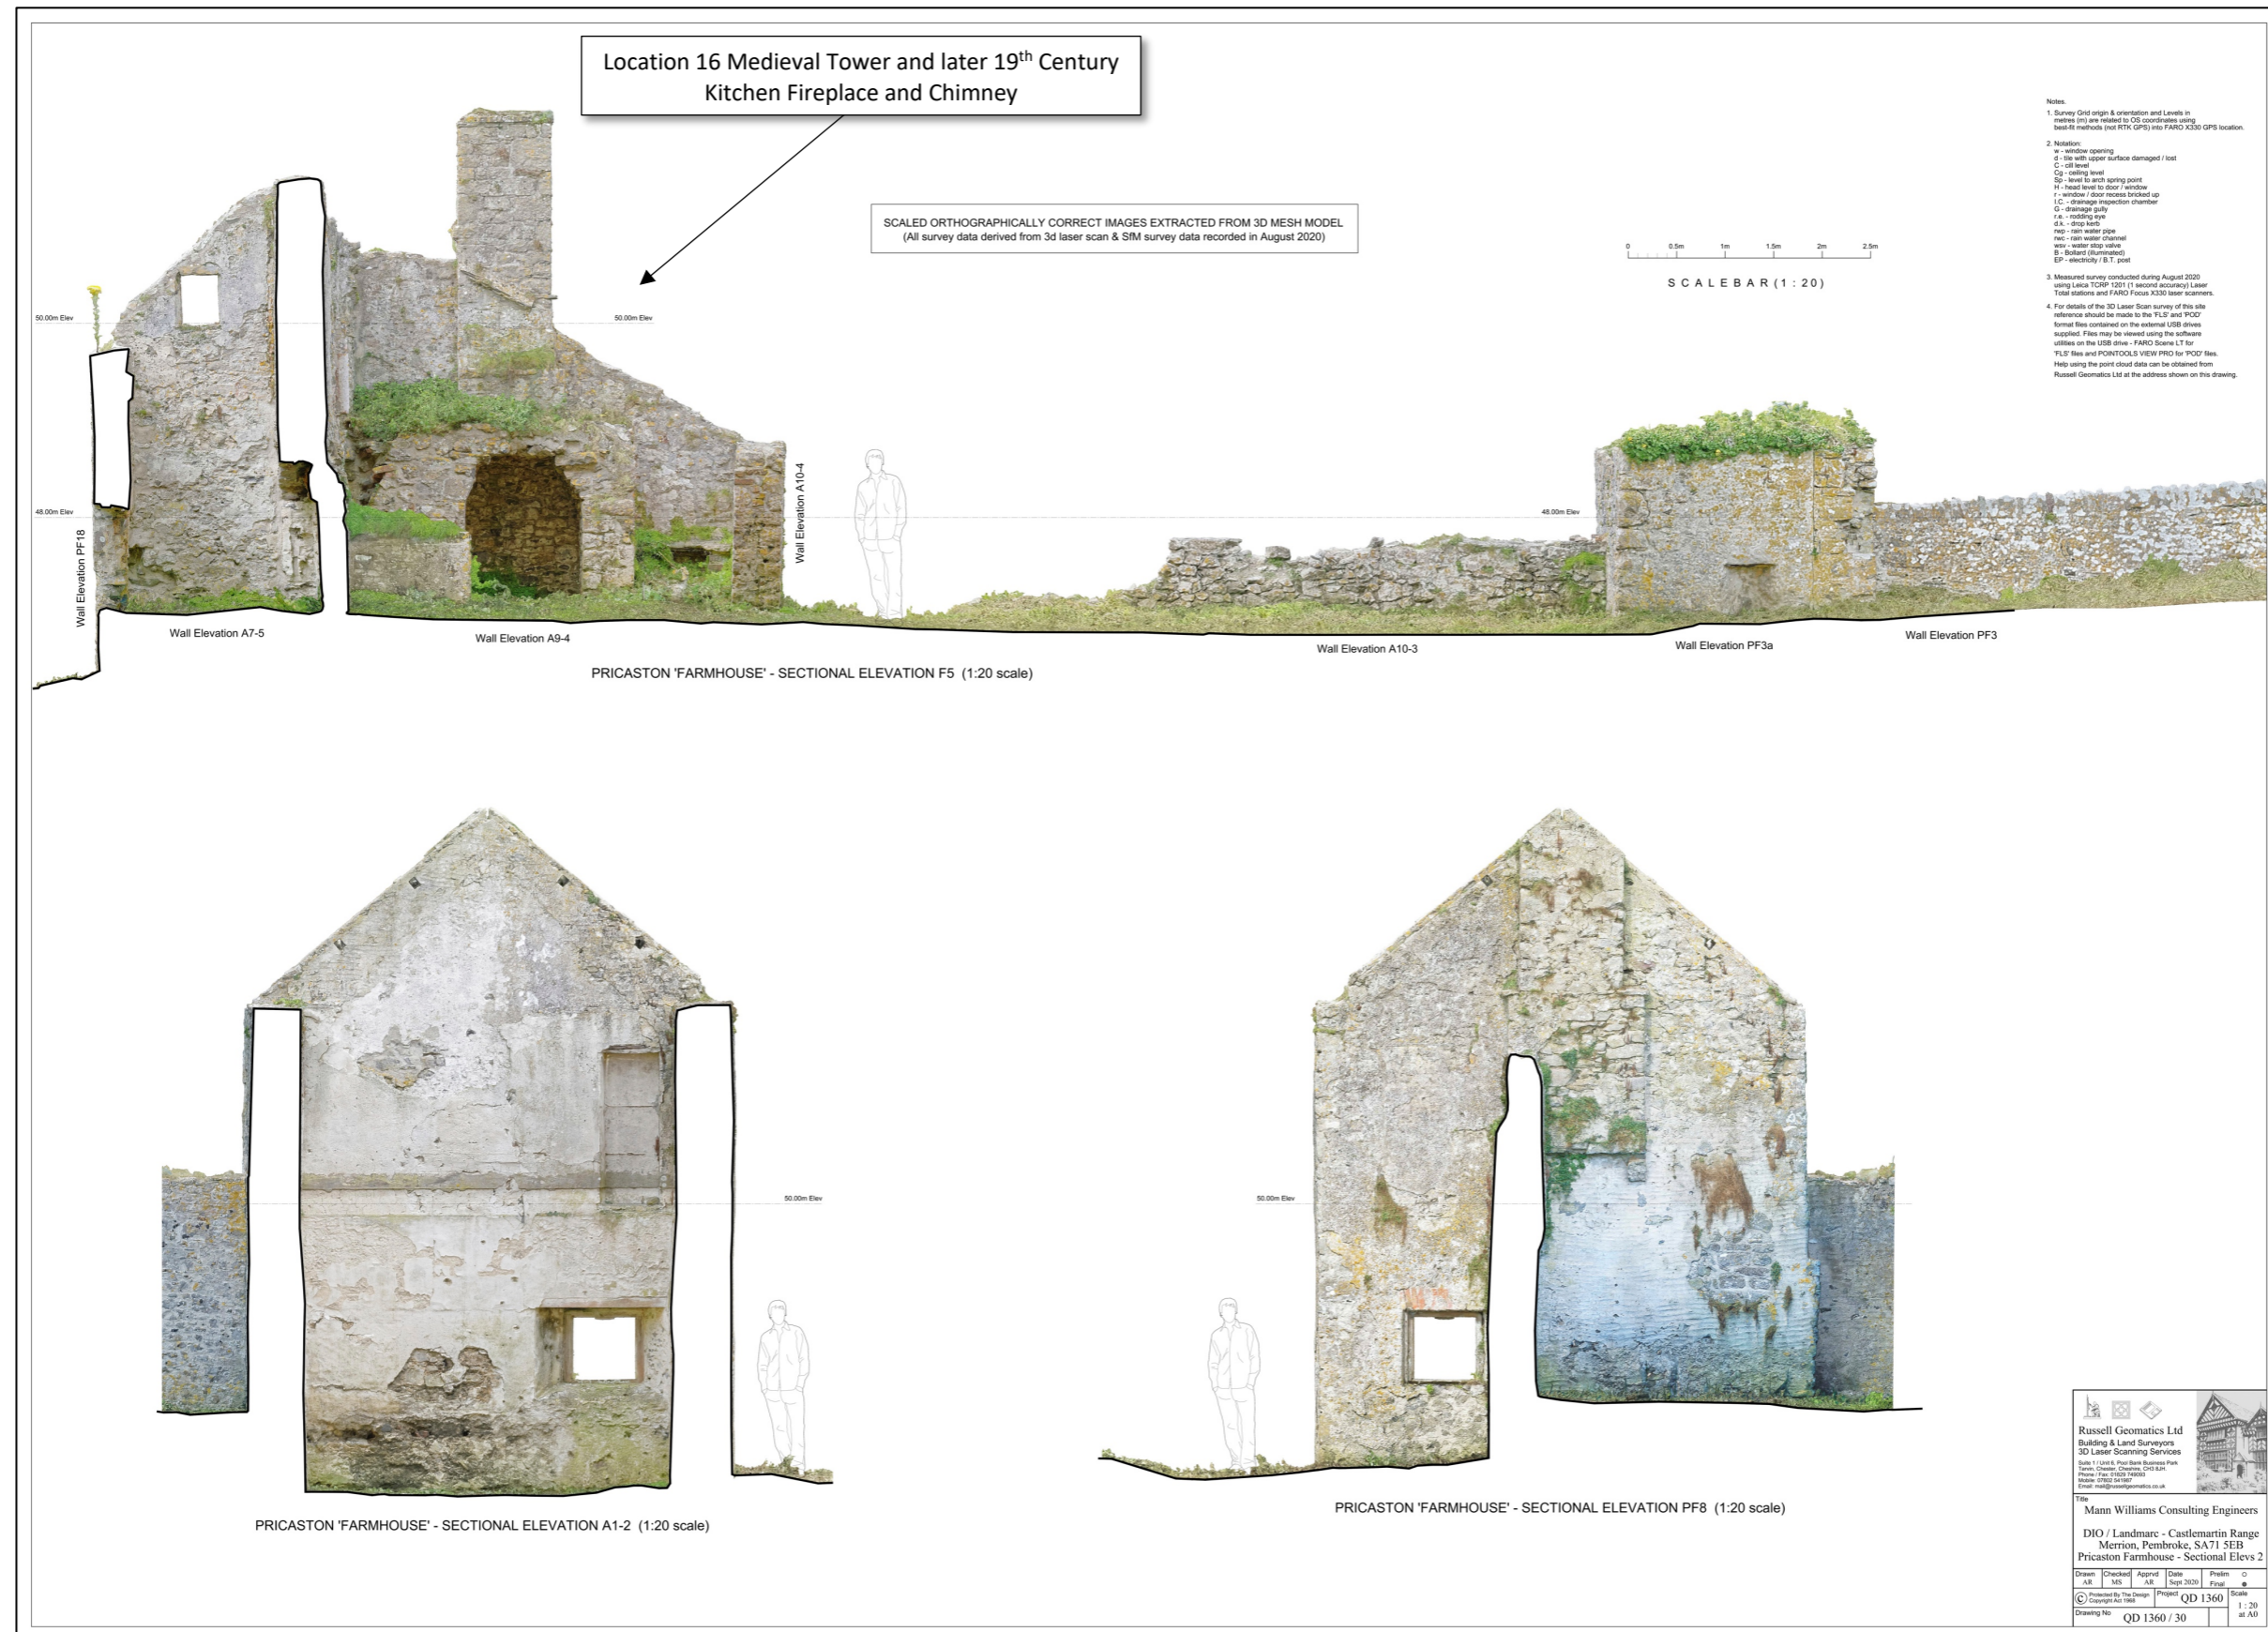
Figure 4. Laser and photogrammetric sections of Location 16, the Medieval Tower and 19<sup>th</sup> Century Kitchen Fireplace and Chimney following vegetation removal. (c) Russell Geomatics 2021.

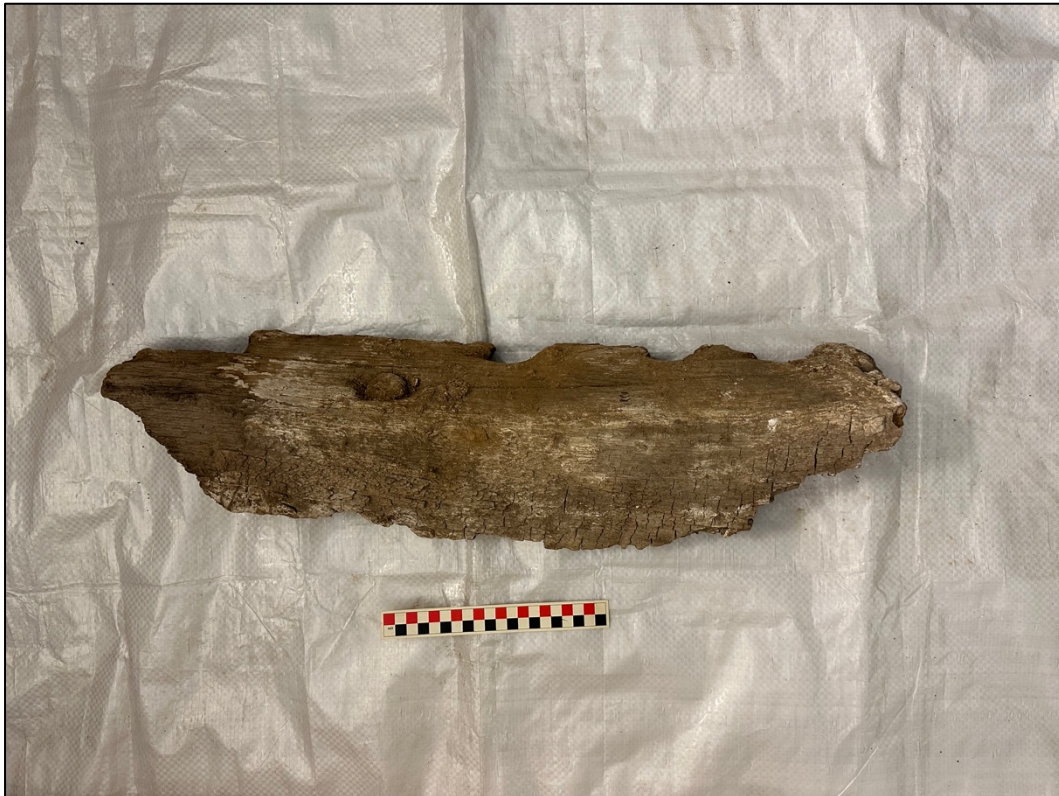
Plate 16. Location 13 NW Service Room, U/S Timber (w001), likely part of Timber (w006).

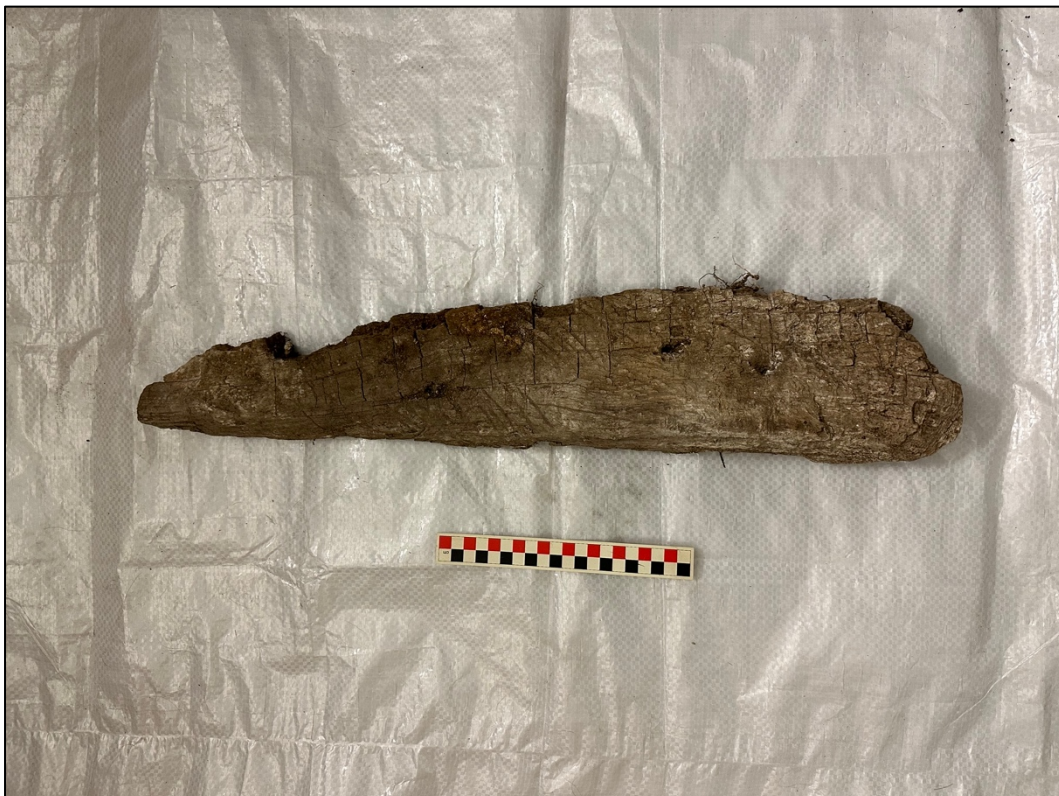
Plate 17. Location 13 NW Service Room, U/S Timber (w002), likely part of Timber (w006).

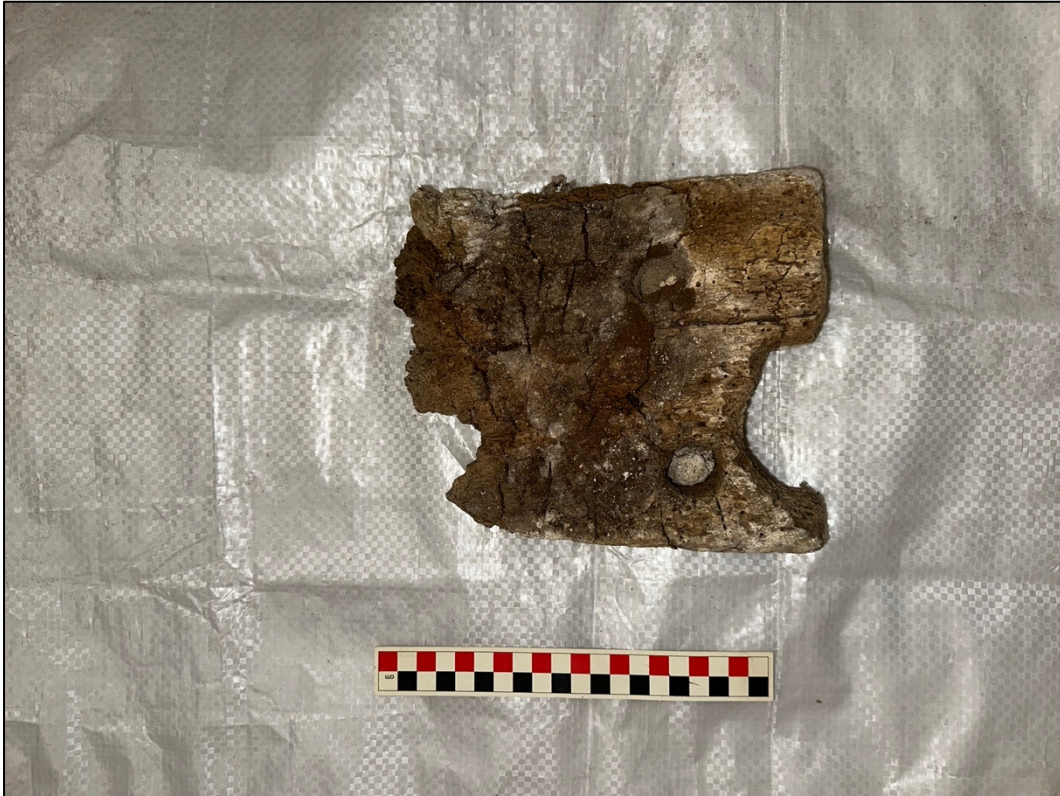
Plate 18. Location 15 Medieval Tower/19<sup>th</sup> Century Kitchen, tenon reused in the wall (15) directly above timber (w004).

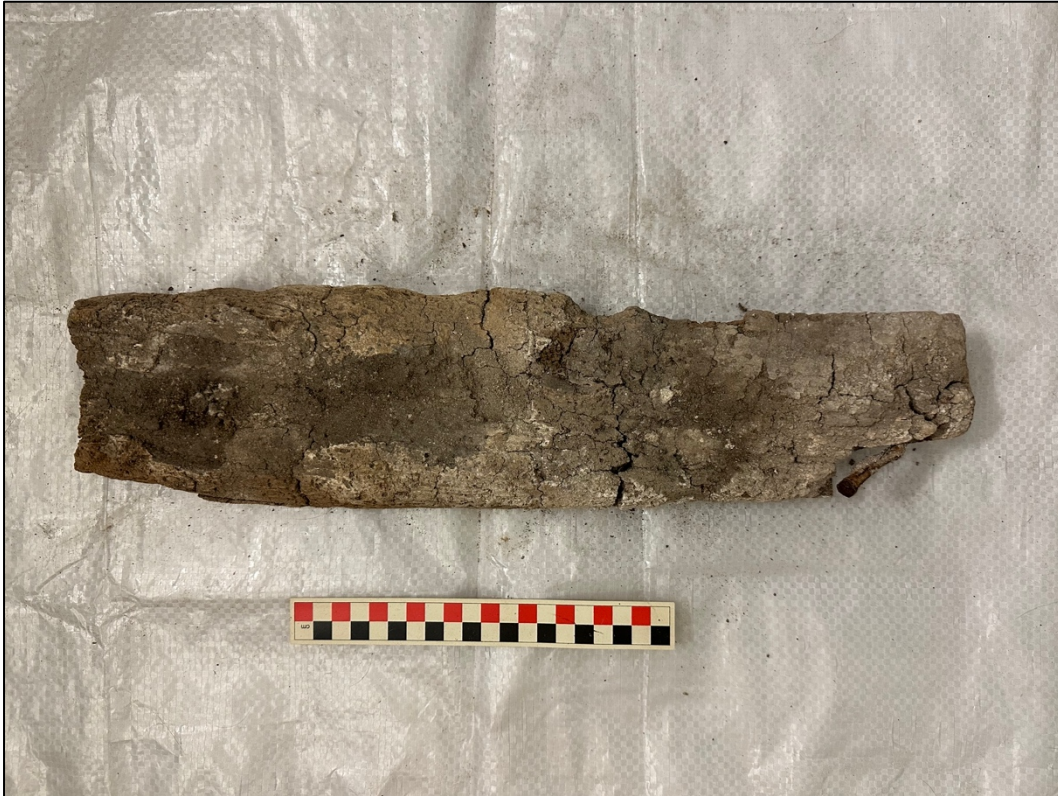
Plate 20. Location 15 Medieval Tower/19<sup>th</sup> Century Kitchen, reused sawn timber (w005) recovered from above timber (w004) within the former medieval tower [1501].

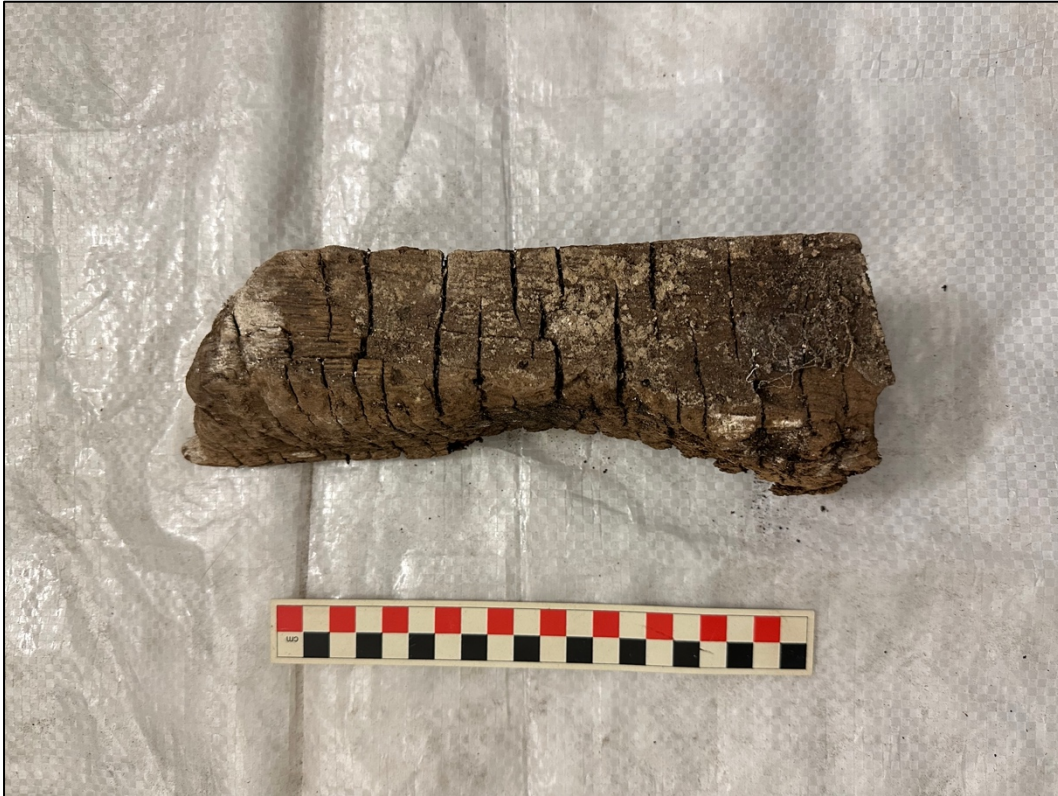
Plate 22. Location 13 NW Service Room, small square sawn timber wedged on top of large, worked timber (w006).

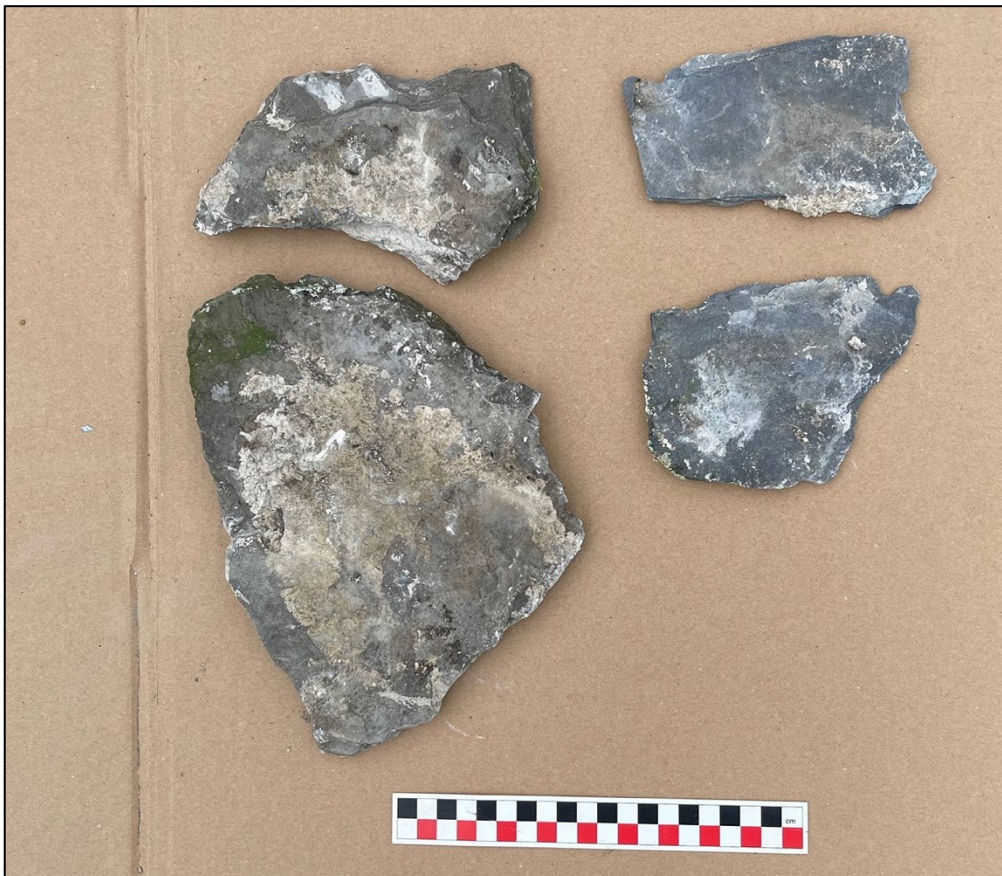
Plate 23. Location 15 Medieval Tower/19<sup>th</sup> Century Kitchen, four fragments of Pembrokeshire roof slate with nail holes found inserted horizontally into the wall [1501] below timber (w004).

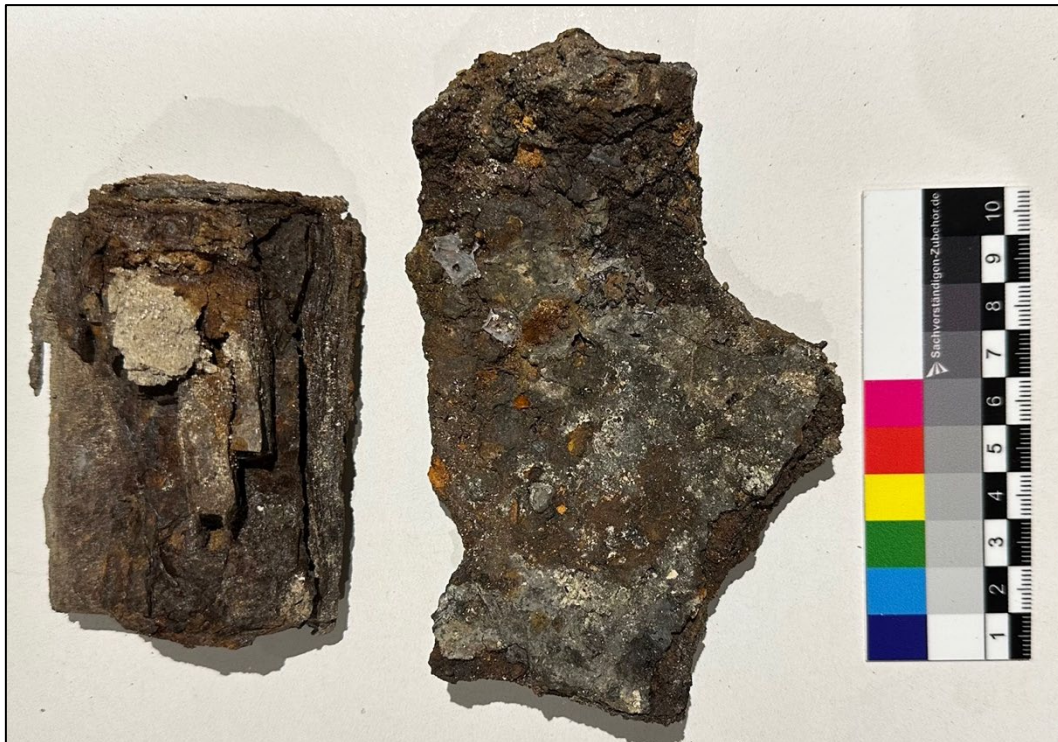
Plate 27. Location 15 Medieval Tower/19<sup>th</sup> Century Kitchen, two corroded fragments of iron. One appears to be the remains of a strap and the other a curved fragment of a bowl or cooking pot (1502).

1502	Deposit	15	Hard grey lime mortar with frequent tiny dark stone flecks found blocking Timber (w003) and behind removed Timber (w004) in wall [1501].	Post-medieval
1503	Deposit	15	Pinkish buff earthbound lime mortar with infrequent white lime flecks and moderately frequent stones/gravel forming the core of the medieval tower wall [1501].	Medieval/Post-medieval
1504	Structure	15	Blocked door in NE facing internal wall [1501] of the former medieval tower.	Medieval
1505	Structure	15	Blocking stone fill of door in NE facing internal wall [1501] of the former medieval tower.	Post-medieval

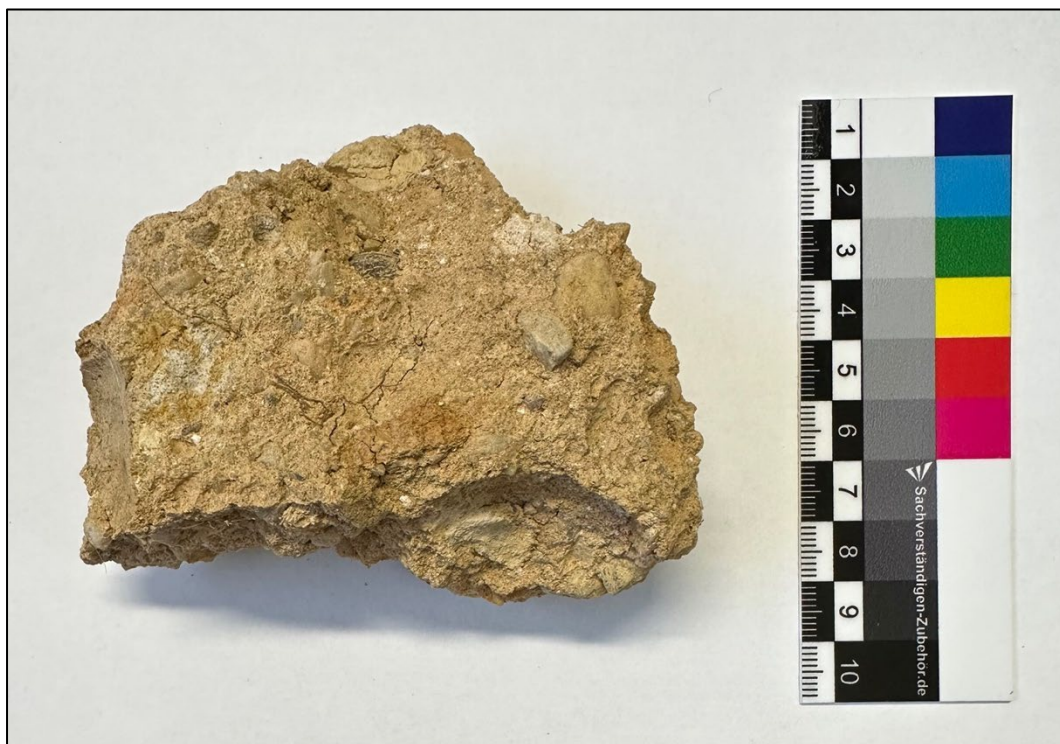
Plate 28. Location 13 NW Service Room, pinkish buff coloured earthbound mortar (\*01) recovered from the infilled base of chimney flue [1305], 17<sup>th</sup> – 18<sup>th</sup> century.

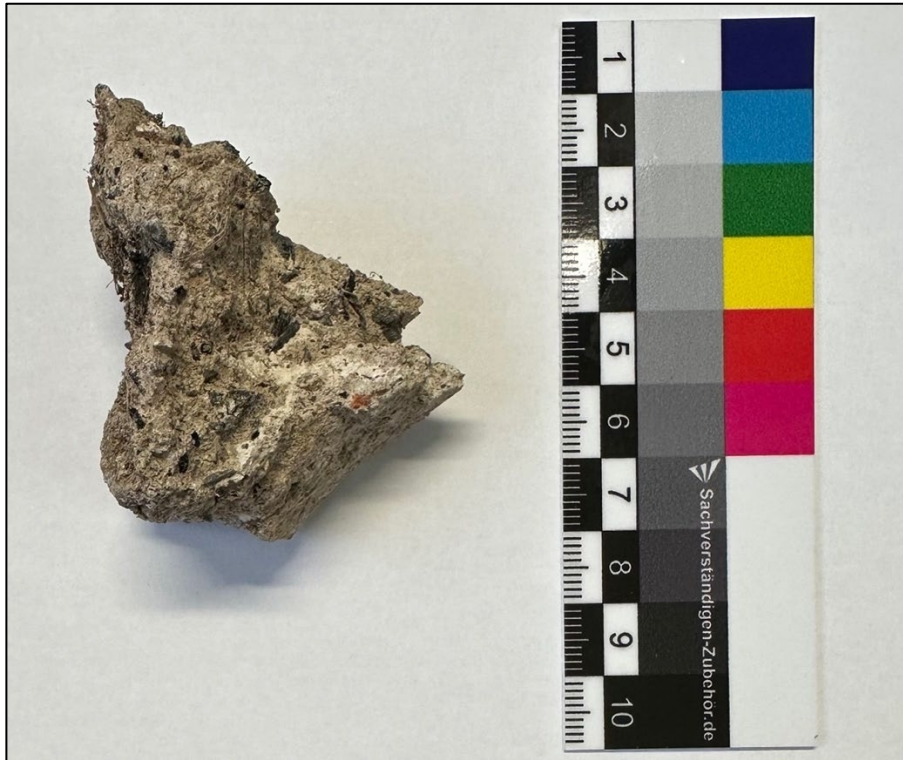
Plate 29. Location 13 NW Service Room, hard grey pozzolan ash (wood) mortar (\*02) with stone aggregate inclusions overlying the west end of timber (w006), 18<sup>th</sup>-19<sup>th</sup> century.

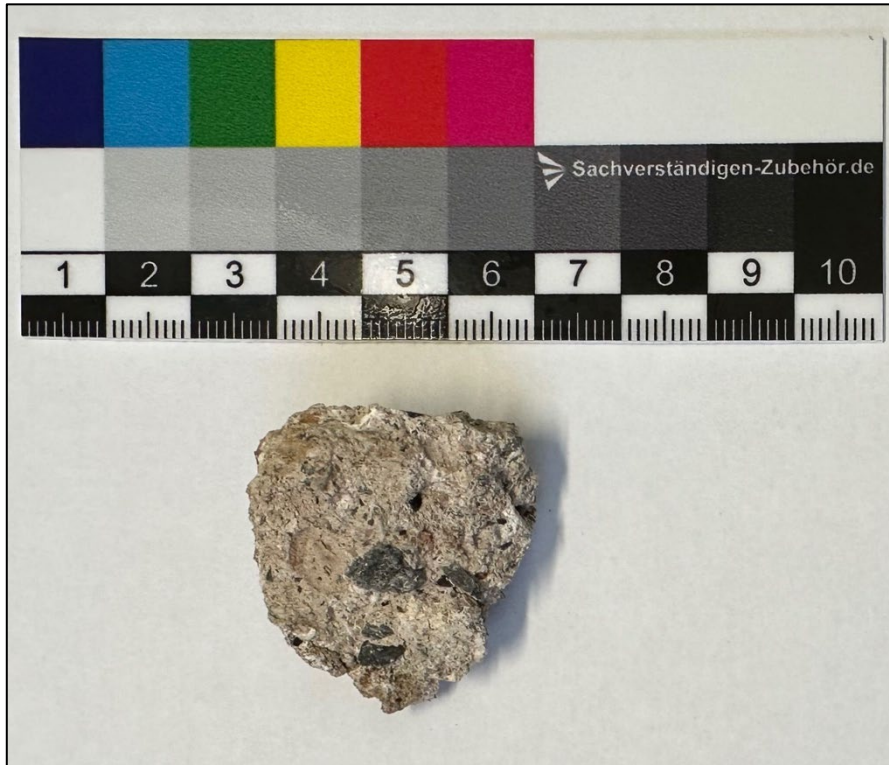
Plate 31. Location 13 NW Service Room, hard grey pozzolan ash (wood) mortar (\*04) with stone aggregate inclusions forming mortar bed for timber (w006), 18<sup>th</sup>-19<sup>th</sup> century.

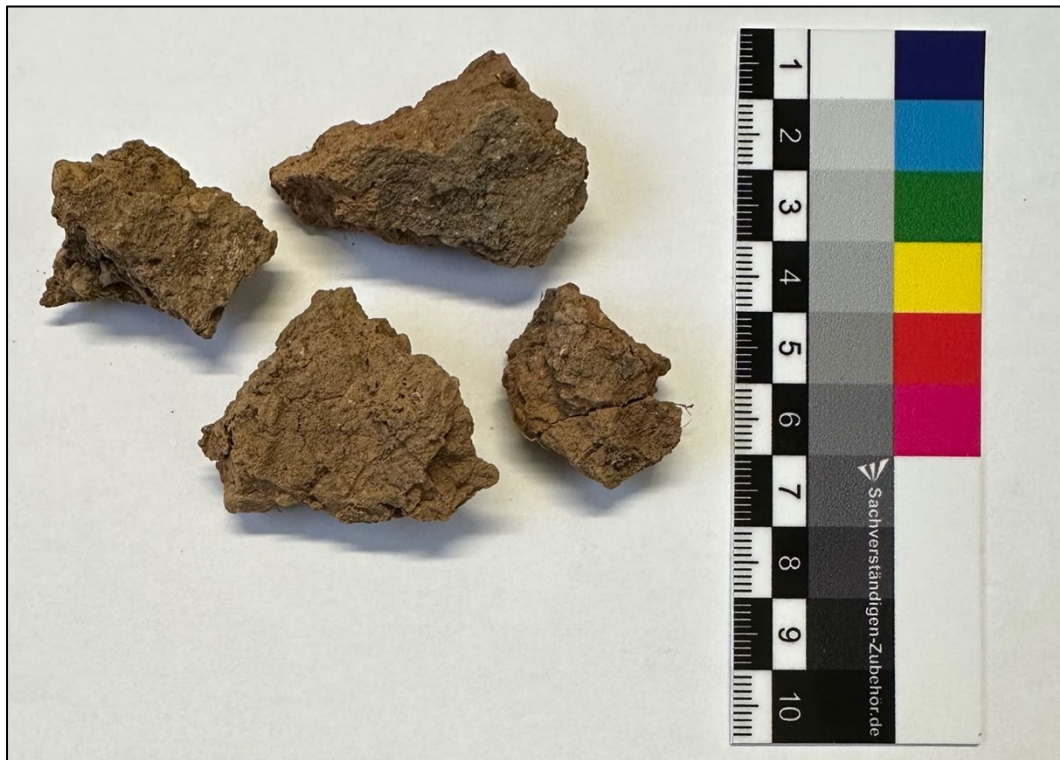
Plate 32. Location 13, earth core of NW Service Room SW medieval wall (\*05) [1307], 14<sup>th</sup> century.

Context	Type	Location	Description	Period
			bonding. Lack of smoke blackening suggest only <i>in-situ</i> for short period of time before blocking occurred.	
1307	Structure	13	Medieval NW Service Room SW wall. Contains earth core (sample *05). It is a common practice in medieval Pembrokeshire buildings to have earthen core with lime bonded or pointed face.	Medieval
1308	Deposit	13	Mortar bed for timber (w006) in the medieval NW Service Room, sample *04. Hard grey pozzolan ash (wood) mortar with stone aggregate inclusions. 18 <sup>th</sup> – 19 <sup>th</sup> century.	Post-medieval
1309	Structure	13	Modern timber lintels above door inserted into medieval NW Service Room.	Post-medieval
1501	Structure	15	NE facing internal medieval tower and later 19 <sup>th</sup> century kitchen wall. A blocked medieval doorway [1504] is partly visible as is a blocked first floor window and another door or perhaps fireplace.	Medieval
