CPAT Report No 1215.1

**Scottish Power Energy Networks
Dolgarrog to Pentir 132kV Overhead Powerline
Foundation Upgrades**

CULTURAL HERITAGE MITIGATION

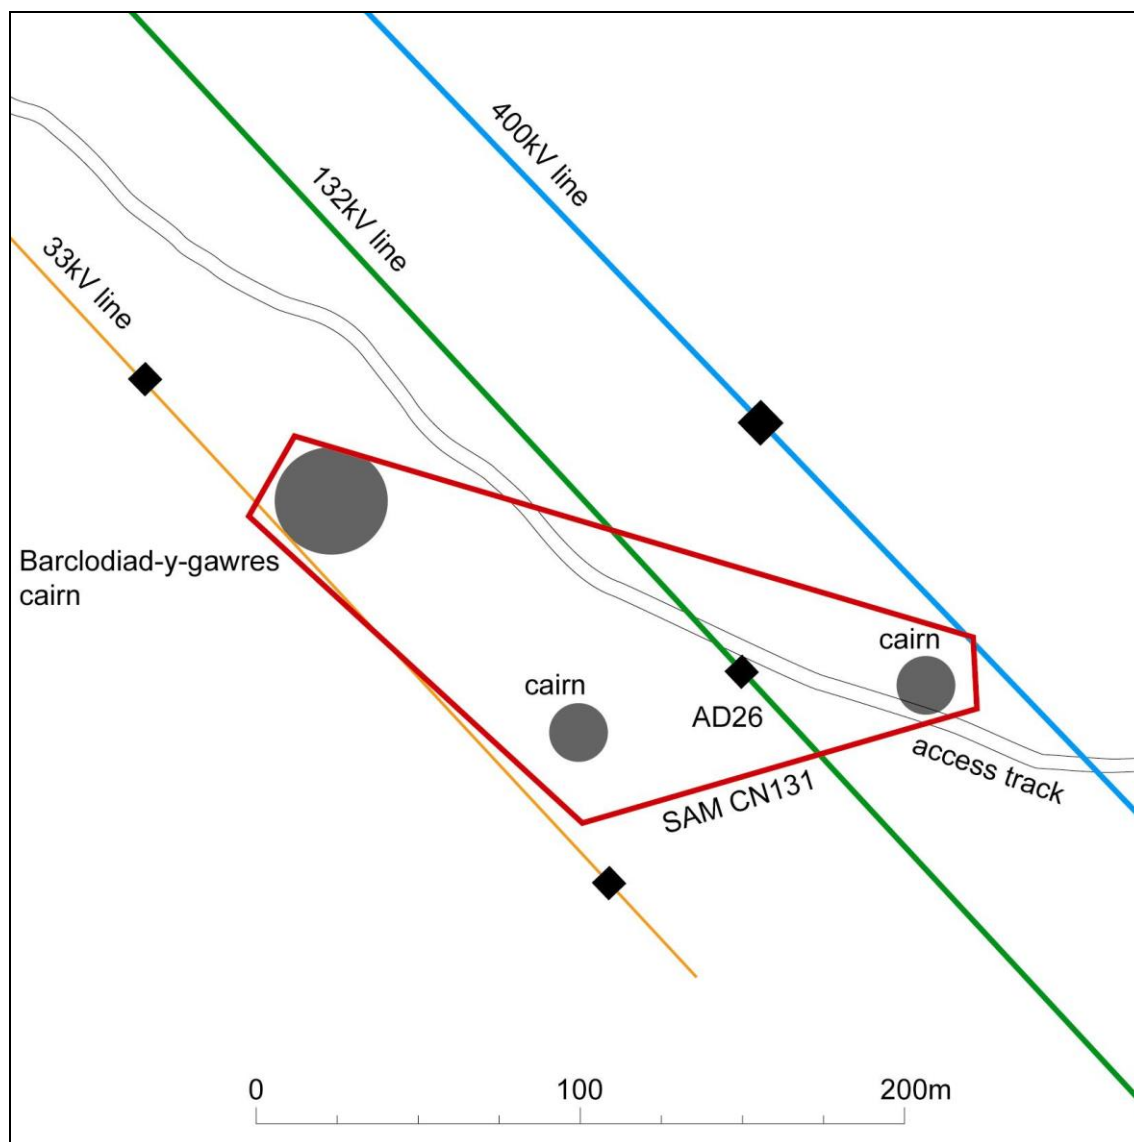
Fig. 3 Location of tower AD26 in relation to the cairns within the scheduled area of SAM CN131

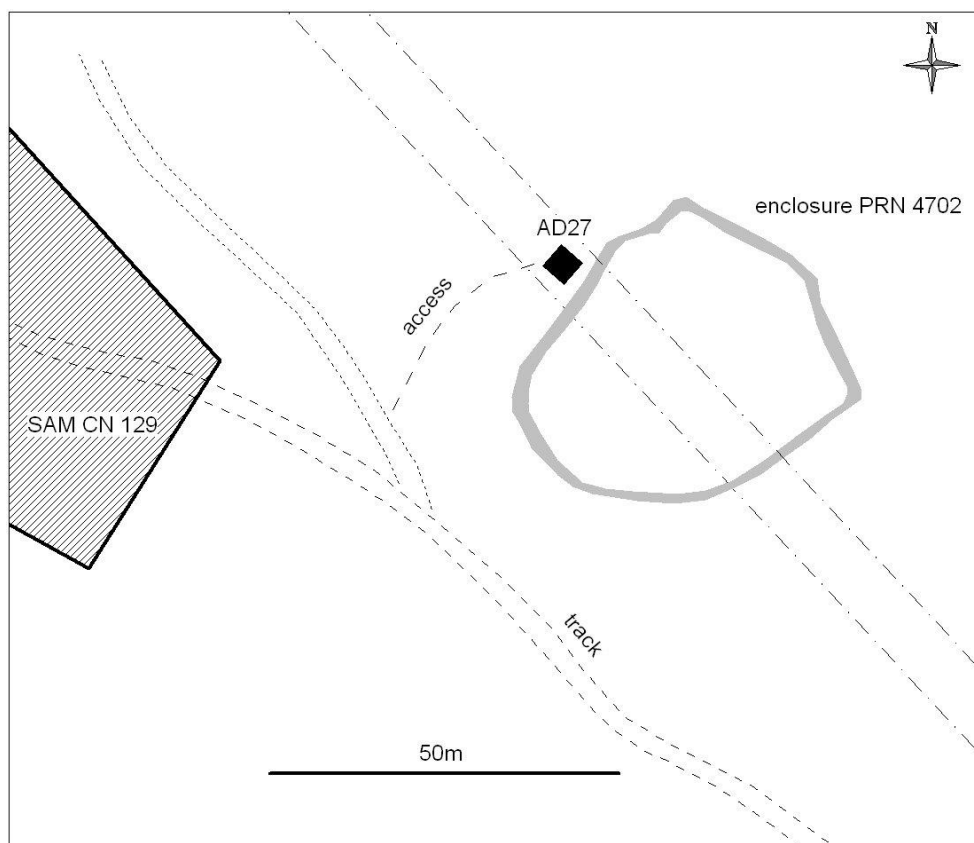
Fig. 4 Plan showing the proximity of enclosure PRN 4702 to tower AD27

Tower	Assets within 50m	Distance to nearest asset	Potential impacts	Mitigation
AD27	PRN 4702 enclosure	<5m	damage to enclosure	Preservation in situ - Avoid / demarcate or prior excavation and survey if damage is unavoidable
AD28	SAM CN129	110m	none	Use existing grassy track to access tower
AD29	none	100m	none	none
AD30	none	70m	none	none
AD31	none	65m	none	none
AD32	none	70m	none	none
AD33	Access crosses holloway (Site 3) - former route of present track	90m	removal of section of field wall for access and damage to holloway (Site 3)	Rebuild wall in same style with original stones Holloway to be preserved in situ and taken into account when determining access route
AD34	none	200m	poss. removal of section of field wall for access	Rebuild wall in same style with original stones
AD35	Predicted line of Roman road follows present track	10m	none	none
AD36	Predicted line of Roman road follows present track	20m	none	none

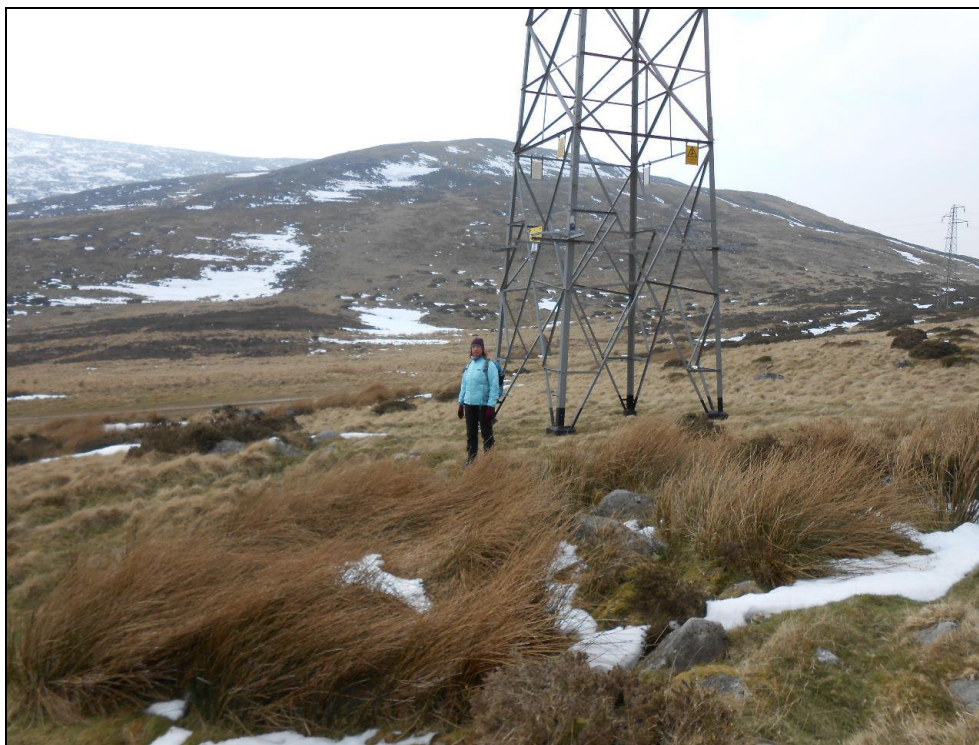
Fig. 5 Tower AD27 – the person is standing at the point at which enclosure PRN 4702 is closest to the tower. Photo CPAT 3610-0060
