HARLECH CASTLE
HARLECH
GWYNEDD

HARLECH CASTLE
GATEHOUSE SOUTH WEST TOWER

Steps 31 - 46

Sheet Information:
 3 OF 10
 Monument Number:
 6220

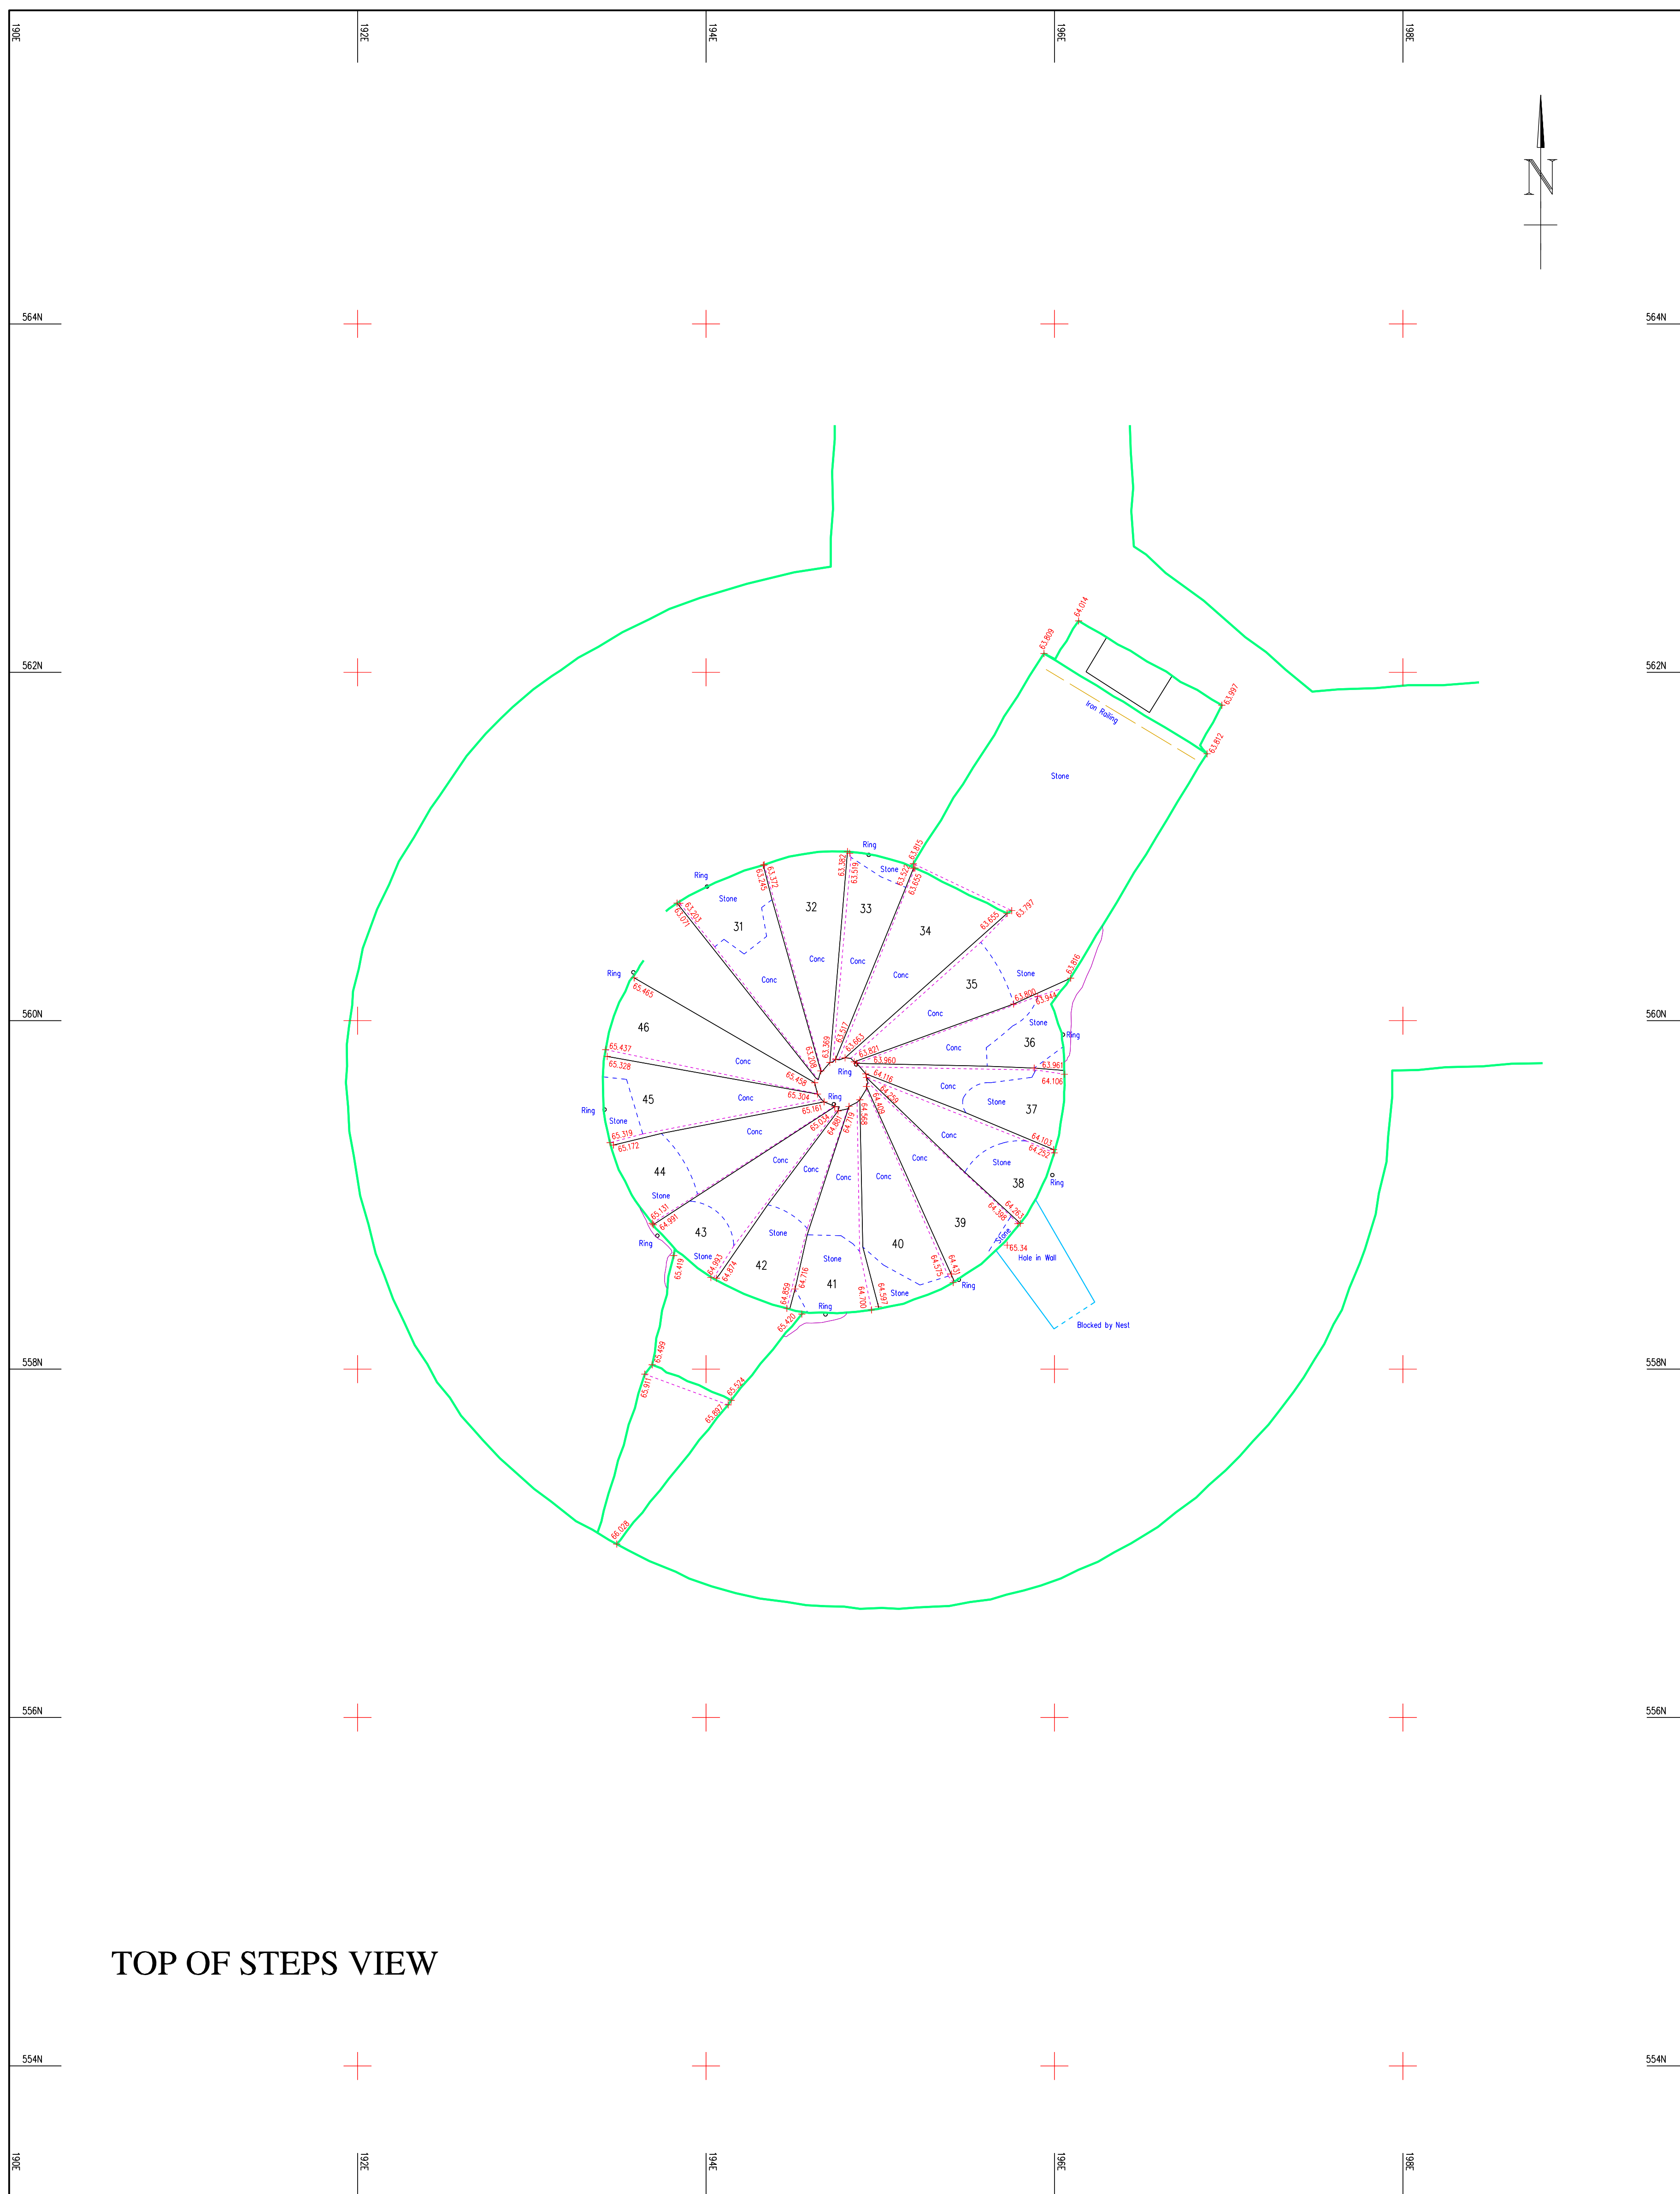
TOP OF STEPS VIEW

Legend	
	Top of step view
	Masonry Wall
	Change of step surface
	Top of step riser
	Base of step riser
	Damage to quoins stones
	Hand rope ring - Position taken at point of fixing to wall due to wall verticality ring may not appear on wall line.
	Underside of step view
	Masonry Wall
	Change of step surface
	Base of step riser
	Top of step riser
	Protruding masonry
	Exposed reinforcing
