**Mumbles Pier
Restoration and
RNLI Lifeboat
Station, The
Mumbles, Swansea**

**Historic Building
Assessment**

October 2010

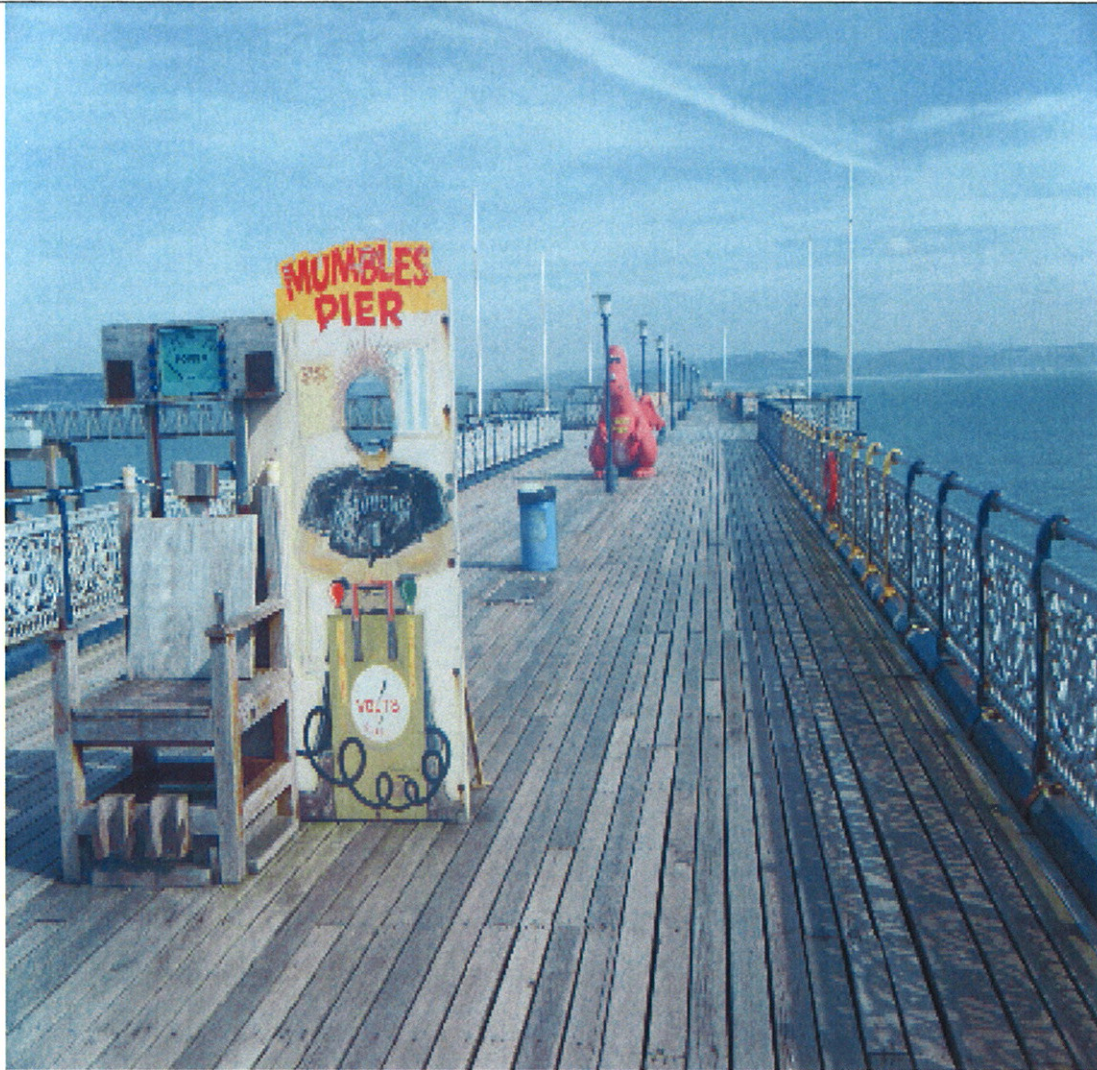
Plate 7	General view towards pier head
Orientation	Viewed from west to east
Structure	Mumbles Pier
Date	16/03/2010

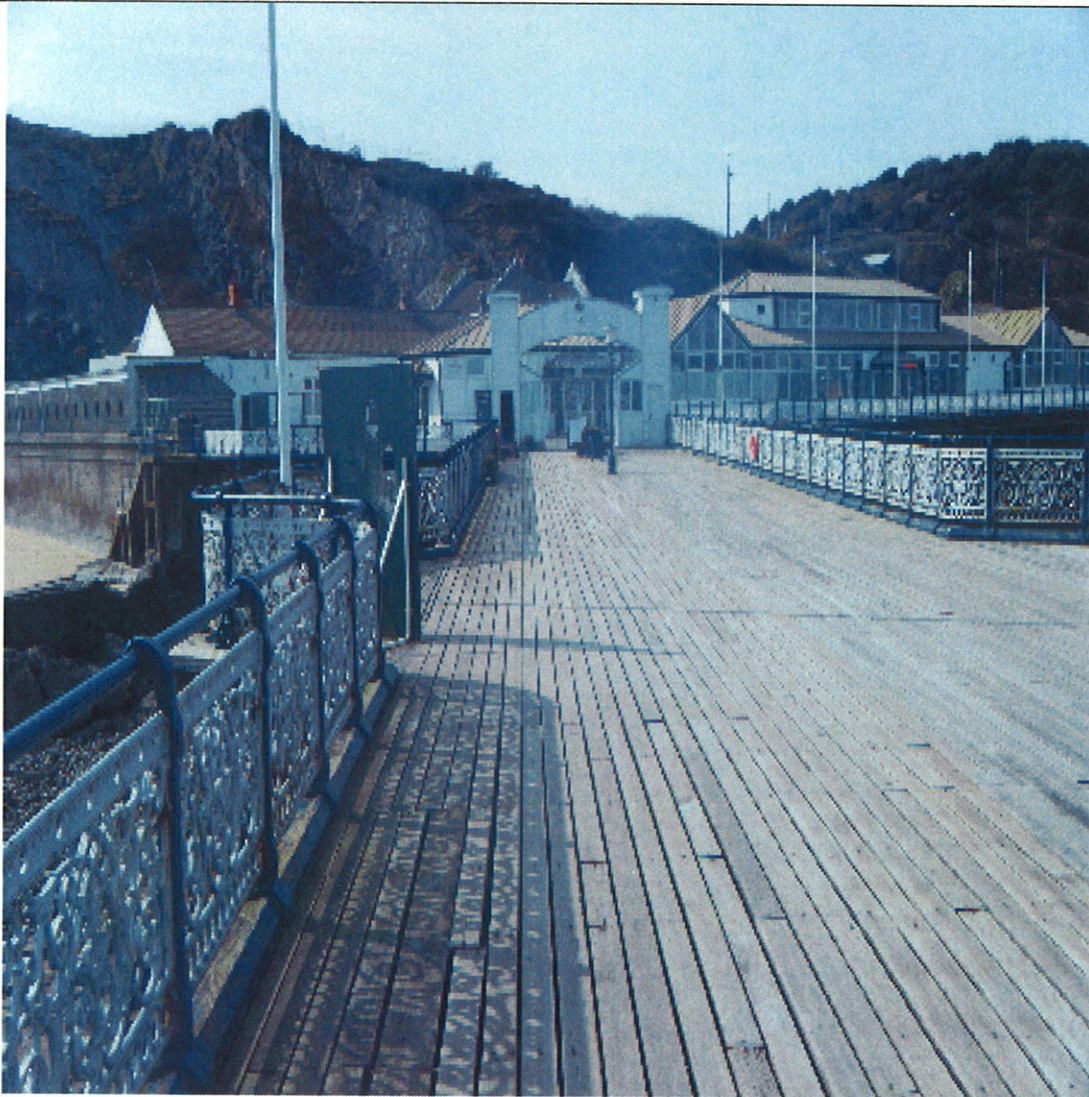
Plate 8	General view towards land
Orientation	Viewed from east to west
Structure	Mumbles Pier
Date	16/03/2010
